RCSL: 44 - RT 1911

PAGE	1	OF	2
RE: ECN NO:	11-069

SERIAL EFFECTIVITY	EQUIPMENT AFFECTED
UNITS SHIPPED AFTER 10-12-1980	<u>RC700</u> RC 702/MIC 702 MICROPROCESSOR
NOTE

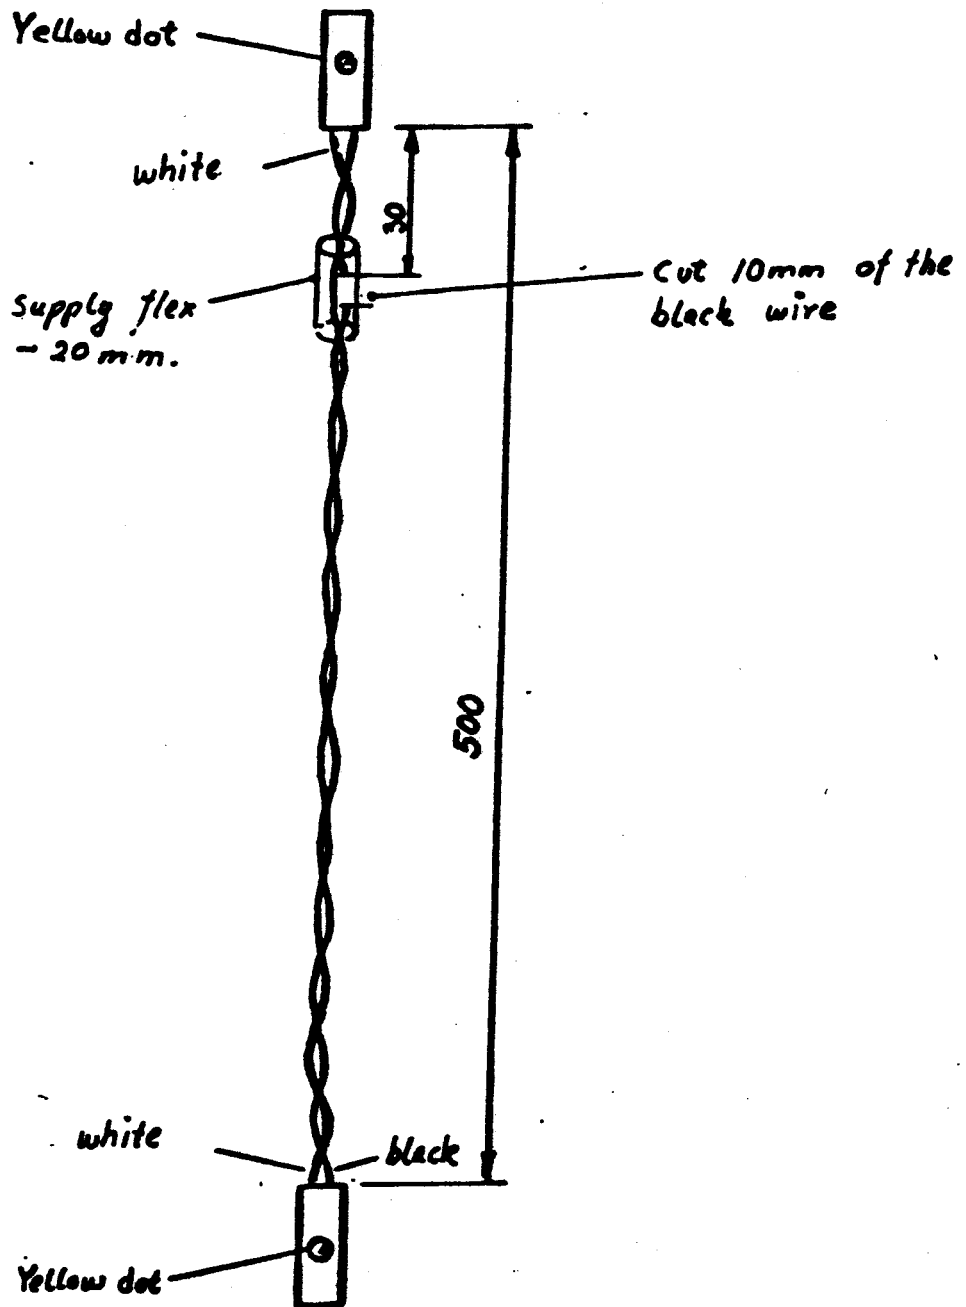
CURRENT IN THE 0 VOLT WIRE FOR THE "SYNC" SIGNAL FROM REC 701 to MIC 702, CAN INTRODUCE NOISE IN SECOND MINI FLOPPY DRIVE IN RC 702.

1. DISCONNECT THE 0 VOLT WIRE BY CUTTING 10 MM OUT AS SHOWN ON PAGE 2.
2. ISOLATE WITH FLEX.
3. CODE THE FCO LABEL 19-005.
