RCSL: 44 - RT 1911

<b>SERIAL EFFECTIVITY</b> All keyboards produced after september th 1st 1981	<b>EQUIPMENT AFFECTED</b> <u>Key-tronic keyboards</u> RC721, RC722, RC801, RC802, RC803, RC805 keyboards.
<b>NOTE</b>

# FIELD CHANGE ORDER

Modification to  
RC 721 / RC 722 Keyboard  
and RC 850

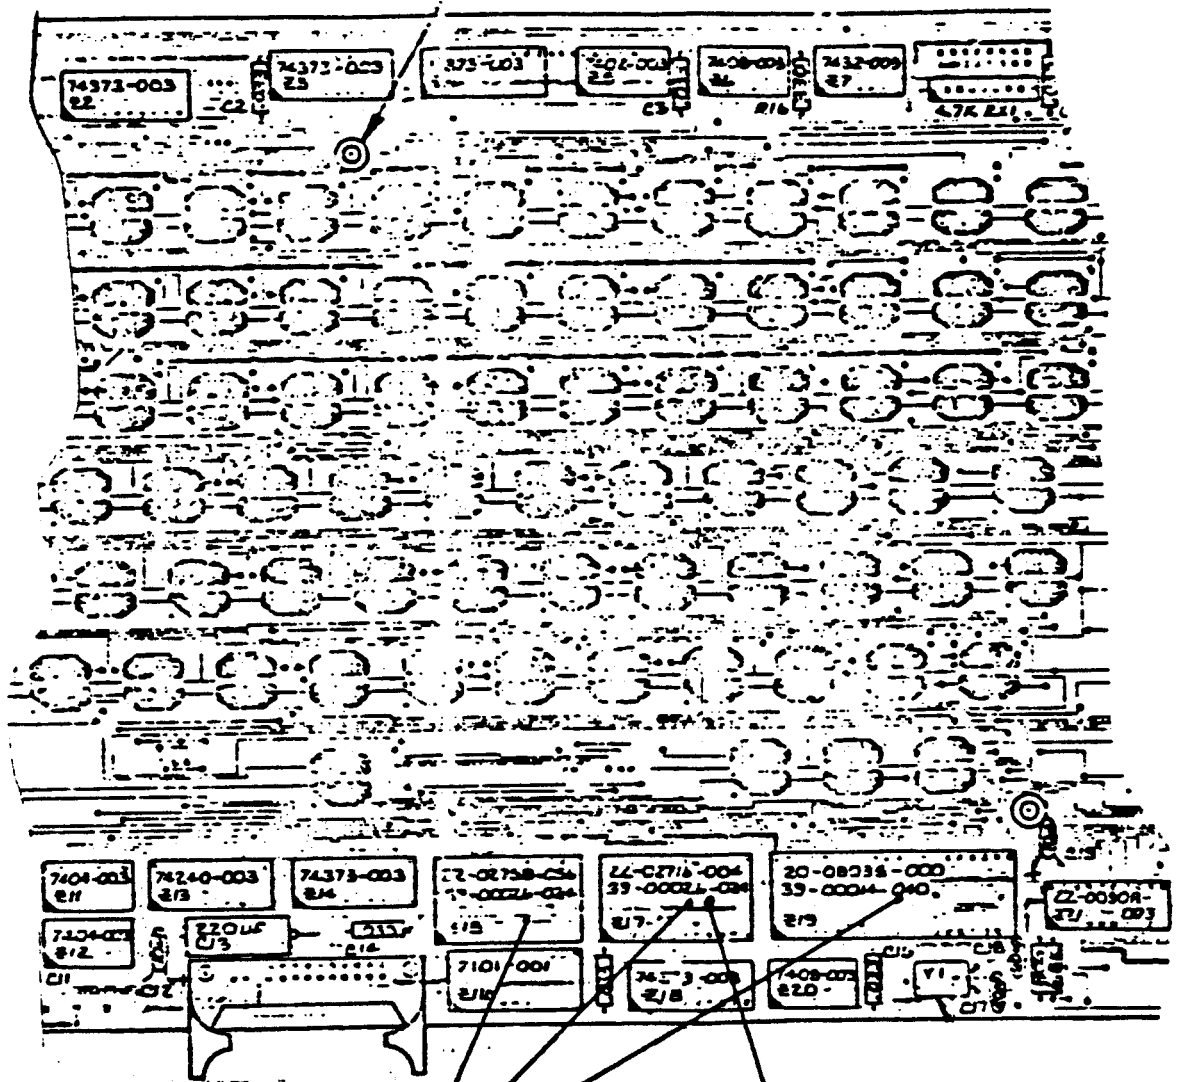
The sockets for the CPU, the program ROM and the external ASCII ROM has too low contact pressure and too poor contact surface.  
The keyboard may fail after an interval of 1 to 12 months. The manufacturer of the sockets is "SCANBE",

The error sympton is keyboard in deadlock, normally with "LOCK" led lit

Insert 3 new sockets

Change EPROM to new version: KTC 013
