SERIAL EFFECTIVITY MIC 703/1001 and upwards	EQUIPMENT AFFECTED RC 700 RC 702 / MIC 702 and MIC 703 Microprocessor.
NOTE

FIELD CHANGE ORDER

NO. 19-004

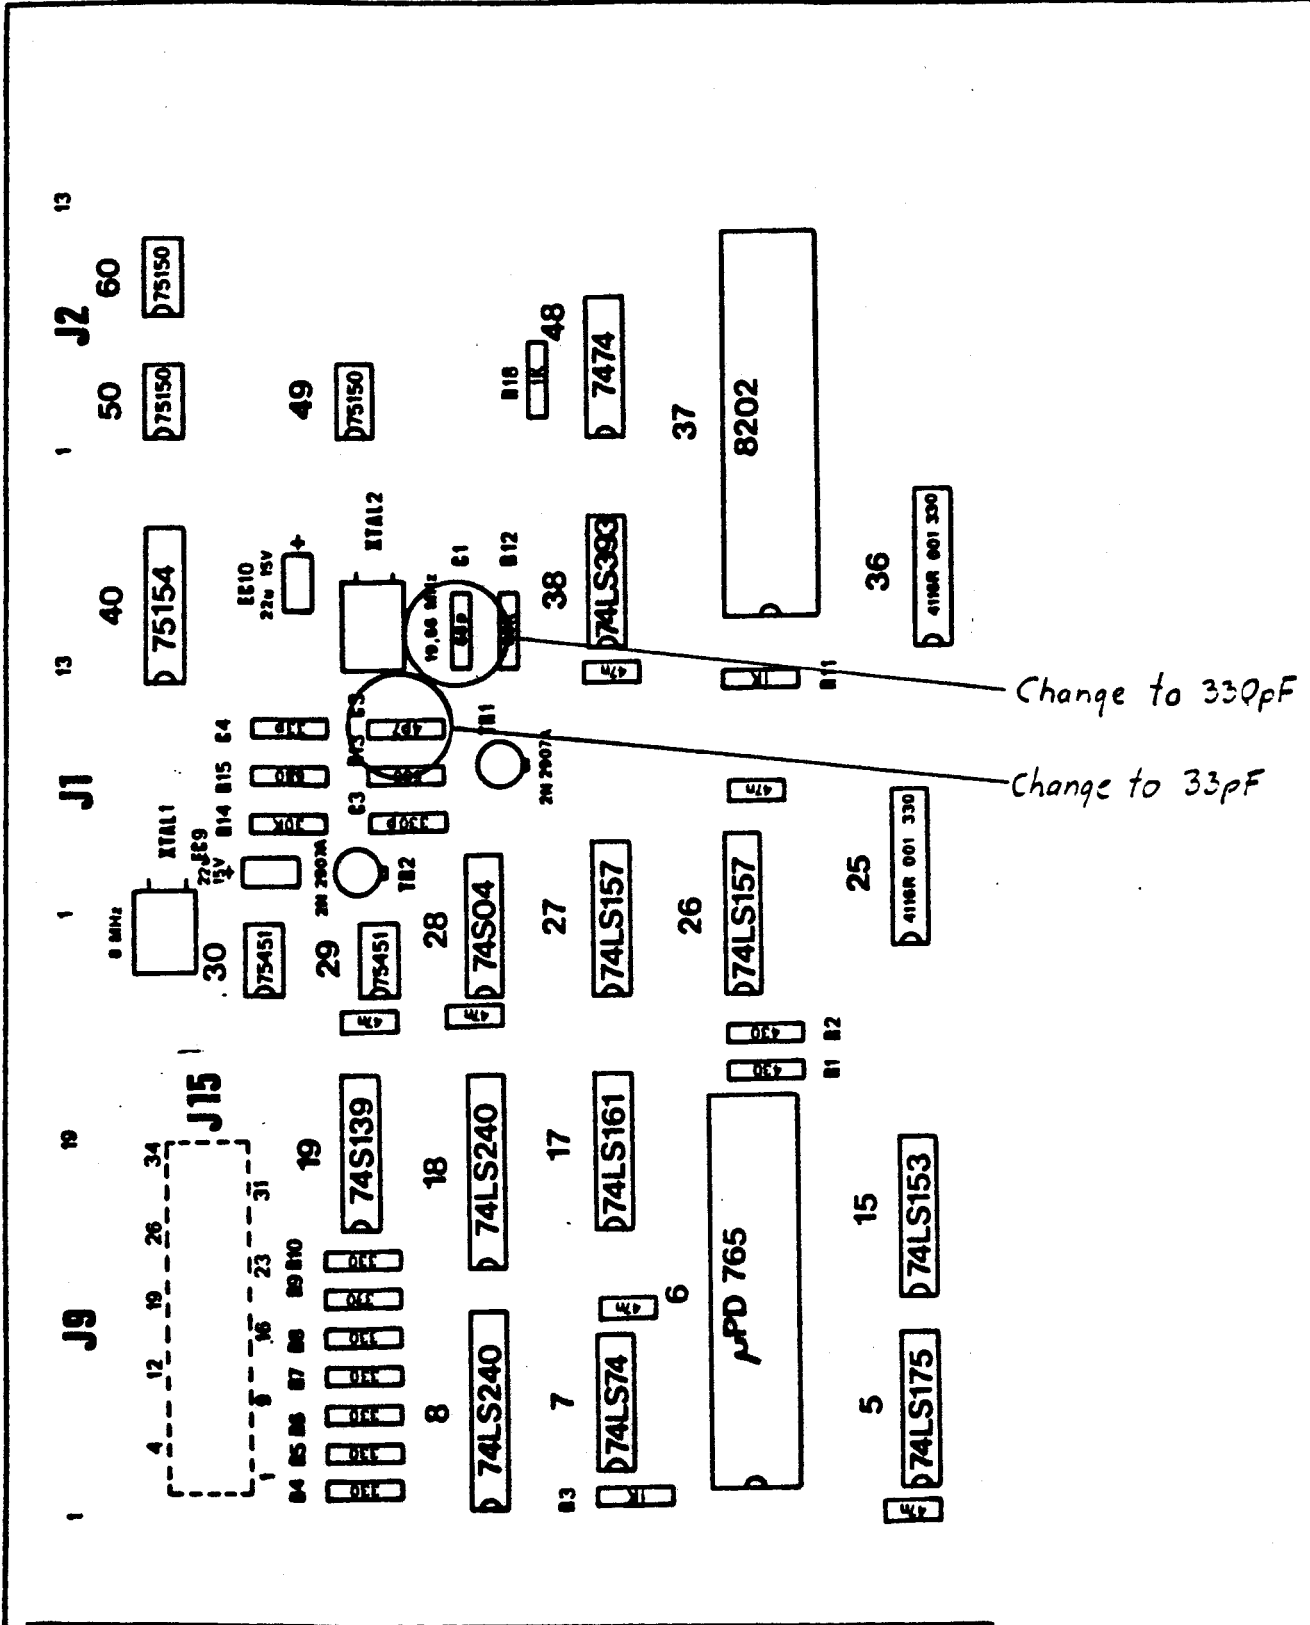
PAGE 2 OF 2

The MEM CLOCK oscillator has caused problems in the production, which has been solved by changing the transistor or the Xtal. In case of such problem change of two capacitors is the correct solution.

- Change C 3 from 4.7 pF to 33 pF. (see page 2)
- Change C 1 from 68 pF to 330 pF. (see page 2)
- Code the FCO-label: 19-004.
