**Dansk Data Elektronik A/S**

**Technical TPP  
Field Change Notes**

**Updated 27th December 1994**

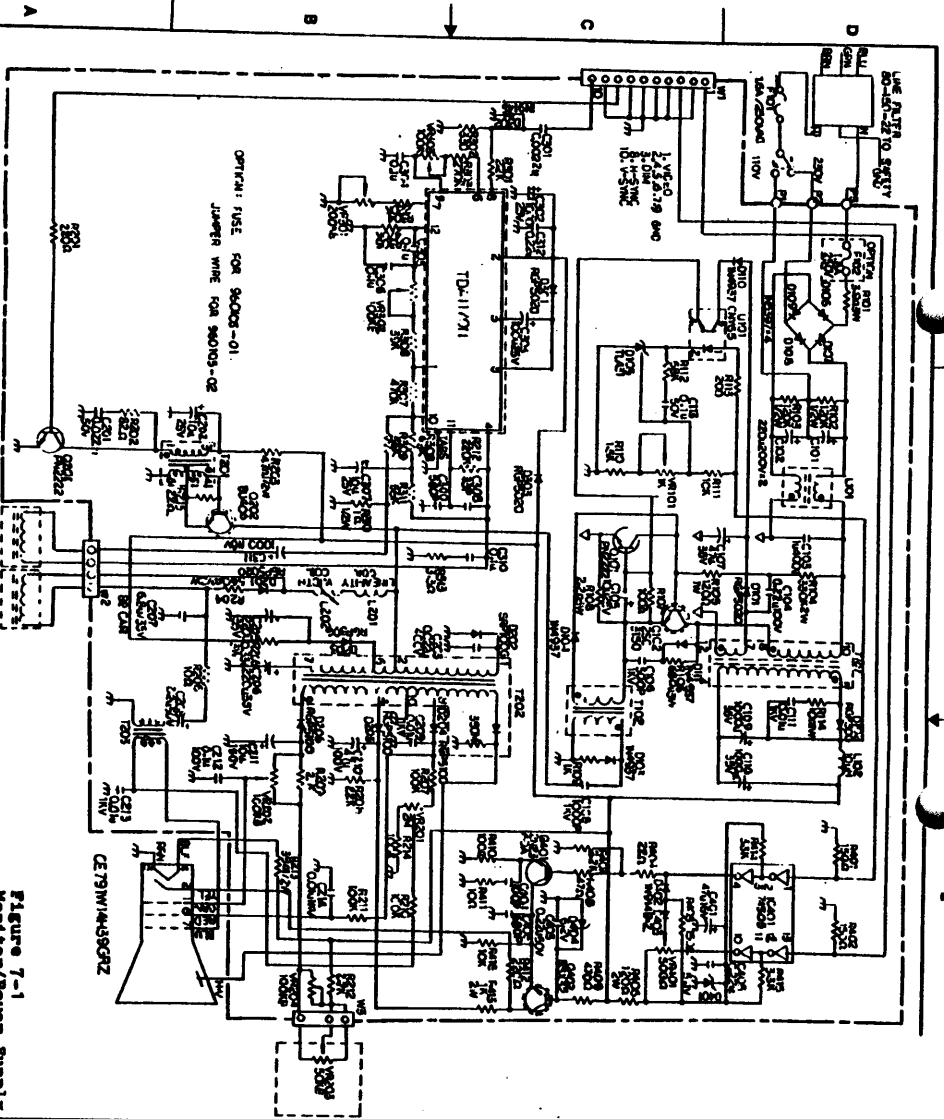
Figure 7-1  
 Motor/Power Supply  
 PCB Schematic  
 (960105-01 Rev. A)

CORRECTS THE ERROR: Missing diagram, Fig. 7-1

DESCRIPTIONS: Diagram of Monitor/Power supply is missing.  
Add the attached diagram to chapter 7 in the TMN-307 manual.

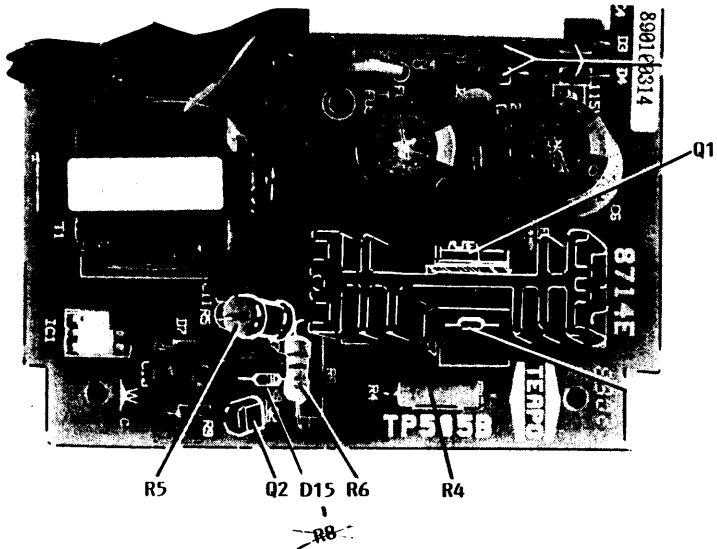
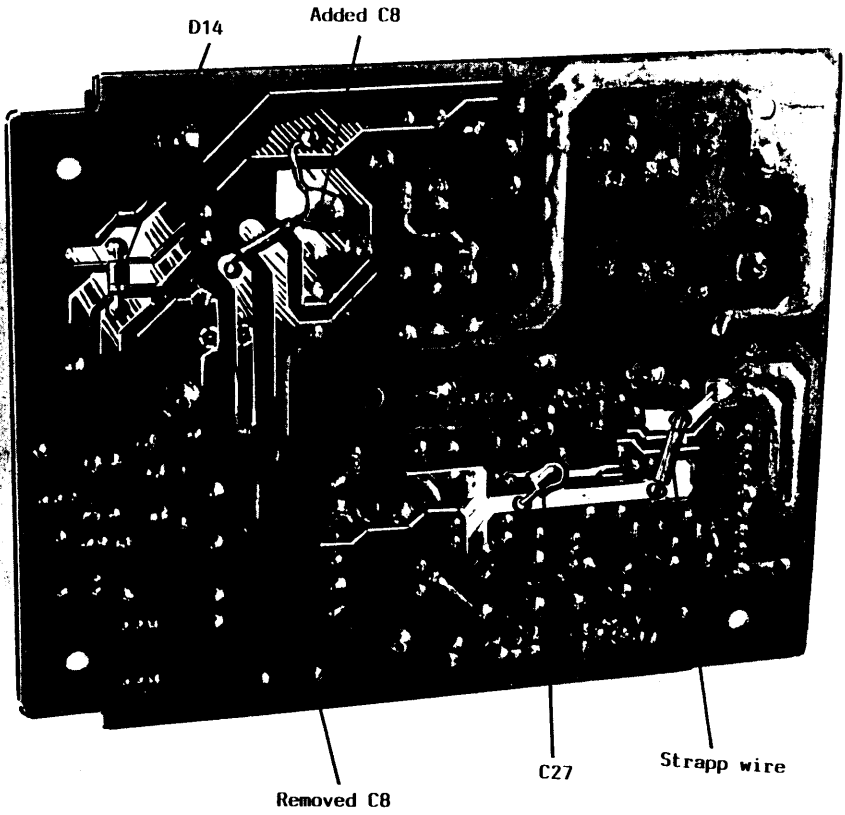
Picture #1:

Do not change R4, change R5 (100kohm/2W to 10kohm/3W), R6 (to 0.82 ohm/2W) and change R8 (2.7 kohm) to diode D15 (1N4148). Check Q1, Q2, Diodes D1 to D5. Add new diode D13, replace IC4, add capacitor to SCR. Add also new diode D14 across C7, move C8 from Q1 to R6. Add ground wire. Please read both SB 290 and SB308 carefully before starting. Estimated time to repair: 45 min.

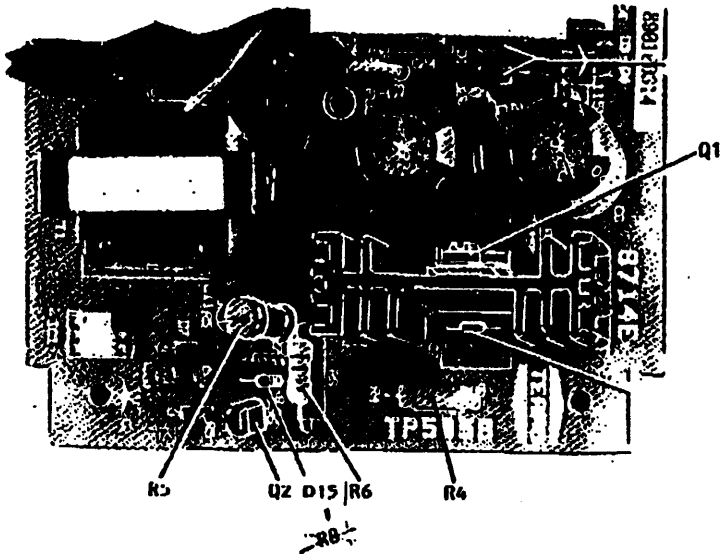
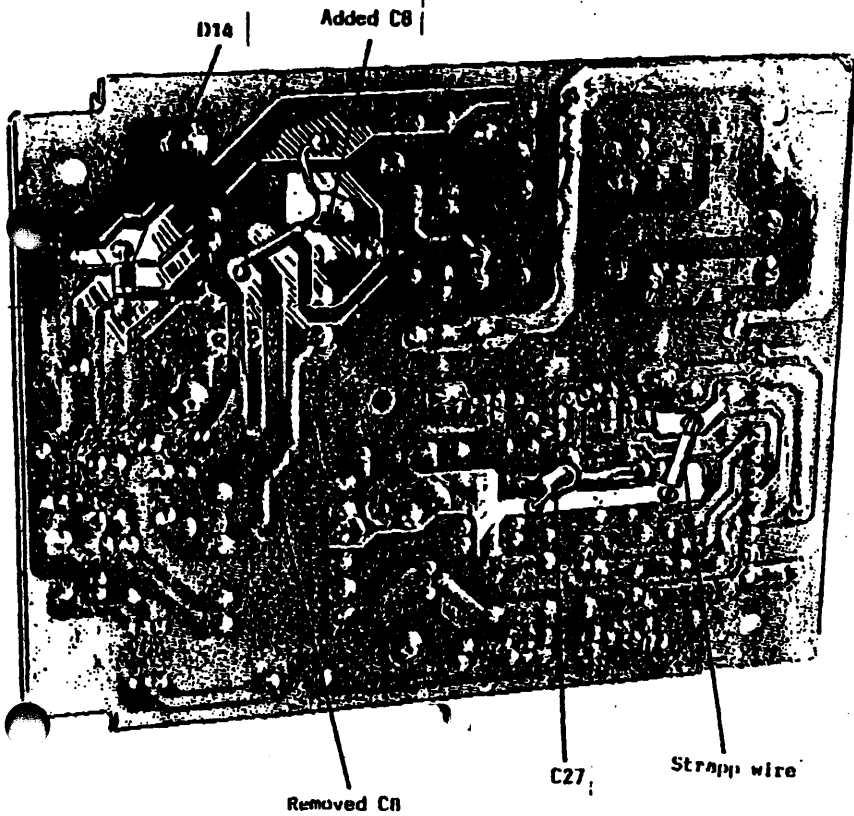
Picture #1:

Do not change R4, change R5 (100kohm/2W to 10kohm/3W), R6 (to 0.82 ohm/2W) and change R8 (2.7 kohm) to diode D15 (1N4148). Check Q1, Q2, Diodes D1 to D5. Add new diode D13, replace IC4, add capacitor to SCR. Add also new diode D14 across C17, move C8 from Q1 to R6. Add ground wire. Please read both SB 290 and SB308 carefully before starting. Estimated time to repair: 45 min.

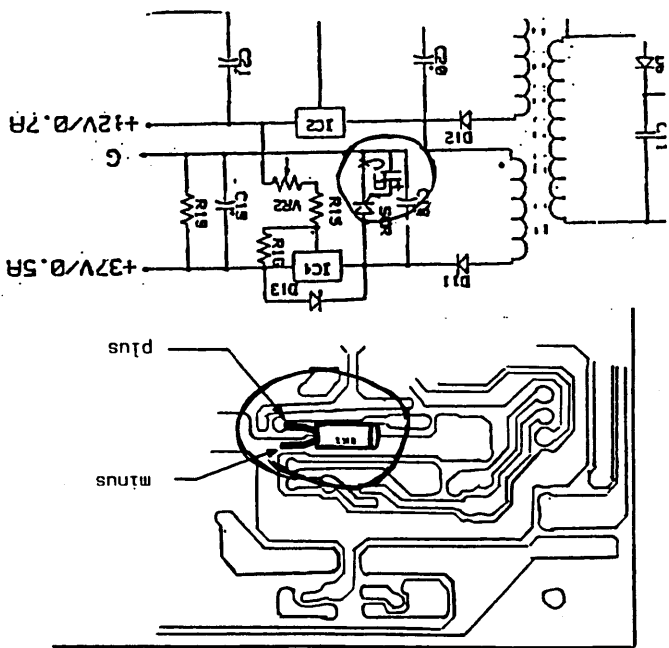
Picture #3:

- Description of problem:
1. Too high voltage is produced across switching transistor Q1 due to design of Power Supply Unit, Facit P/N KDY 199 0538. This will eventually make a short-circuit in the transistor and cause a major malfunction of the PSU.
  2. When switching the mains on and off, the voltage regulator, IC4 (LM317), sometimes will be reverse biased, which can destroy the regulator.
  3. In some cases the 37 VDC output is too low and thereby the picture width can't be properly adjusted.
  4. Static or transient voltages can cause misfiring of the thyristor, SCR, in the +37V-line, which in turn may blow the switching transistor, Q1.

- Solution:
1. Changing the operational parameters of transistor Q1, to make the transistor work in a safe operating area.
  2. Connecting a protecting diode (D13) across the terminals of the regulator IC4.
  3. Replace the regulator IC4 (if necessary).
  4. Connecting a capacitor across the gate of thyristor SCR to prevent the thyristor from misfiring.

Note 3: In case you are repairing a broken power supply board, check the four bridge rectifier diodes D1-4, and change if necessary any faulty diode. (D1, D3 type 1N5397 and D2, D4 type 1N4005). Also check diode D5 (type 1N4148) and exchange it if necessary.

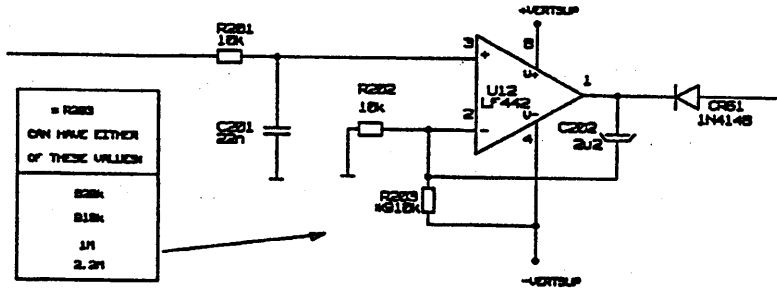
- The circuit U12 is changed to the type LF442 (TD.part no. 422344).
- The strap in the pcb-layout, S16, is cut and replaced with diode CR61. The diode's anode is connected towards the contrast pot-meter R169. (CR61=1N4148, TD.part no. 384841).
- A new capacitor, C202 is inserted between U12-2 and CR61's cathode. (C202=2,2uF, TD.part no. 380466).

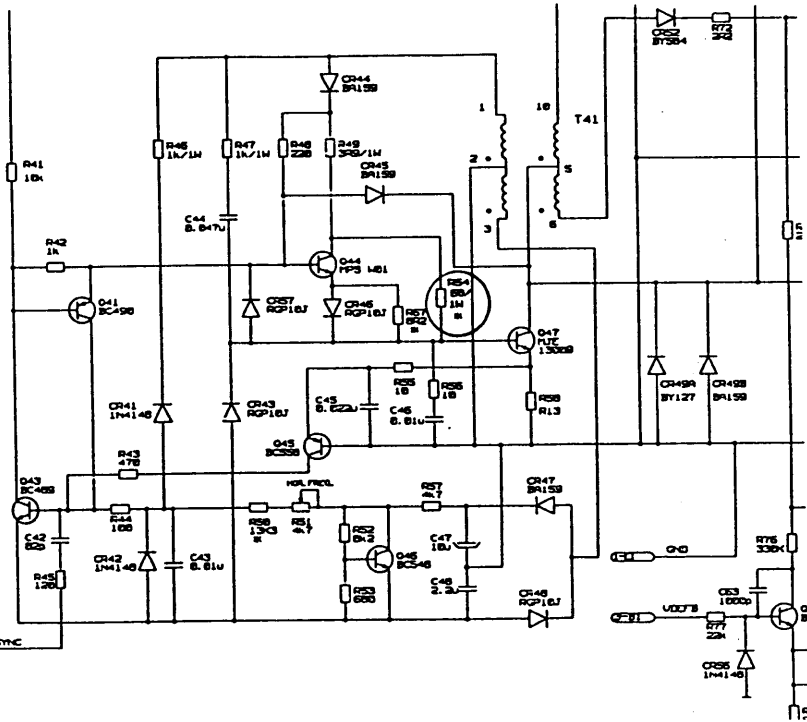
The value of the resistor R54 has been reduced from 220 ohm to 68 ohm, 1W, (TD part no. 392981).

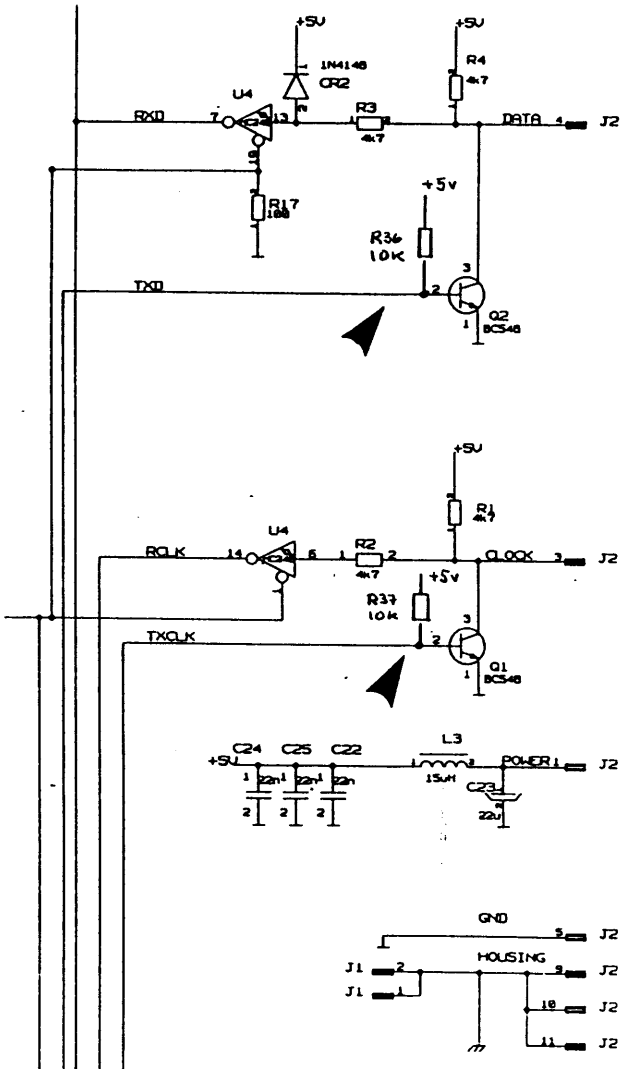
Part of the keyboard circuit diagram showing the two extra resistors, R36 and R37, each 10 kohm.

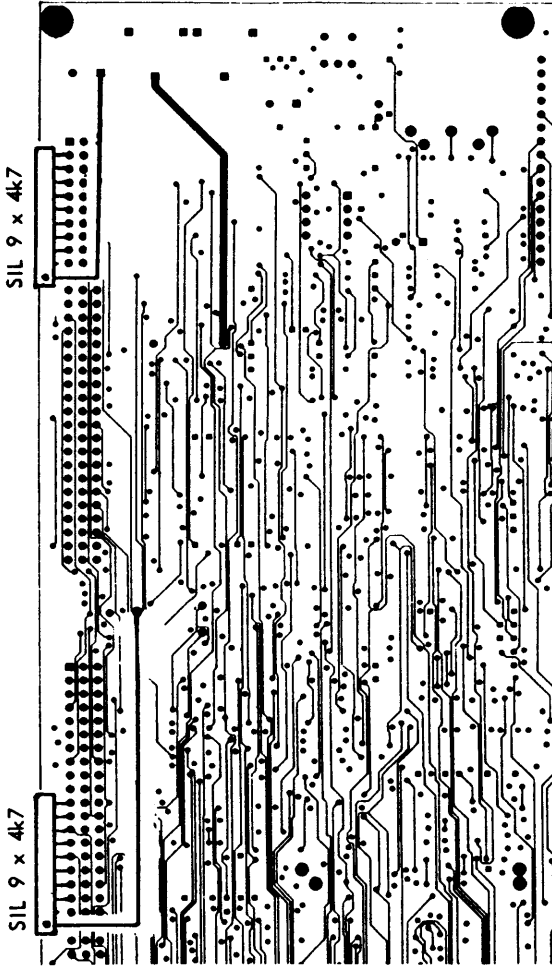
CPU453B: Two 9\*4k7 SIL's placed on the solder side of the PCB 2214973.

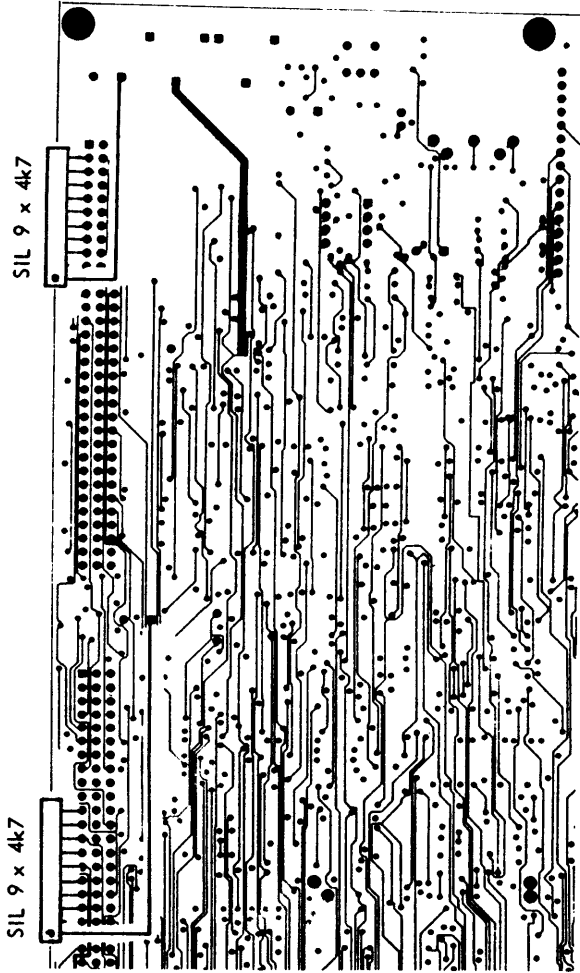
CPU453: Two 9\*4k7 SIL's placed on the solder side of the PCB 2214950A.

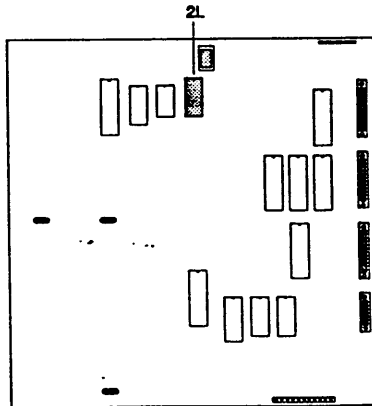
FIGURE 1 - Component Locations

- Replace UMC 8259A interrupt controllers on WYSEpc 286 and WYSEpc 386 systems with approved vendor components. WYSE recommends that the interrupt controllers be replaced with interrupt controllers manufactured by the same vendor. Locations for the interrupt controller components are shown in Figure 1.

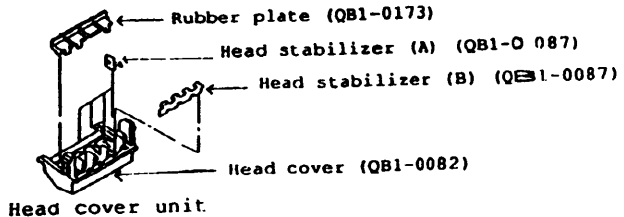
Figure 3

To prevent the dot mis-alignment among four-color heads, a rubber plate has been newly assigned as a service part. This rubber plate can fully press the head cover against the head units. (As a temporary countermeasure, the four rubbers have been separately applied from the beginning of mass production, but each rubber has not been assigned as a service part. If any of rubbers should be replaced, replace the whole rubber plate.) Also, to improve the service efficiency, the head cover unit, which consists of the parts as shown in Figure 3, has been newly assigned as a service part.

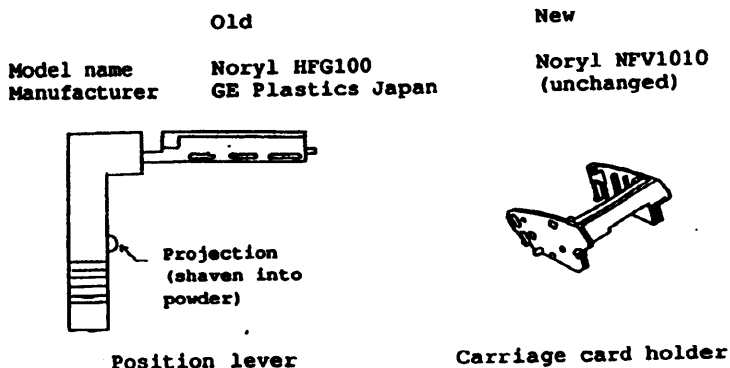
Figure 8

It has been found that the projection on the position lever (QB1-0086) is partially shaven into powder during the durability test (the motor is put into action approx. 1,000 times). To prevent this, the material of the carriage card holder has been changed. This change has been implemented at any time since the new material should have required the UL, and since the position lever is not so frequently used as is in the durability test.

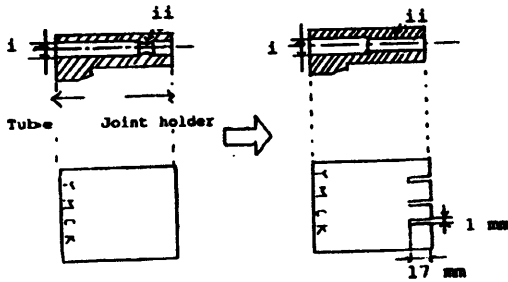
- i. To make the connection between the joint holder (QB1-0067) and the tube (NPN) tight, the joint part has been changed in diameter from 1.9 mm to 1.7 mm.
- ii. The shape of the supply joint has been changed. As a temporary countermeasure, the supply joint has been notched at three parts on the joint holder side from the beginning of mass production.

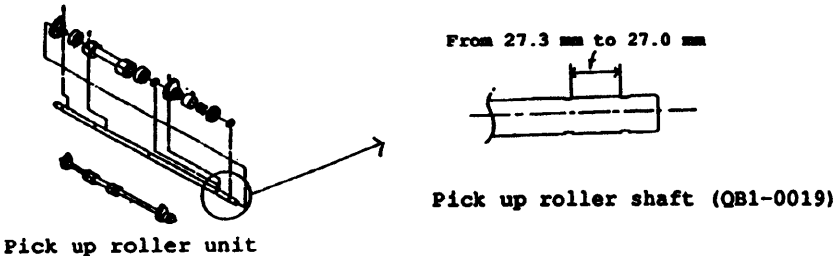
Figure 14

It has been found that there may be a play around the pick-up roller shaft (QB1-0019). To prevent this, the distance between grooves for E rings on the pick-up roller shaft has been changed. Along with this, the 0.1 mm-thick washer, which was installed from the beginning of mass production as a temporary countermeasure, has been eliminated

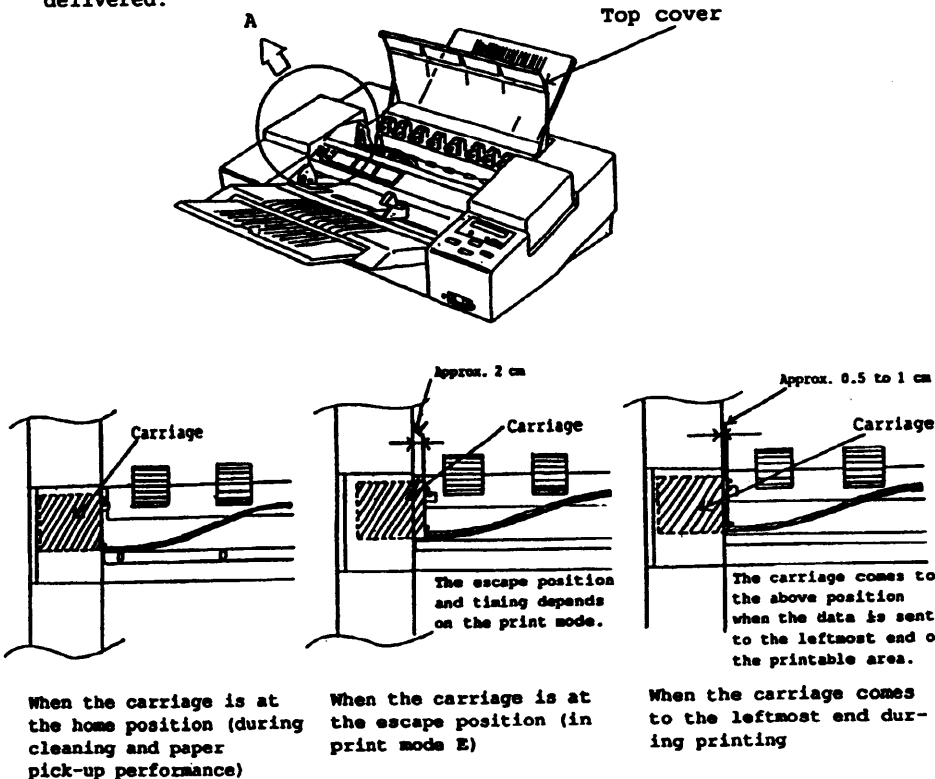
Figure 1

In print mode E, if the top cover is opened just before the paper is delivered (when the carriage is moving to the escape position), the "5E SERVICE" error may be indicated when the carriage moves from the escape position to the home position after the paper is delivered.

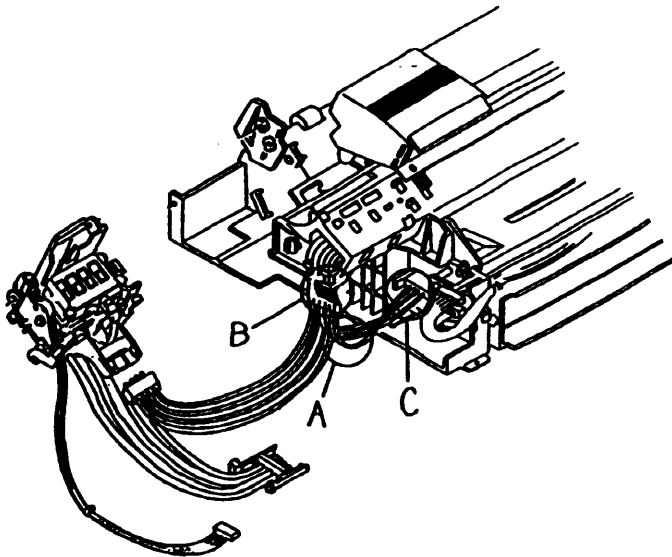
Figure 1

When the upper cover is installed, there is a possibility that the ink supply tubes (A in Figure 1) of the carriage unit may be caught in the upper cover. To prevent this, a guide was added to the left frame plate of the carriage frame unit (B in Figure 1). However, it has been found that when the joint holder is attached to the hook on the left of the carriage frame in servicing, stress may be applied between the supply joint and the ink supply tubes (C in Figure 1). In such a case, there is a possibility that the ink supply tubes may come off or loose the supply joint. To prevent this, be careful for the following.

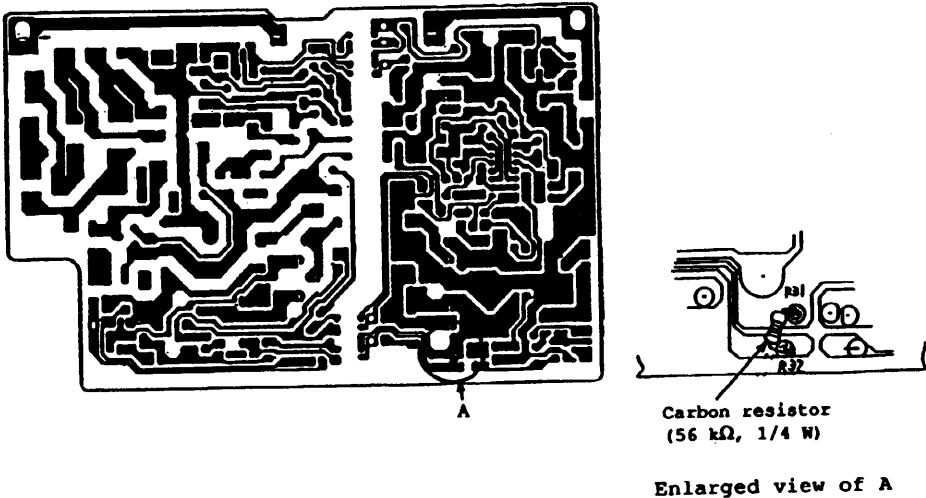
Figure 1

Note: As a temporary countermeasure, a carbon resistor (56 k $\Omega$ , 1/4 W) is soldered on the P.C. Board (figure 1).

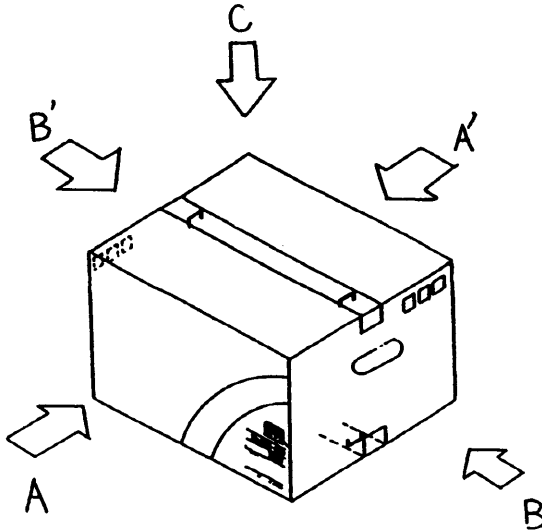
Figure 1: Outer carton

If the printer is transported with one side down (A, A', B, B' and C in figure 1) and left for a long time, the head cap is apt to shift, resulting in ink leakage. However, even if the head cap is shifted, the ink does not leak if the printer is left with the bottom side down as shown in figure 1.

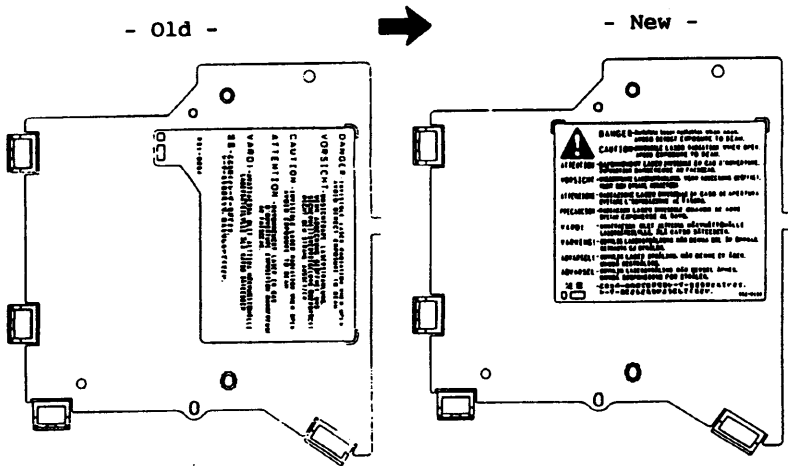
**Fig.1: Cover**

- 1) The warning, written in six languages before, is now written in ten languages.
- 2) The warning sign has been added.
- 3) The shape of the label has been changed. Along with this, the position of the rib on the cover has also been changed.

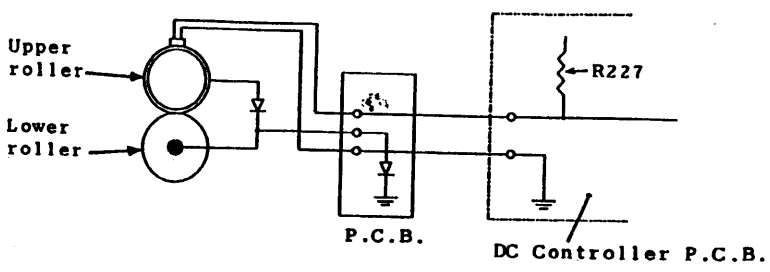
Fig. 1: Circuit diagram of 2D Fixing Assembly

To eliminate this problem, a third diode (D503) has been added to allow the lower fixing roller to discharge to ground (see figures 1 and 2). To simplify installation, a "3 Diode Upgrade Kit" has been assigned as a service part.

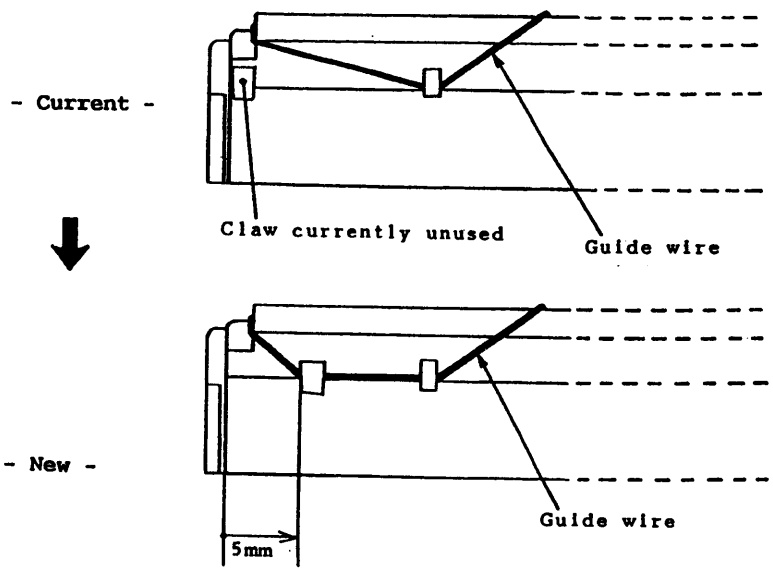
**Figure 1**

To prevent the guide wire from coming off the claw on the static charge eliminator, unused claws at both ends are now also used as shown in figure 1.

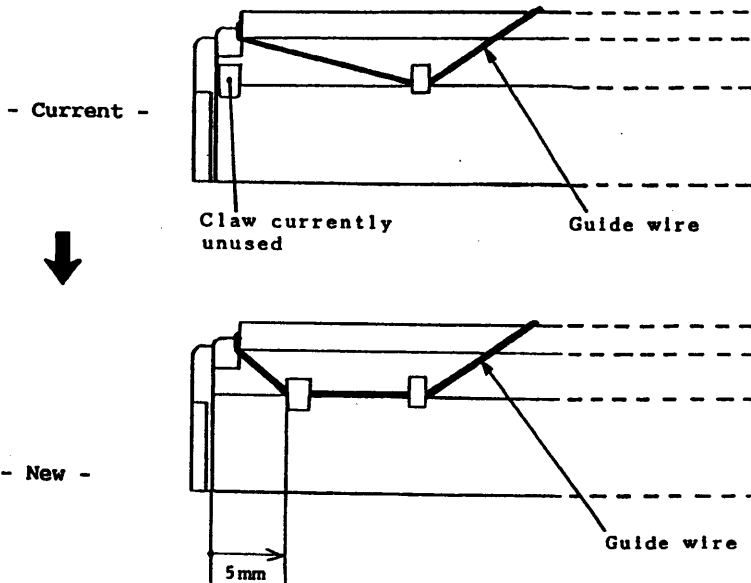
Figure 1

To prevent the guide wire from coming off the claw on the static charge eliminator, unused claws at both ends are now also used as shown in figure 1.

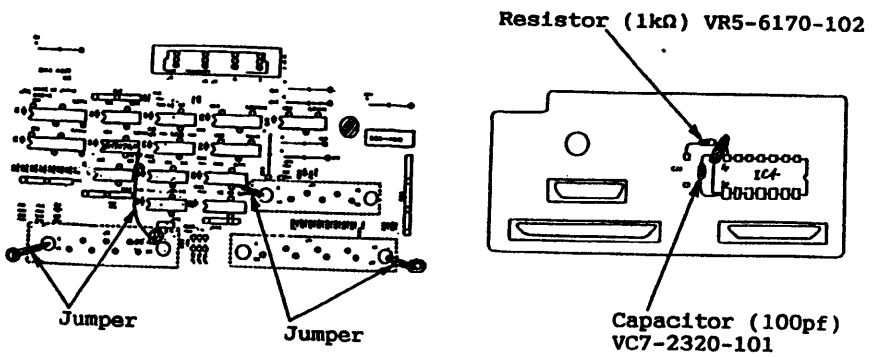
**Fig. 1: Interface P.C.B. Assembly**

To increase the margin for electrostatic discharge, IC4 and R10 on the Interface P.C.B. Assembly have been changed. Along with this change, jumpers, a resistor (1k $\Omega$ ) and a capacitor (100pF) have been added. Refer to figure 1.

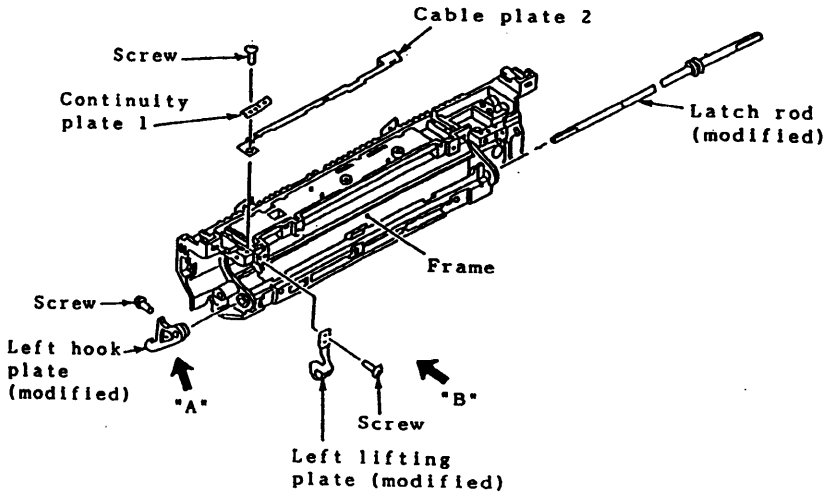
**Fig. 1: Fixing Assembly**

The positions of the screws fixing the left hook plate and left lifting plate have been changed, in order to increase the distance between these screws and the AC line of the halogen heater. For further details, refer to figures 1, 2 and 3.

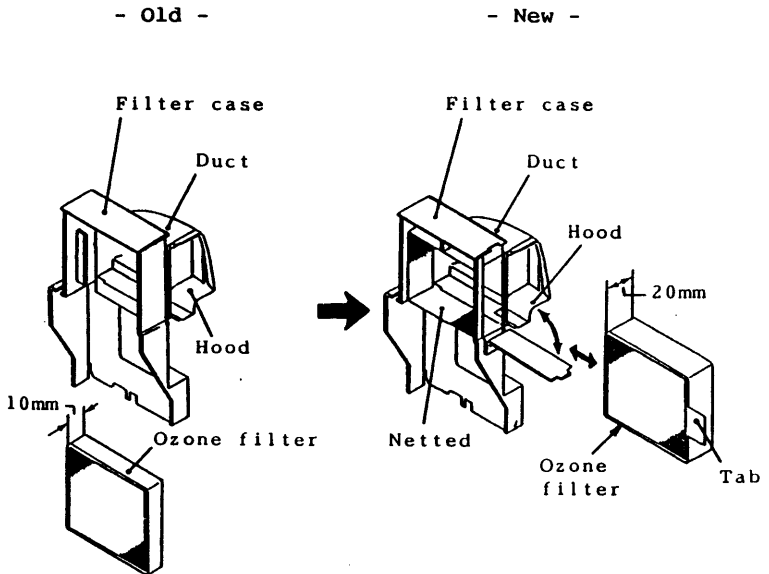
Figure 1

To reduce ozone emission, the ozone filter has been changed. Along with this change the ozone filter case, duct and hood have been modified, so that the ozone filter can easily be replaced. Refer to figure 1.
