Dansk Data Elektronik A/S

**Technical
Field Change Notes**

Updated 1st November 1996

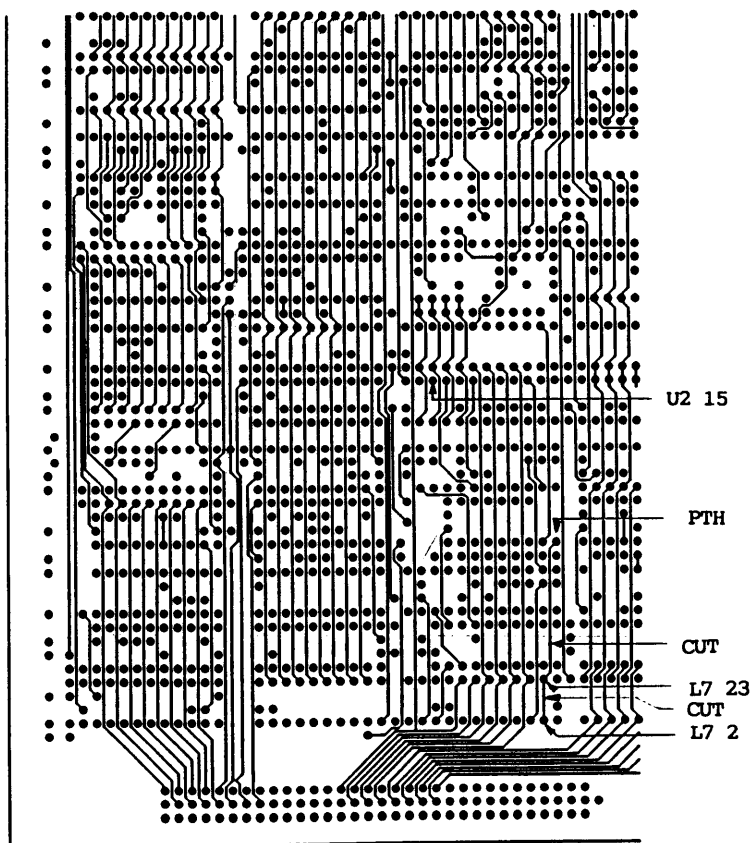
CPU module 4100/4101 seen from the solder side.

There is a possibility that the module changes the unit number during the last clock cycle of an access to the I/O bus. If that happens, it may cause an error in another unit connected to the I/O bus.

1. Disconnect L7 pin 23 by making two cuts on the solder side of the of the board. (See next page)
2. Connect L7 pin 2 to the plated through hole, PTH, with a wire on the solder side of the board.
2. Connect L7 pin 23 to U2 pin 15 with a wire on the solder side of the board.
5. Update PCB revision level B to C by removing the letter B.

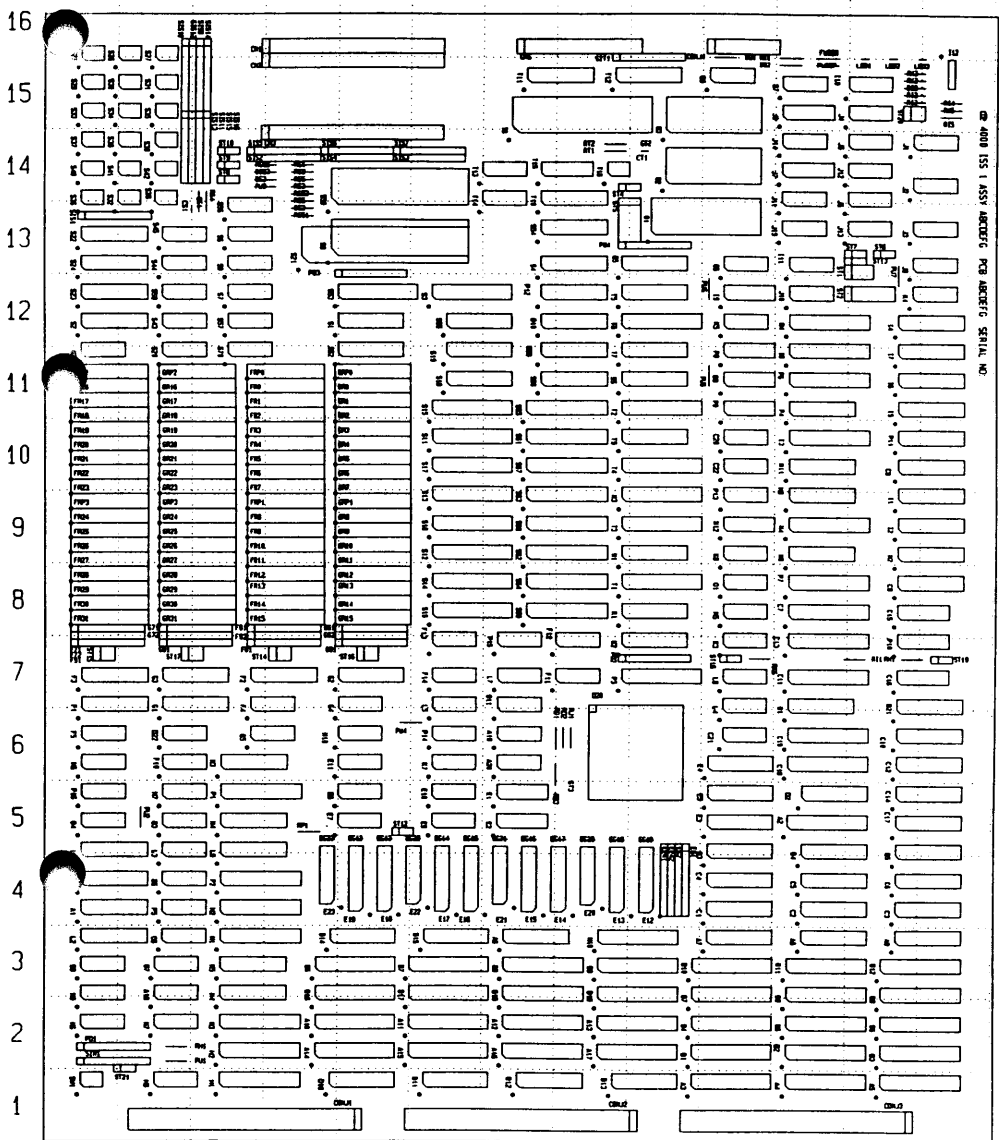
During a read access to the Supermax I/O bus the internal databus starts to oscillate. The oscillation introduces voltage levels on several PALs above the max. specification. Due to the high voltage levels the PALs fail.

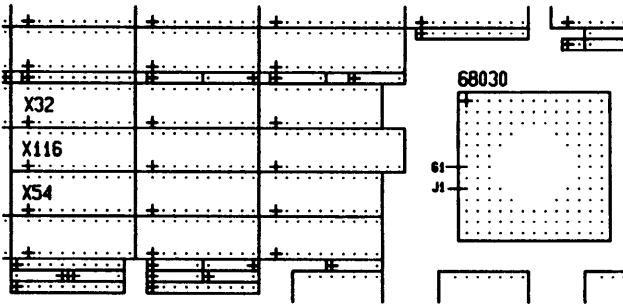
Board layout details 4600.

- Hazardous timing of various control signals.

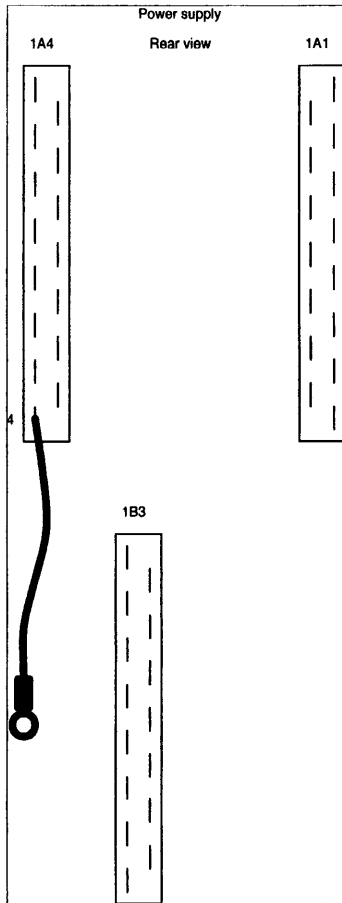
Supermax 6. Power supply.

The primary EARTH and secondary GND (0V) of the power supply should be tied together. If not, noise is generated, that affects the writing ability of the streaming tape drive. This error has been observed using the Diagnostic Programs.

1. Insert the "AMP standard timer contact" end of the wire in connector 1A4 pin 4 and attach the other end below a screw to the left of the connector.
2. Update the revision level by removing the letter B from the label on the rear of the cabinet.
