Dansk Data Elektronik A/S

**Technical
Field Change Notes**

Updated 15th June 1994

SECTION 1.0 : Supermax Field Change Notes

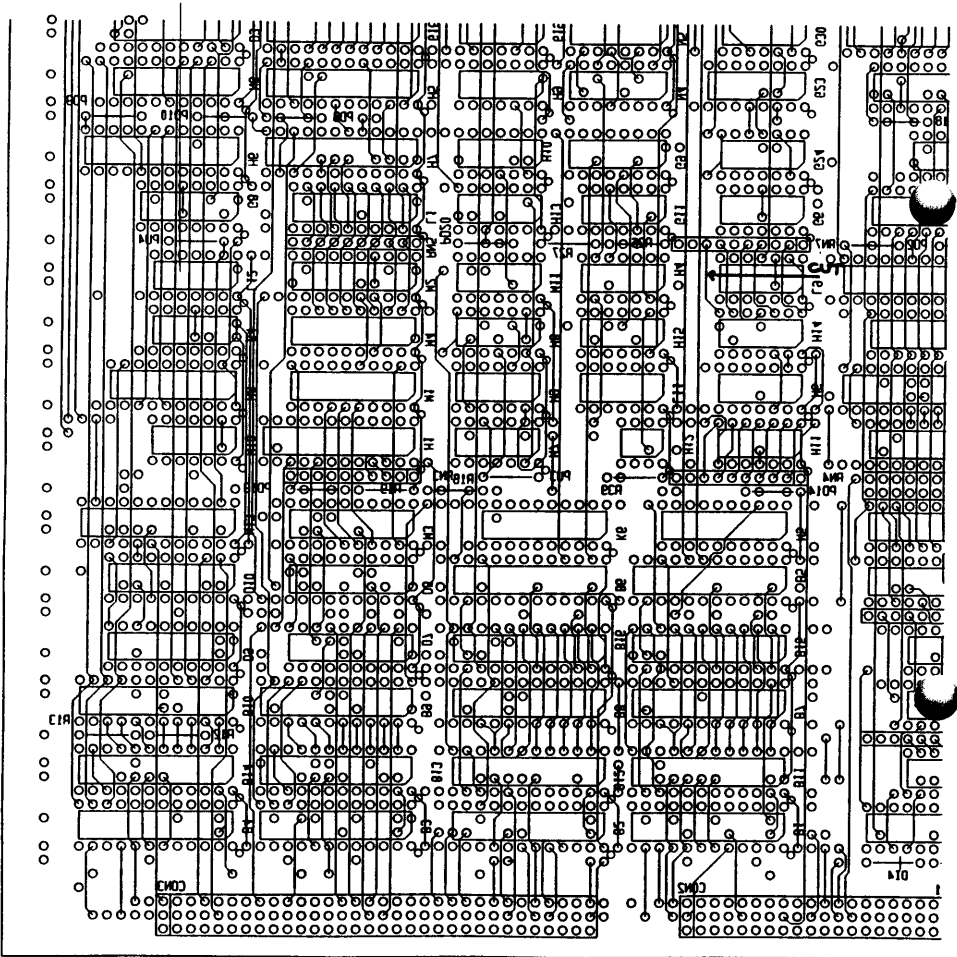
CPU 4501, ISS 1. Solder side.

- A PAL device does not comply with its AC specification. The PAL is replaced with a different type.
- The error results in unpredictable errors, system crash, core dumped or trace files with the Supermax Operating System.
- The error is seen as memory errors with the Supermax Diagnostic programs. Worst case environment is high supply voltage and high temperature.

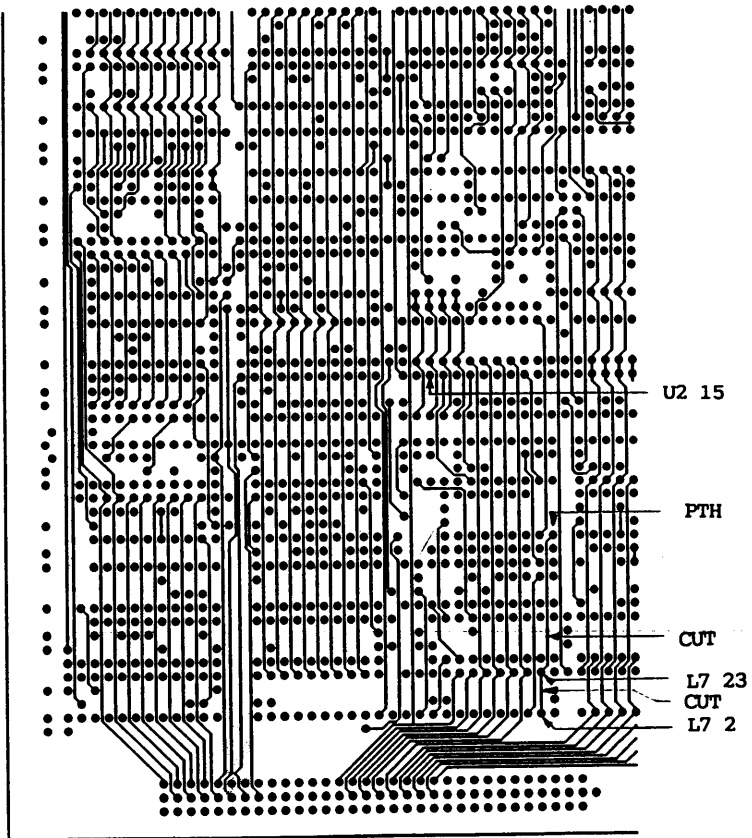
CPU module 4100/4101 seen from the solder side.

There is a possibility that the module changes the unit number during the last clock cycle of an access to the I/O bus. If that happens, it may cause an error in another unit connected to the I/O bus.

1. Disconnect L7 pin 23 by making two cuts on the solder side of the of the board. (See next page)
2. Connect L7 pin 2 to the plated through hole, PTH, with a wire on the solder side of the board.
2. Connect L7 pin 23 to U2 pin 15 with a wire on the solder side of the board.
5. Update PCB revision level B to C by removing the letter B.

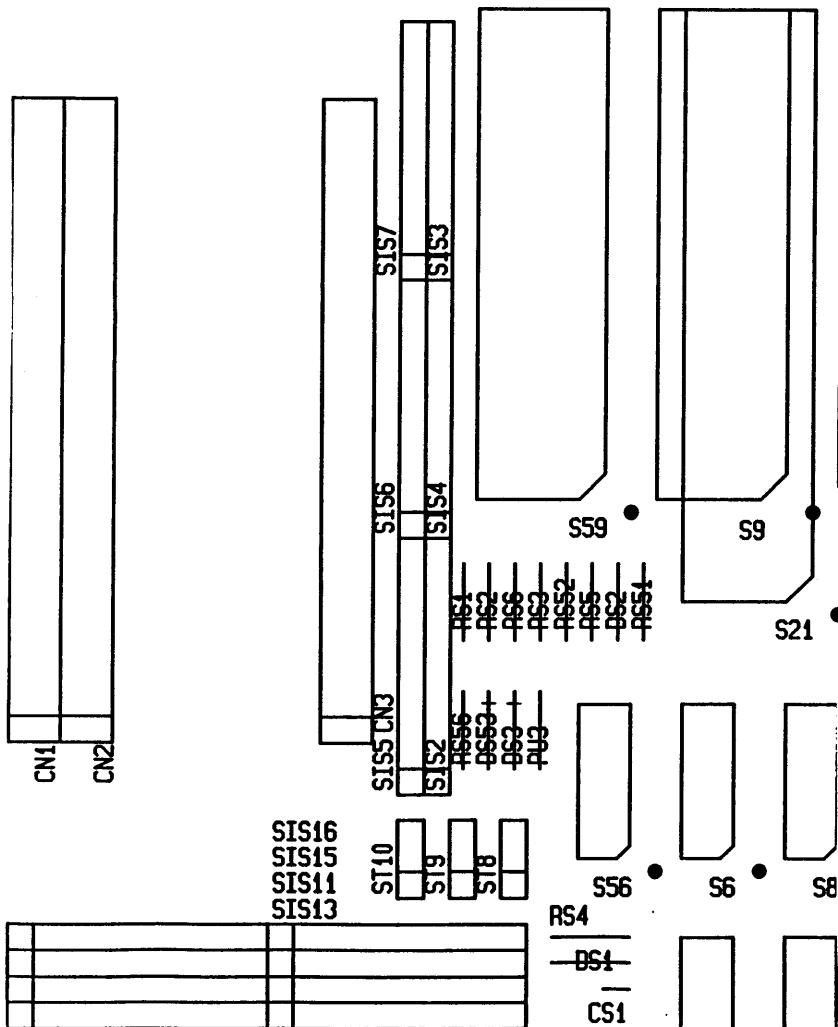
- The SCSI interface cable is terminated with resistor-networks at each end of the cable. Power to the resistor-network is provided by the SCSI device which holds the network (DIOC or disk drive) or by the *termination power signal* in the cable.
- The *termination power signal* is used when two DIOC modules are connected to the same cable. Each DIOC module holds a termination networks and both DIOC modules provides the termination power to the cable.
- If one DIOC module looses the power the other DIOC provides the termination power and the SCSI bus is still properly terminated.
- This note describes how to provide correct termination power.

1. Replace diode DS3 and DS53 with 1N5818 types.
2. Connect strap ST10 pin 2 to connector CN3 pin 26 with insulated wire on the solder side of the PCB.
3. Strap ST8 provides termination power to SCSI interface 0. Set strap to short between pin 2 and 3.
4. Strap ST10 provides termination power to SCSI interface 1. Set strap to short between pin 2 and 3.
5. Update PCB revision field:
 - 4000 ISS 1: Update to revision G by removing the letter F in the PCB identification field.
 - 4000 ISS 2: Update to revision D by removing the letter C in the PCB identification field.

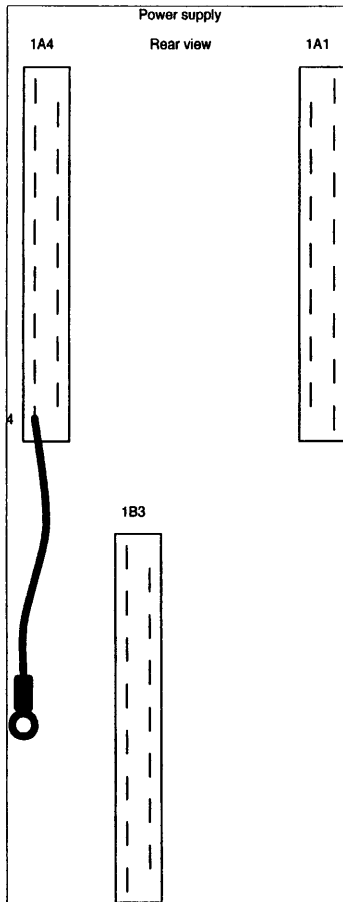
Supermax 6. Power supply.

The primary EARTH and secondary GND (0V) of the power supply should be tied together. If not, noise is generated, that affects the writing ability of the streaming tape drive. This error has been observed using the Diagnostic Programs.

1. Insert the "AMP standard timer contact" end of the wire in connector 1A4 pin 4 and attach the other end below a screw to the left of the connector.
2. Update the revision level by removing the letter B from the label on the rear of the cabinet.

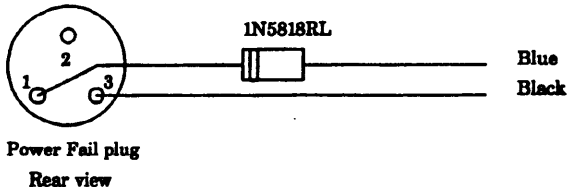
The second Supermax will detect a power fail situation, when the first Supermax is turned off.
The Service Computer does not correctly control the voltages of the power supply (SM6, SM12 and SM24 only).

1. Insert the diode in the blue wire on the POWER FAIL INPUT connector. See the drawing for orientation details. Remember to install the flexible insulation on the wire. Seal the component by heating the flexible insulation.
2. Cut the brown wire in the cable connecting the SCB4260 Service computer backplane plug JPS1 (JPS2) and the power supply connector 1A1 pin z32 REMOTE MARG.
3. Place the label on the rear panel, next to the label containing the model/type information. Update to revision B by removing the letter A from the label.

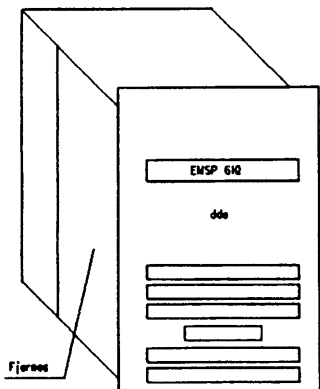
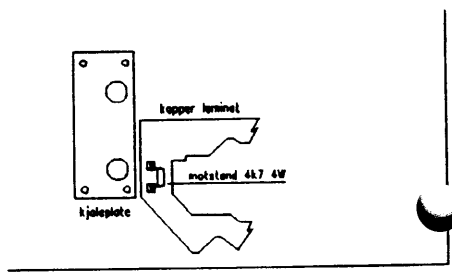
Figure 1.

- Occasional error 03 (media error) from the Video Streamer in the old disk cabinet. The airflow may take in dust particles that may cause the video streamer to fail.
- The error is corrected by exchanging the mounting bracket for the streamer with a new version including a fan that will re-route the airflow.

- Replace the mounting bracket assembly for the video streamer in the disk cabinet. Connect the fan to the +12V supply.
