PAGE	1	OF	2
RE: ECN NO:	19-001

SERIAL EFFECTIVITY	EQUIPMENT AFFECTED
N/A	RC 700 RC 721, RC 722 / KBU 721, KBU 722, KBU 72 Keyboard.

FIELD CHANGE ORDER

NO.	19-001
PAGE	2 OF 2

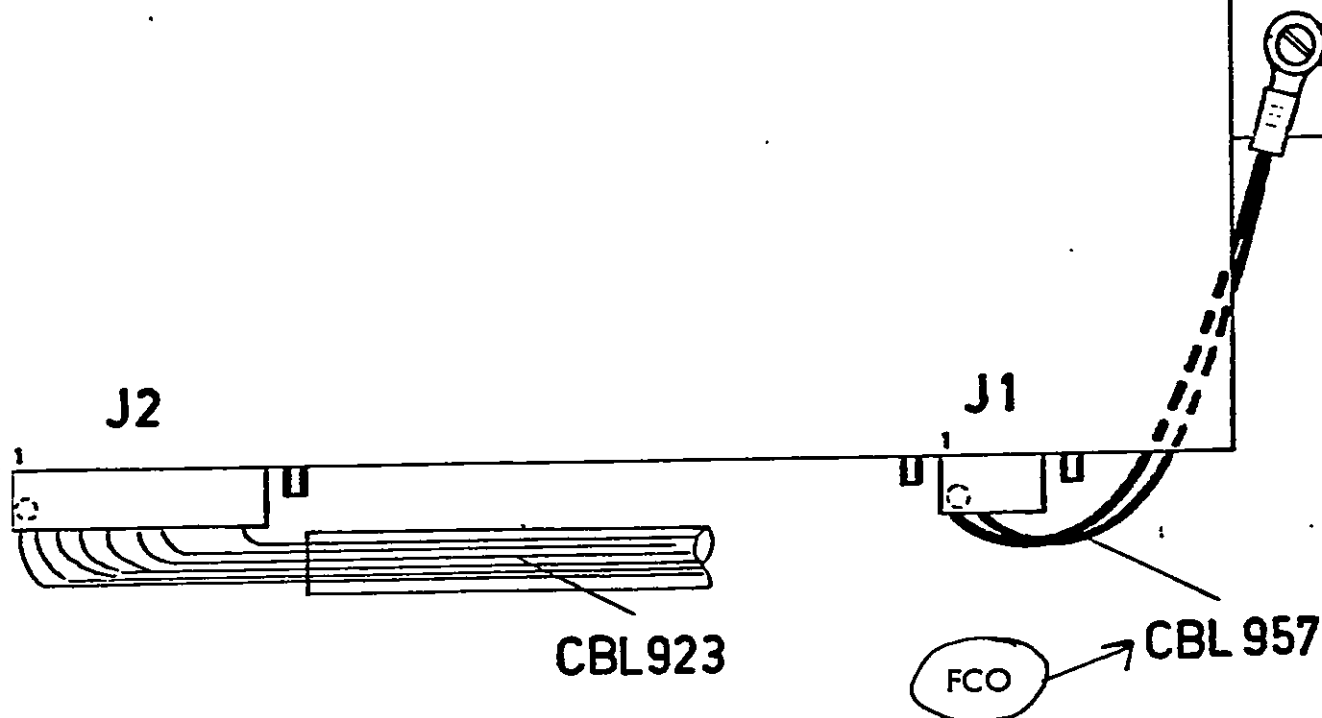
KEYTRONIC KEYBOARD BOTTOM VIEW

The keyboards may be sensitive to static electricity. To prevent this the 0 Volt on the keyboard is connected to the chassis of the keyboard.

Connect the cable CBL 957 between J1 and chassis as shown on page 2.
Code the FCO-label: 19-001.
