RCSL: 44 - RT 1911

SERIAL EFFECTIVITY  KBU 722, S/N 1112 KBU 223, S/N 291	EQUIPMENT AFFECTED RC700 RC722/KBU 722/KBU 723 Keyboard
---	--

# FIELD CHANGE ORDER

NO. 19-012

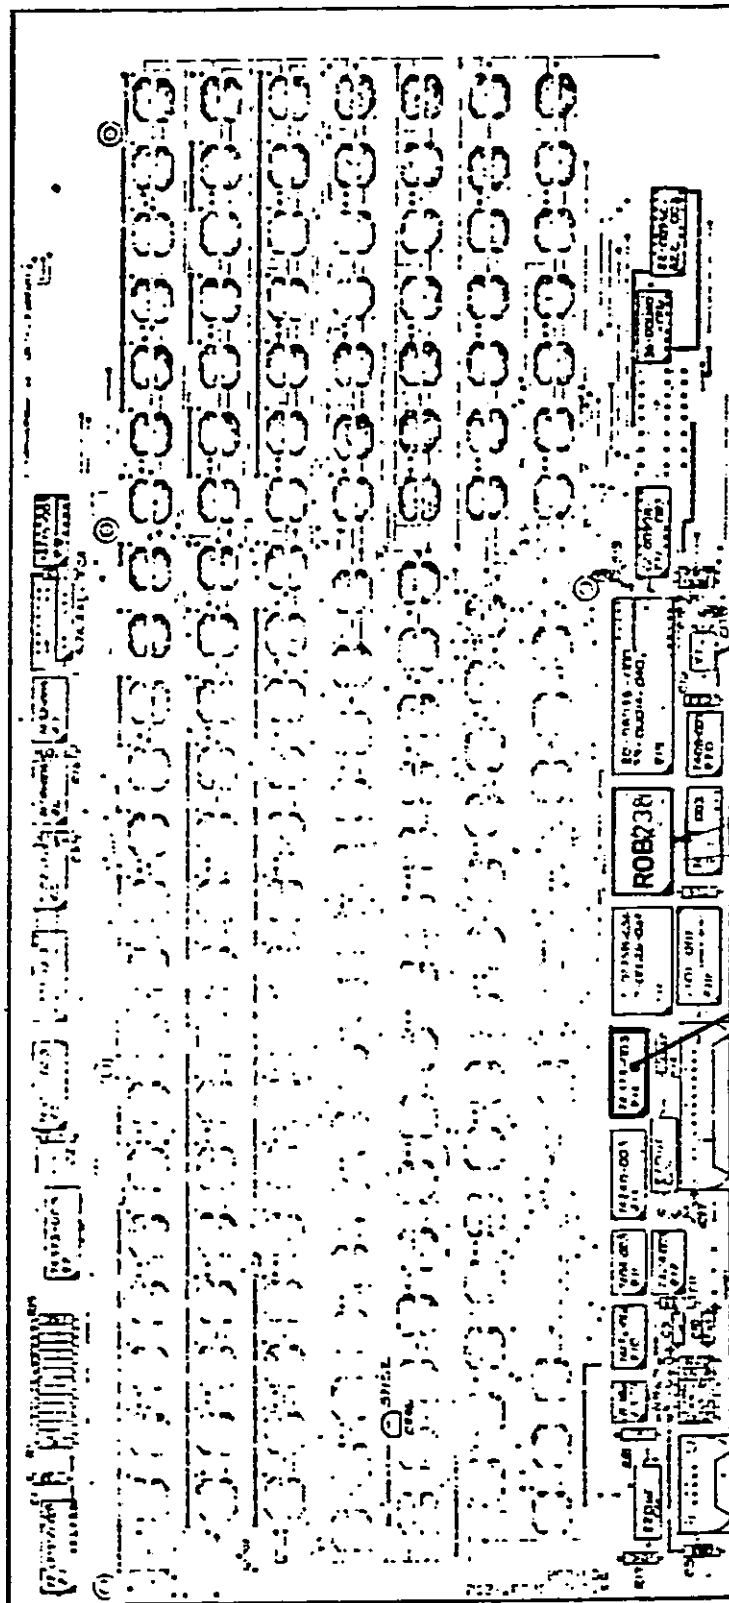
NOTE This FCO concerns only keyboards with IC14 = 74LS374 from National Semiconductor

Signals coupled in the keyboard cable may change the output of bit 0 from a logical zero to a logical one. Pressing the keys "."0" (point, zero) may result in "."1" (point, one). The buffer is 'back set'.

1. Change the Output Buffer 74LS374 to a type not manufactured by National Semiconductor. See next page.
2. Code the FCO-label 19-012.
