RCSL: 44 - RT 1911

SERIAL EFFECTIVITY RCM705, S/N 438-444, 455-486, 500 and upwards	EQUIPMENT AFFECTED RC700 RC702, RCM705, REC702 Rectifier and Interconnection
--	---

FIELD CHANGE ORDER

NO. 19-015

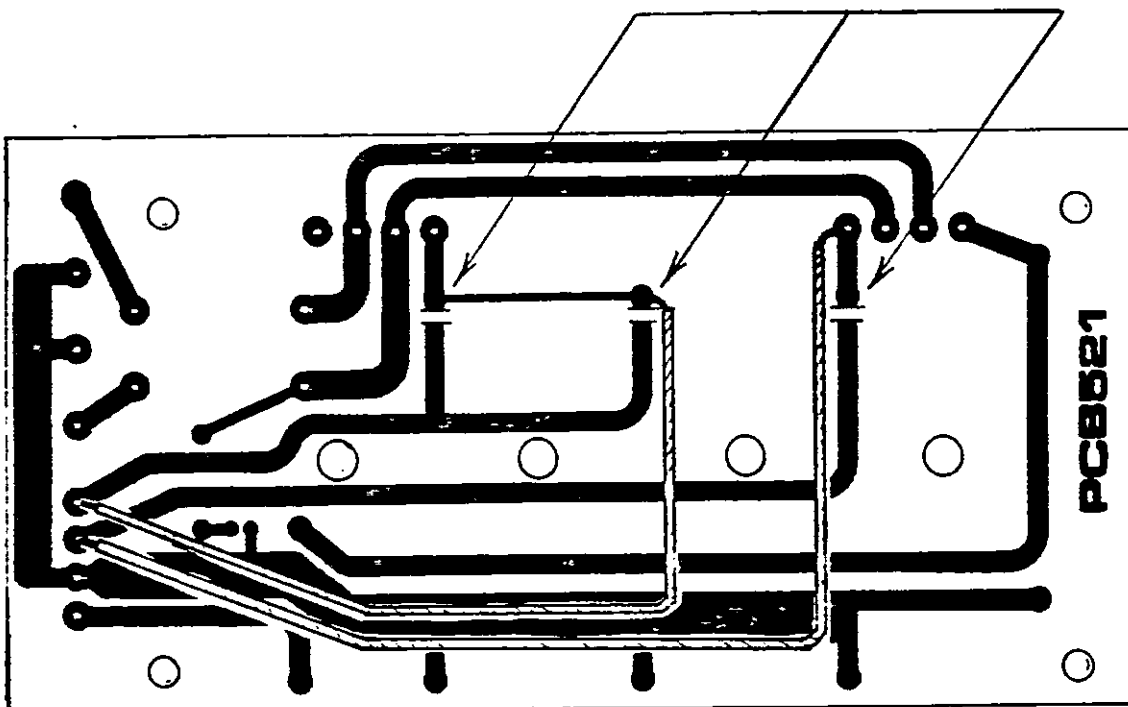
MODIFICATIONS ON THE REC702:

To decrease the error rate on the 5 1/4" floppy - especially on the inner tracks.

1. Cut trace at these
3 locations

2. Mount the two wires as shown.
It is important that the physical routing of the wires
are as close as possible to the one shown.
