FIELD CHANGE ORDER

NO: 11-032
ISSUE WEEK 48-78

EQUIPMENT AFFECTED
RC3600/6000/7000/8000
POW728
Master Power Supply Electronics

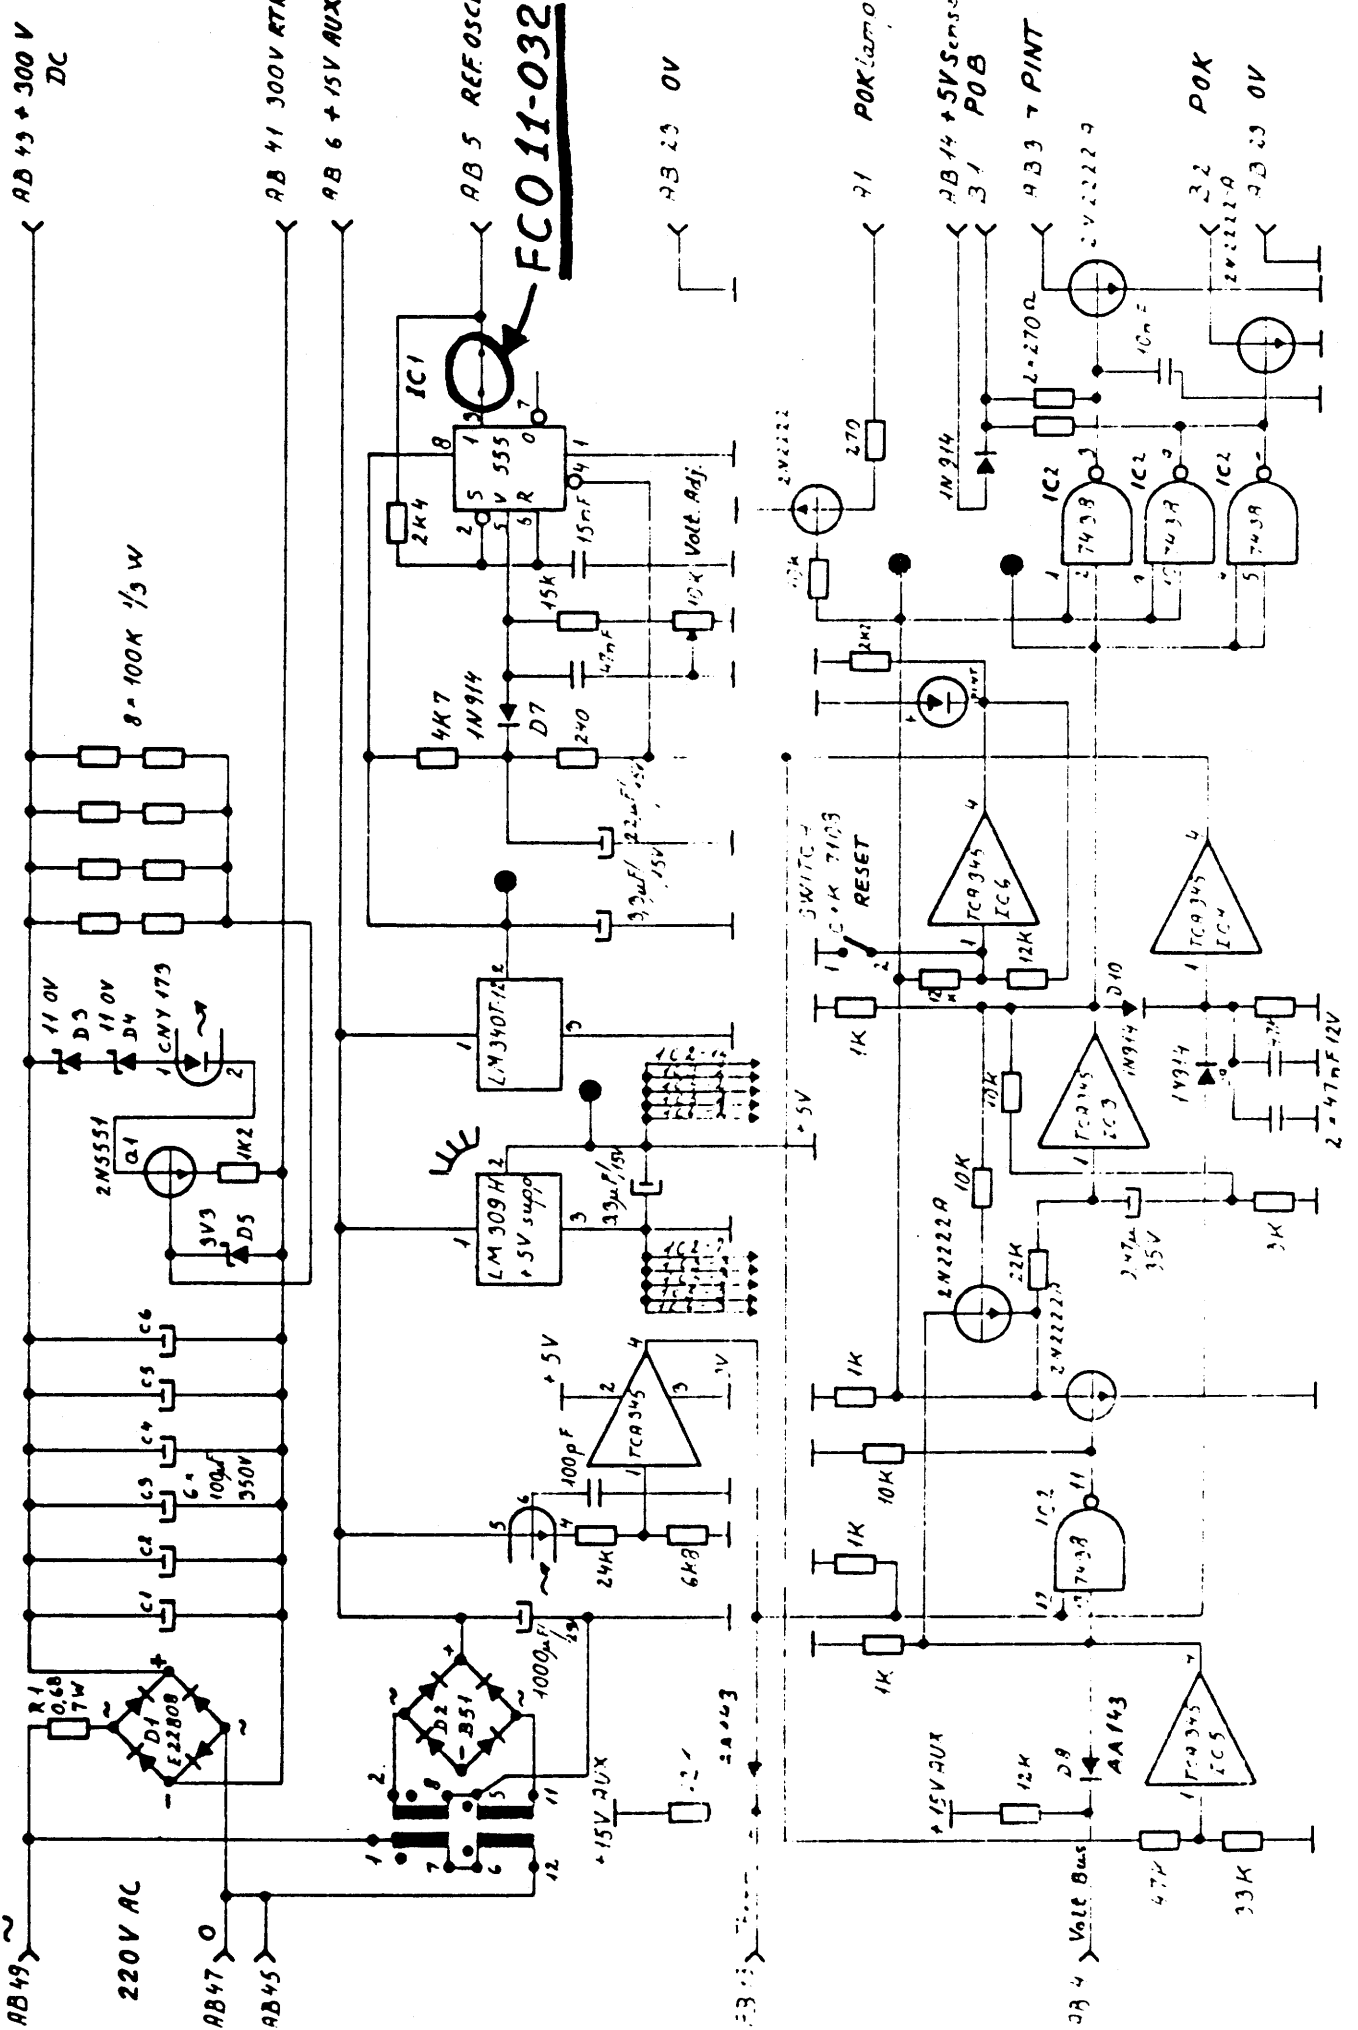
REASON FOR CHANGE
To eliminate undesired output voltage-dependency of the number of POW716 installed with the POW 728.

1. Replace a 100 ohms resistor by a jumper, as shown on page 2.
2. Install POW728 and remove all load (all boards).
3. Adjust the POW716 one by one to 5.00 Volts.
4. Reinstall all boards, power modules and the cover. Check that the voltage is within 4.9 to 5.1.
5. Code the FCO-label 11-032.

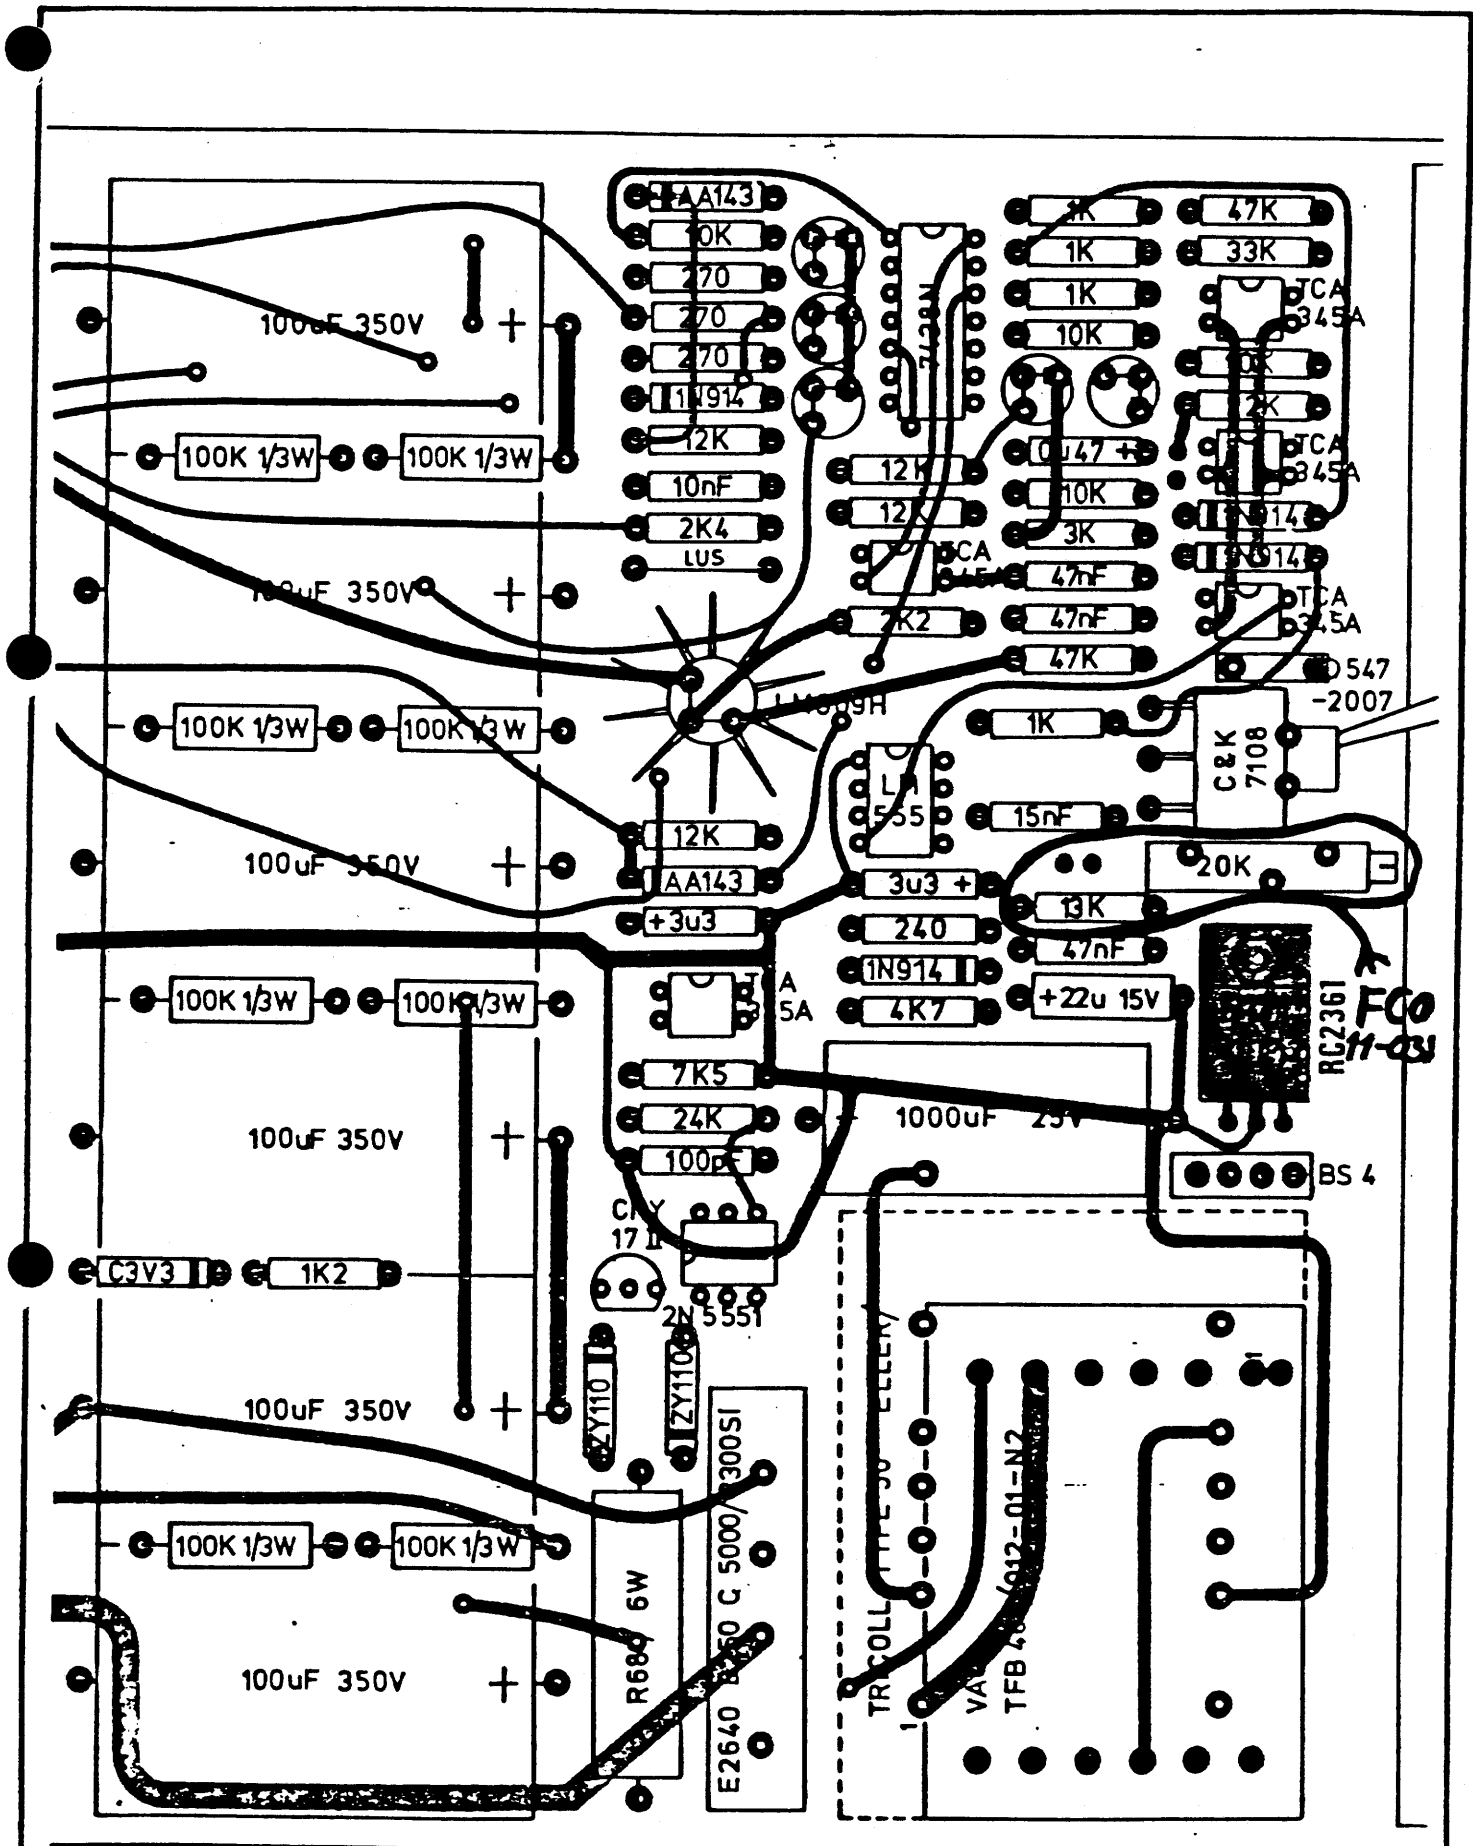
FCO 11-038

On some POW728's, the Voltage Adjustment Range does not cover the nominal +5% marginal of the Reference Clock (5.25 Volts DC).

1. Replace the 10 Kohms Voltage Adjustment Potentiometer with a 20 Kohms Potentiometer (see page 2).
2. Replace the 15 Kohms resistor, serial-connected to the Voltage Adjustment Potentiometer, with a 13 Kohms resistor (see page 2).
3. Code the FCO-label 11-038.

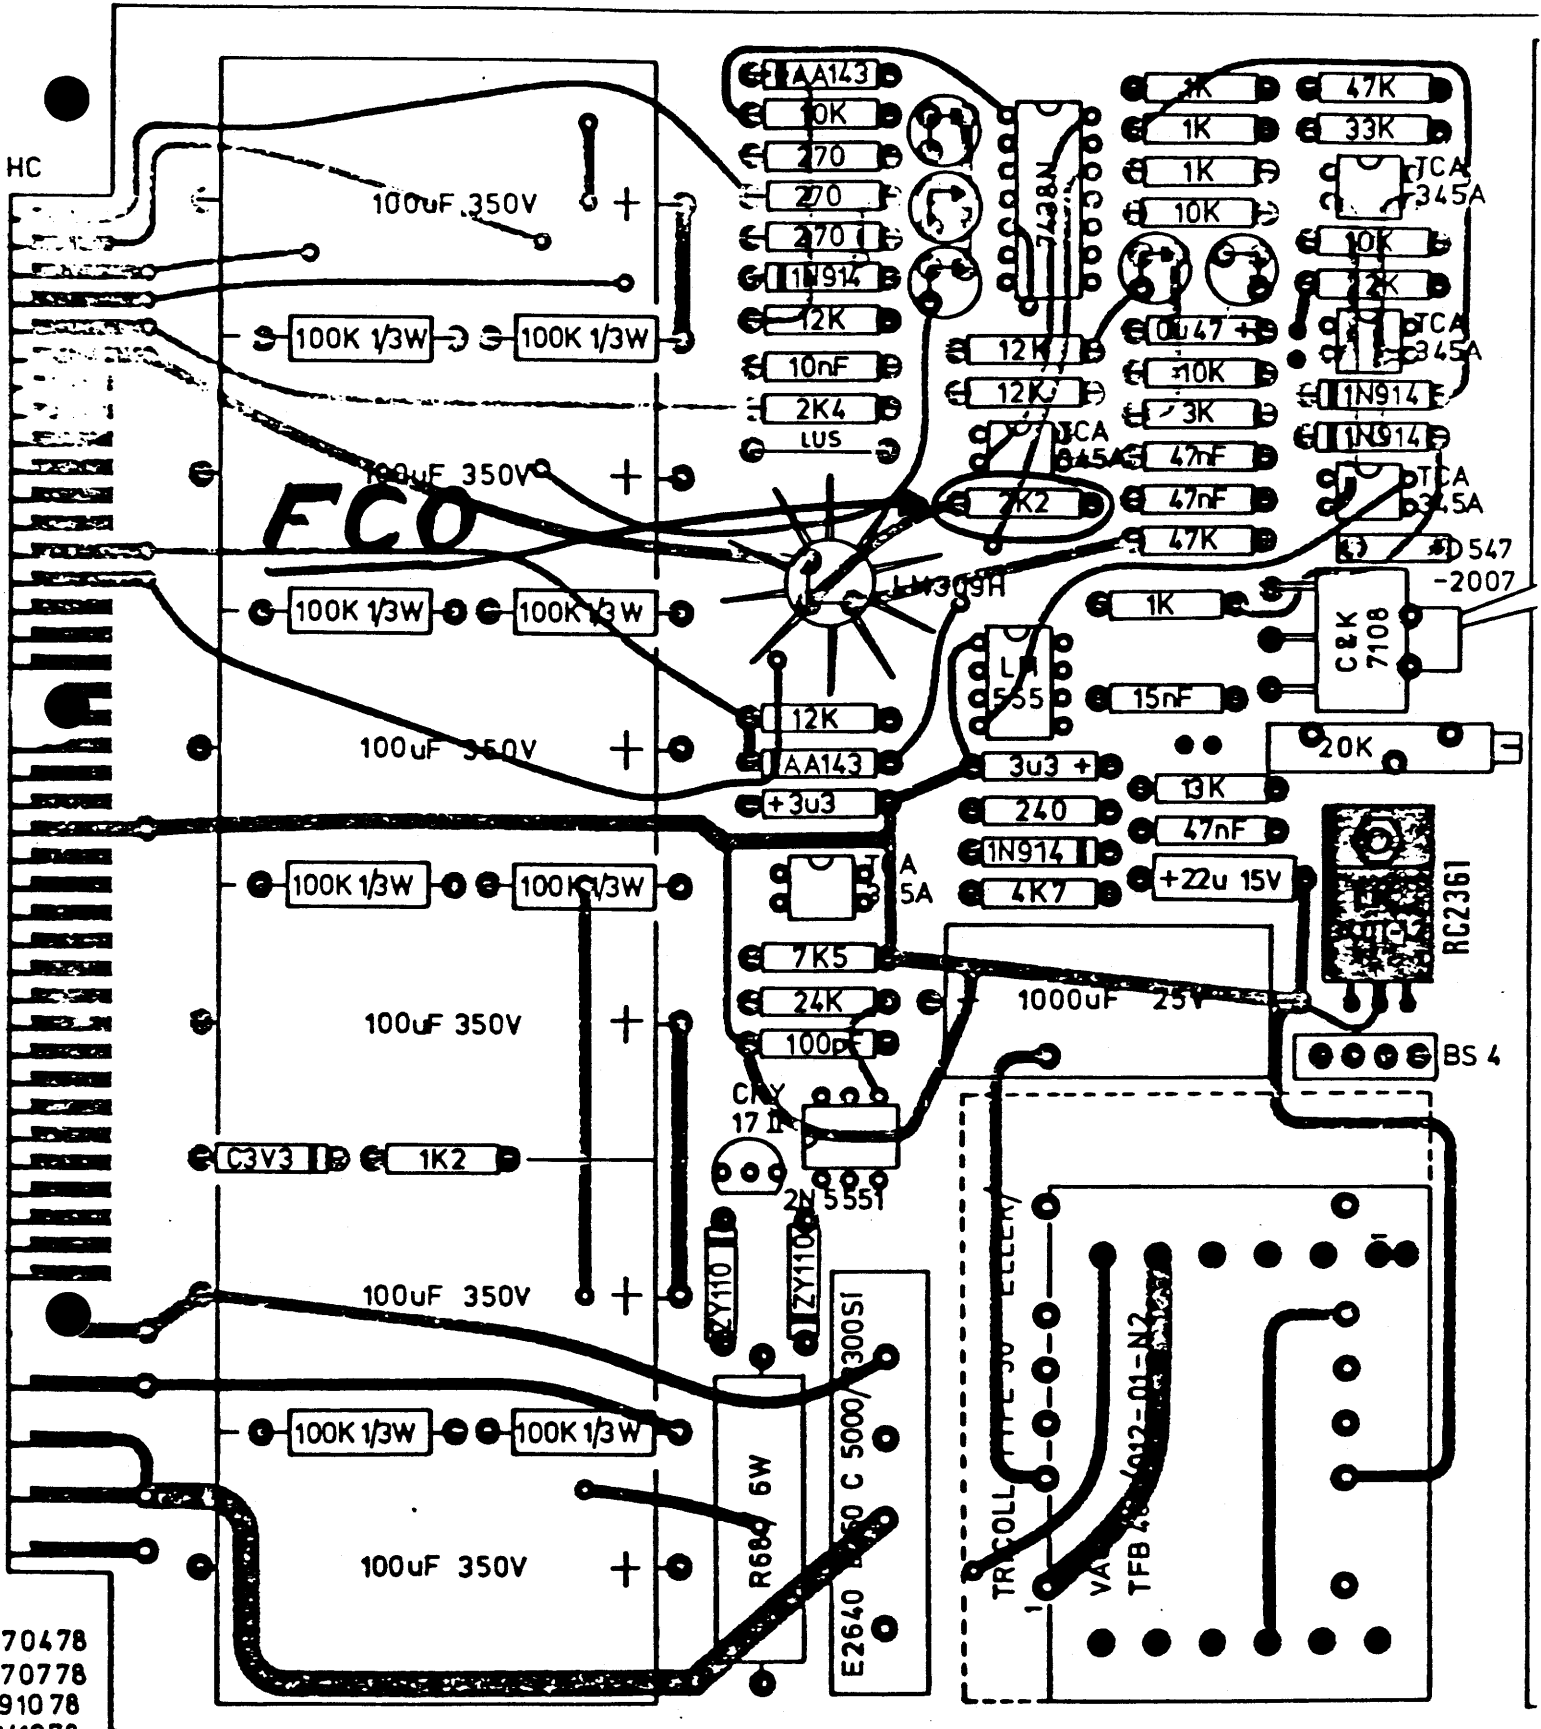
On some POW 728 it is possible to reset the Power Interrupt Indicator LED even if the >PINT signal is active.

The failure has no effect on the electrical function of the module, but concerns only the diagnostic power interrupt indicator.

Remove the 2K2 (2.2 Kohms) resistor parallel connected to the LED.

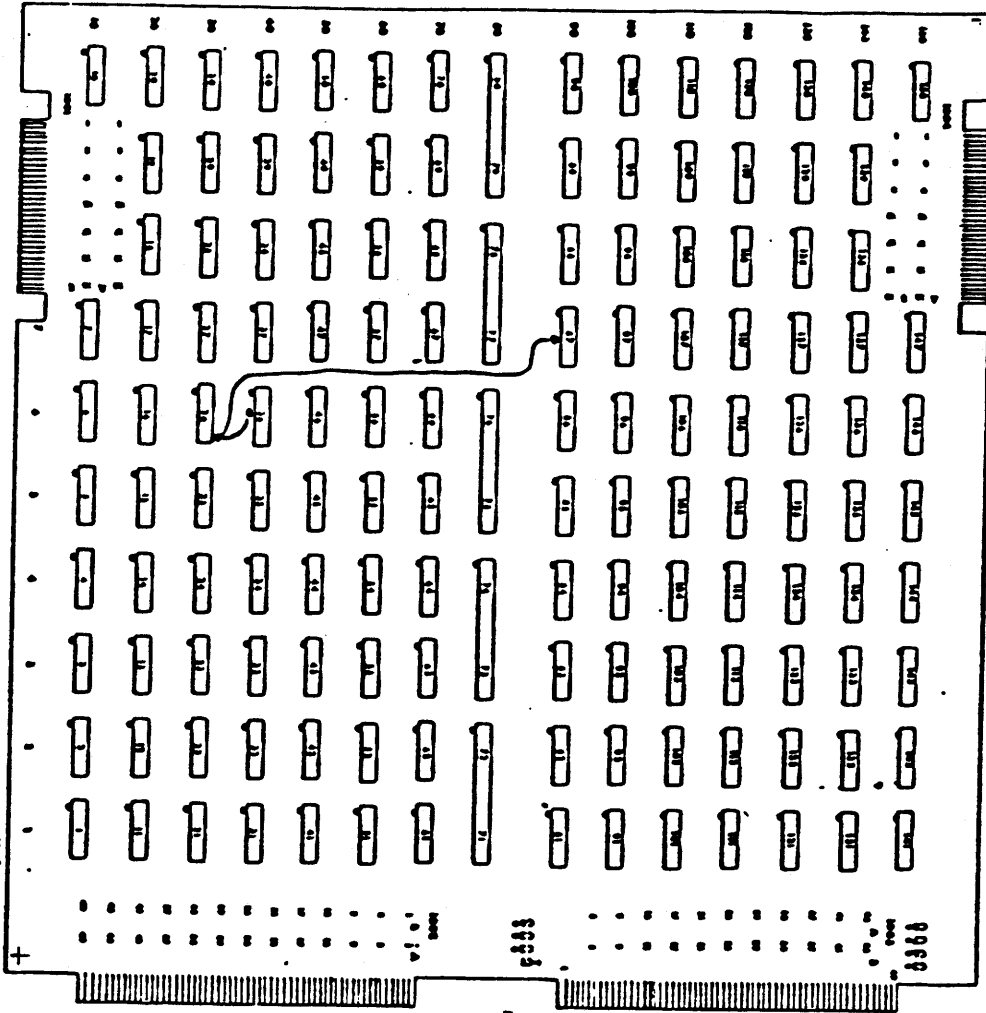
REASON FOR CHANGE
On the units with the serial numbers mentioned, the wire carrying the signal ENABLE STEP has been placed in noisy environments. If so, you might experience that the CPU cannot run except with the Technicians Panel (TCP) connected and enabled.

Remove wire (36 - 4) - (26 - 8) - (87 - 5)

DESCRIPTION OF CHANGE
The solution to the problem is to relocate the wire (36 - 4) - (26 - 8) - (87 - 5).
1. Remove the wire (36 - 4) - (26 - 8) - (87 - 5). (see page 2)
2. Insert the wire (36 - 4) - (26 - 8) - (87 - 5) as shown on page 3.
3. Code the FCO-label 11-049.

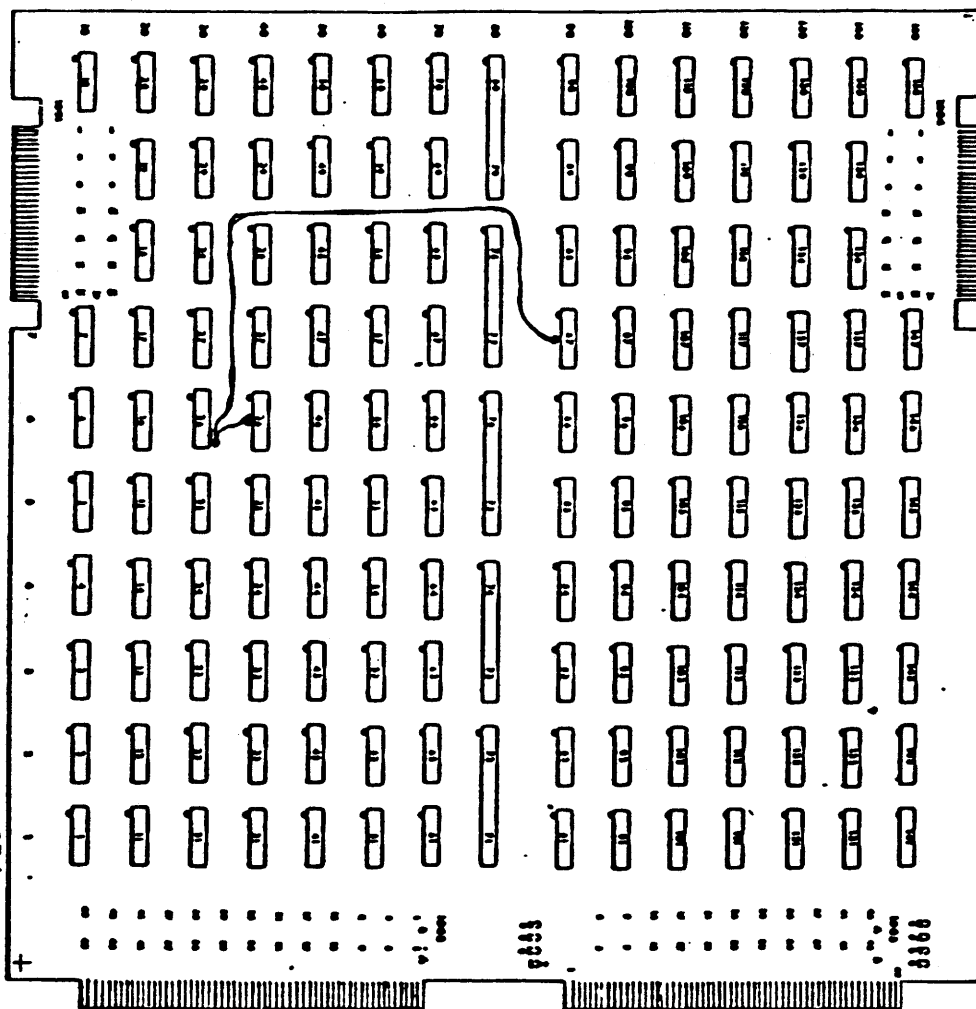
Insert wire (36 - 4) - (26 - 8) - (87 - 5)

ATTENTION : The drawn path MUST be followed.

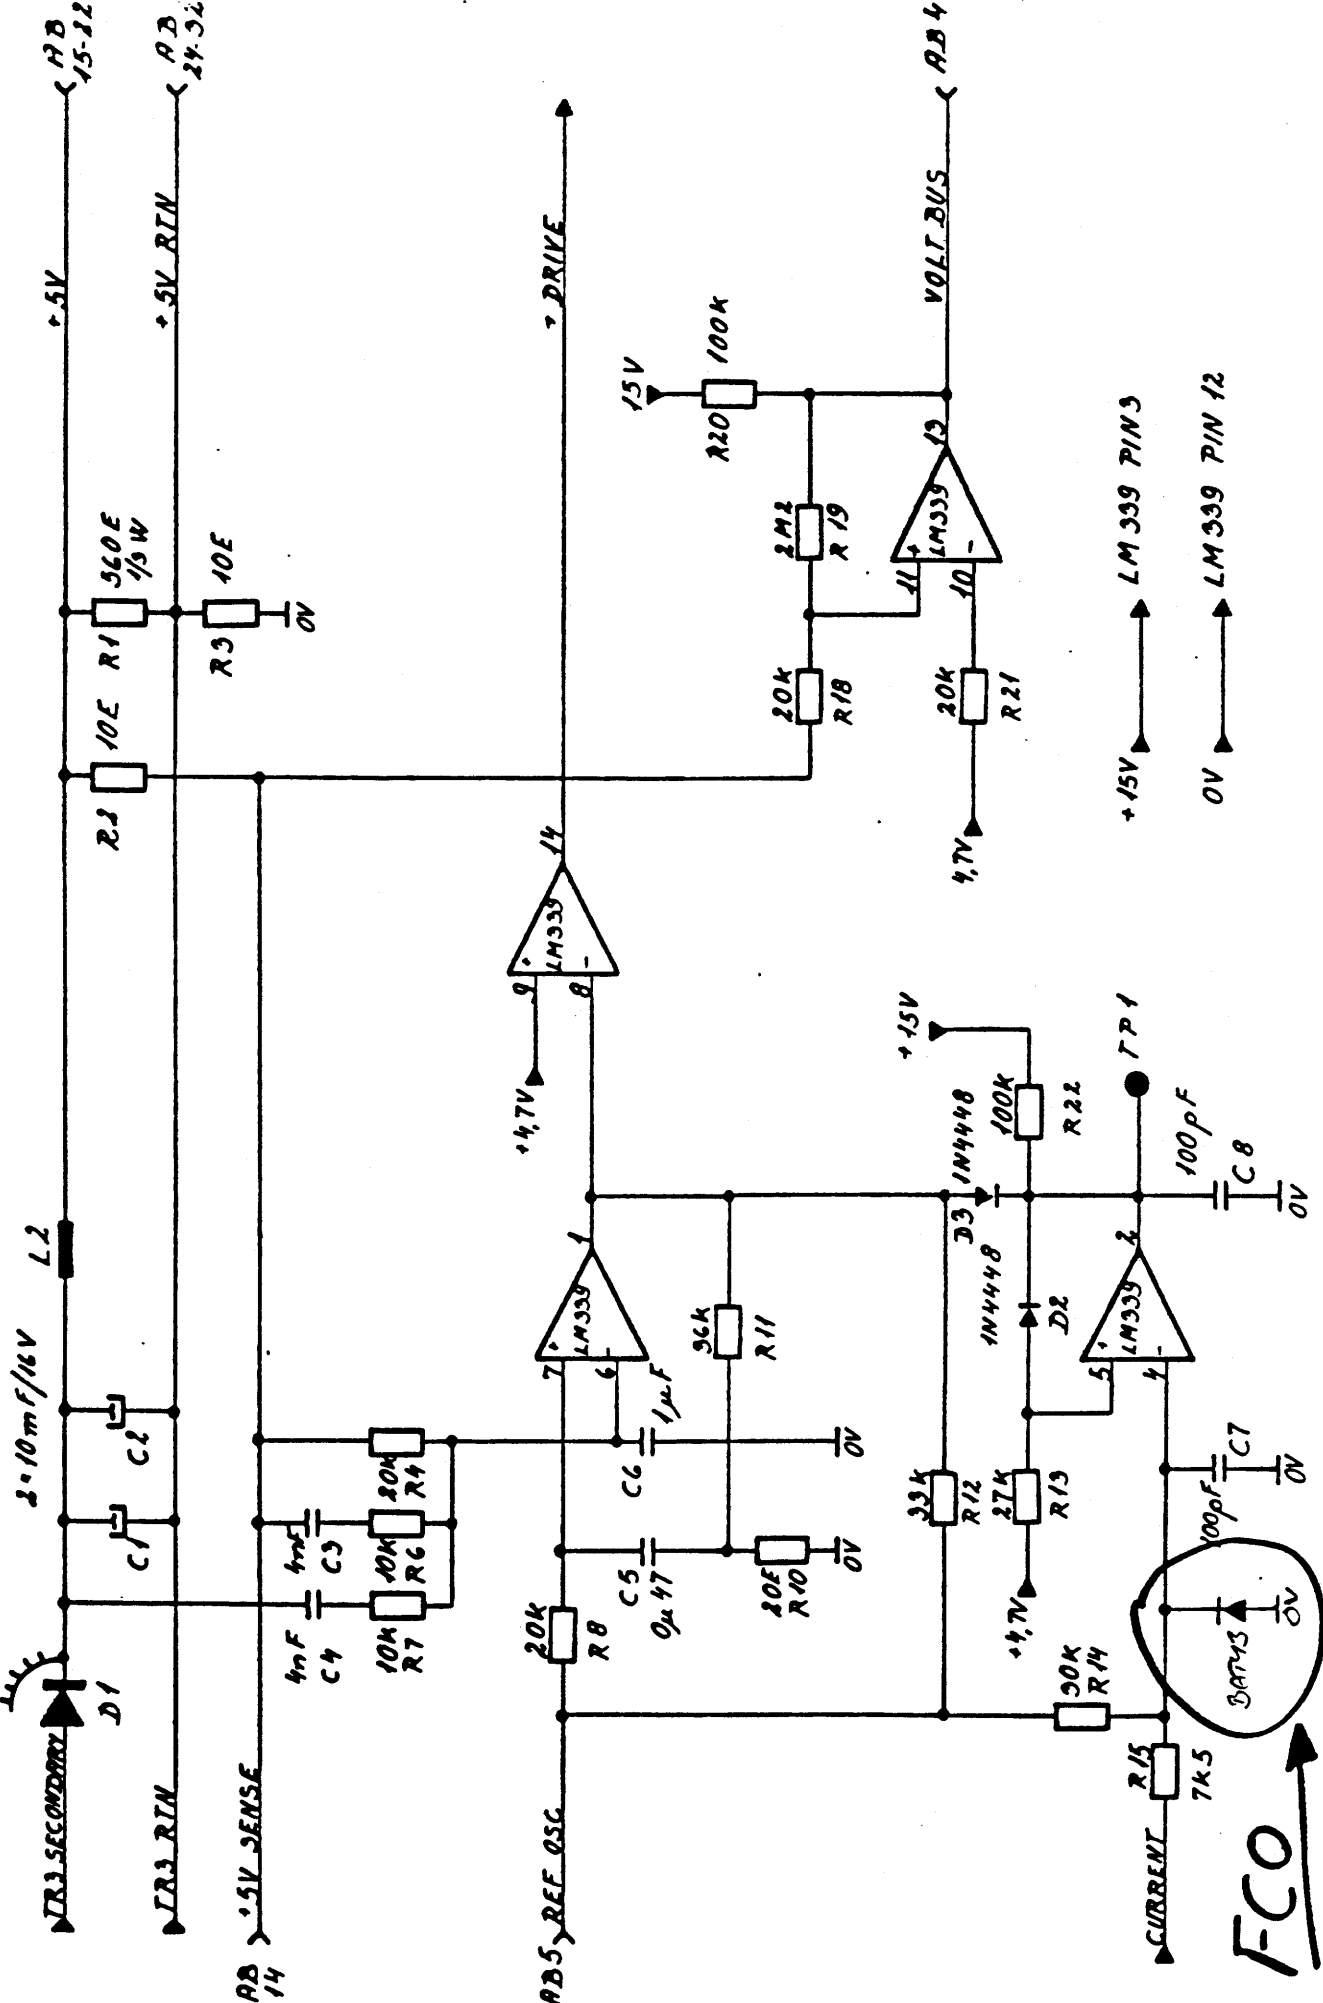
POW 729
R 13 121

The RMS value of the ripple current to which the capacitor C 1 is exposed, exceeds the absolute maximum rating. As a result, the capacitor is overheated and the life-time is decreased.

Some samples of the POW 729 module are not able to deliver 100 Watt of output power if the input DC voltage is decreased to 200 Volts. This is caused by a negative voltage on pin 4 of the LM339 comparator build up during the off-time of the switch transistor, affecting the correct function of the comparator.

1. Unsolder the positive terminal lead of the capacitor C 2 from the print.
2. Increase the diameter of the hole using a 2.5 mm drill.
3. Mount the capacitor C 2 according to the illustration, see page 2.
4. Code the FCO-Label
