FIELD CHANGE ORDER

NO: 11-032
ISSUE WEEK 48-78

EQUIPMENT AFFECTED
RC3600/6000/7000/8000
POW728
Master Power Supply Electronics

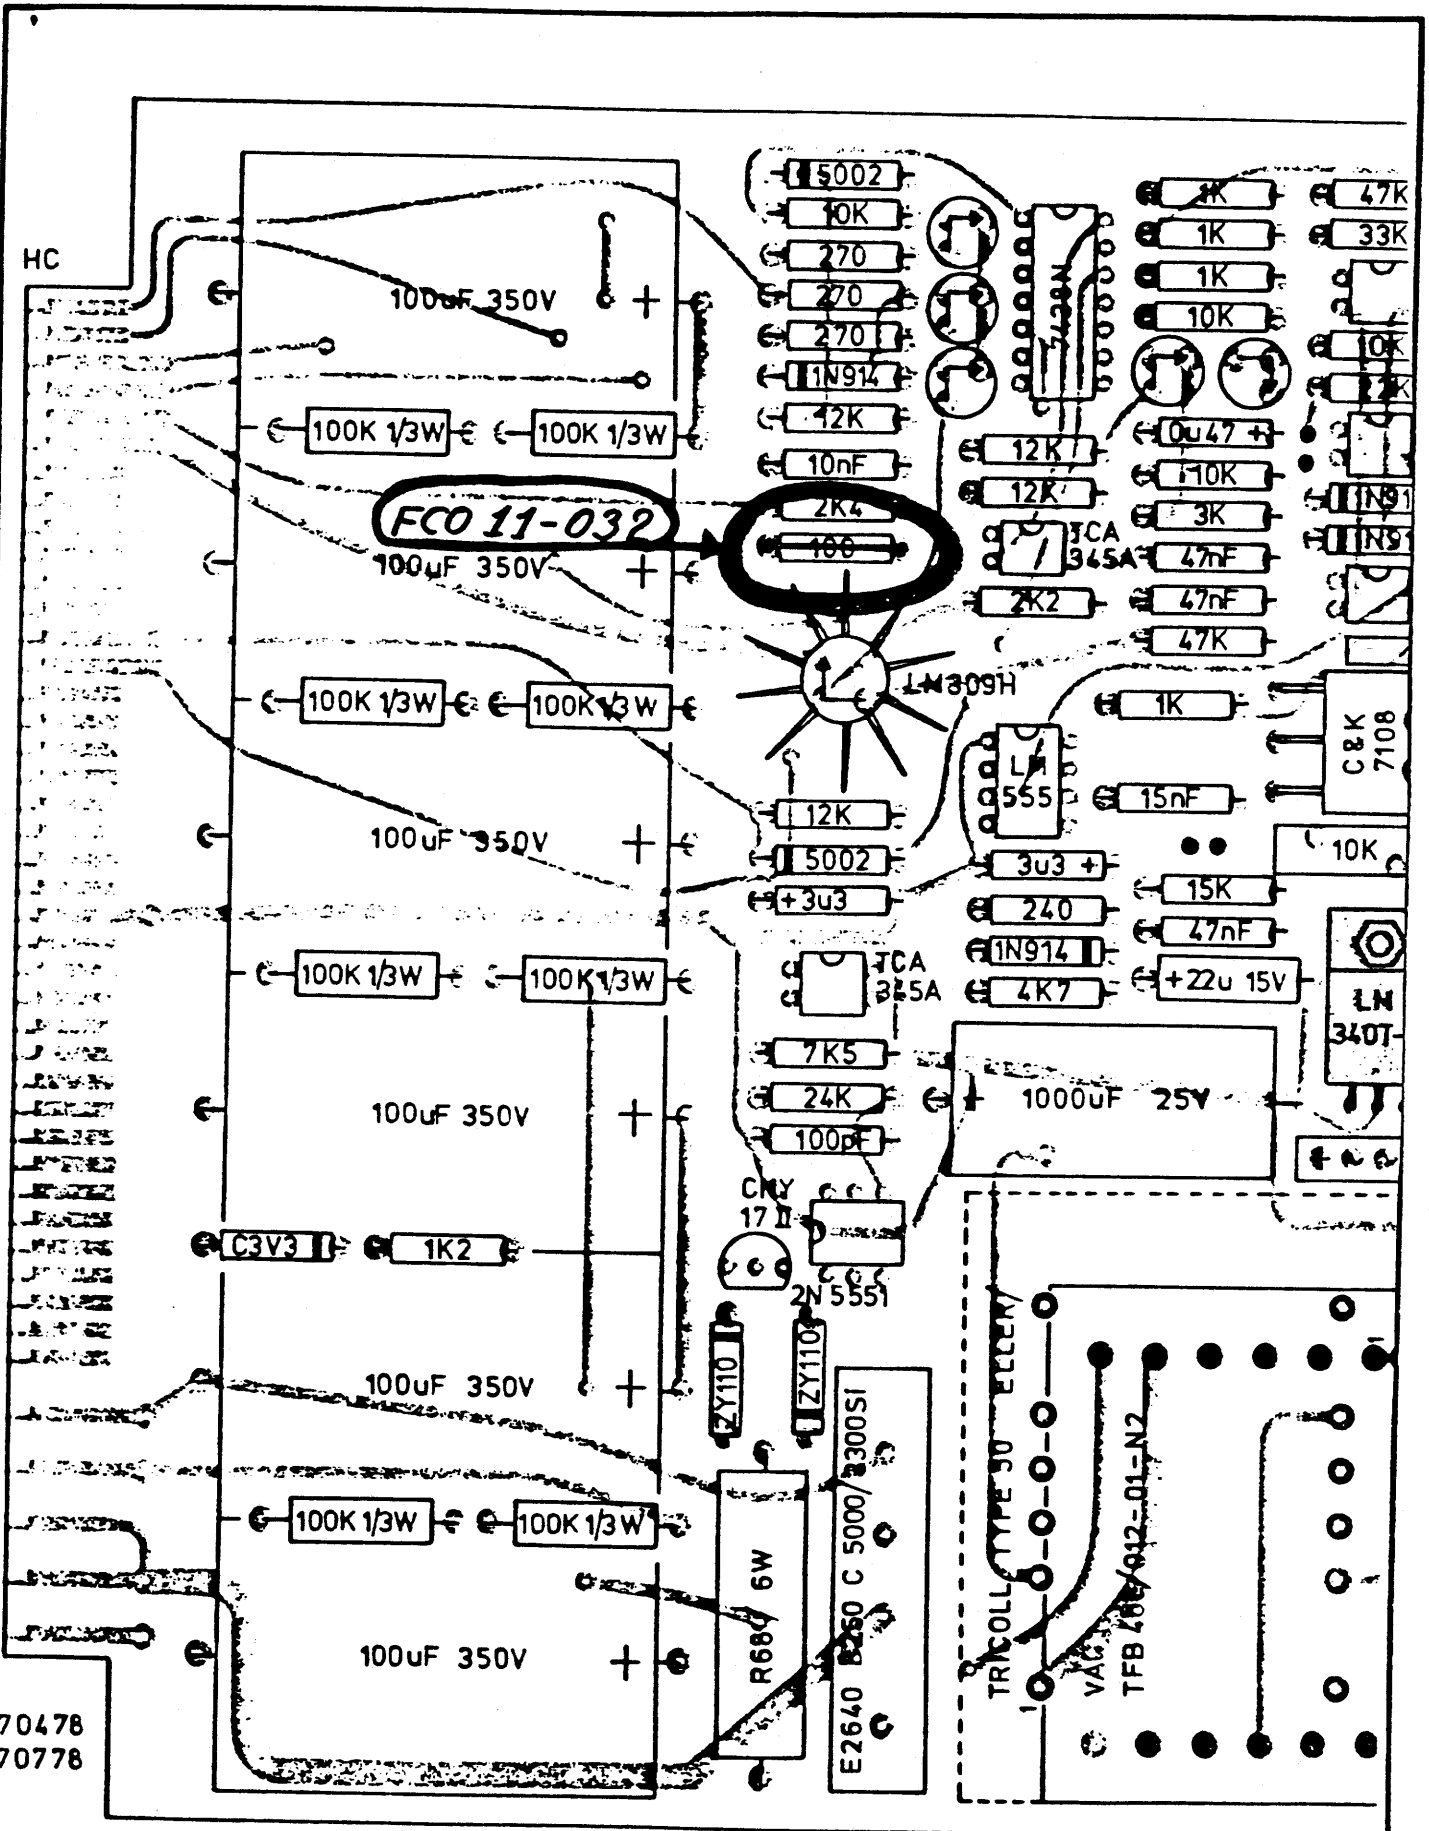
POW 728
S 12567

REASON FOR CHANGE
To eliminate undesired output voltage-dependency of the number of POW716 installed with the POW 728.

1. Replace a 100 ohms resistor by a jumper, as shown on page 2.
2. Install POW728 and remove all load (all boards).
3. Adjust the POW716 one by one to 5.00 Volts.
4. Reinstall all boards, power modules and the cover. Check that the voltage is within 4.9 to 5.1.
5. Code the FCO-label 11-032.

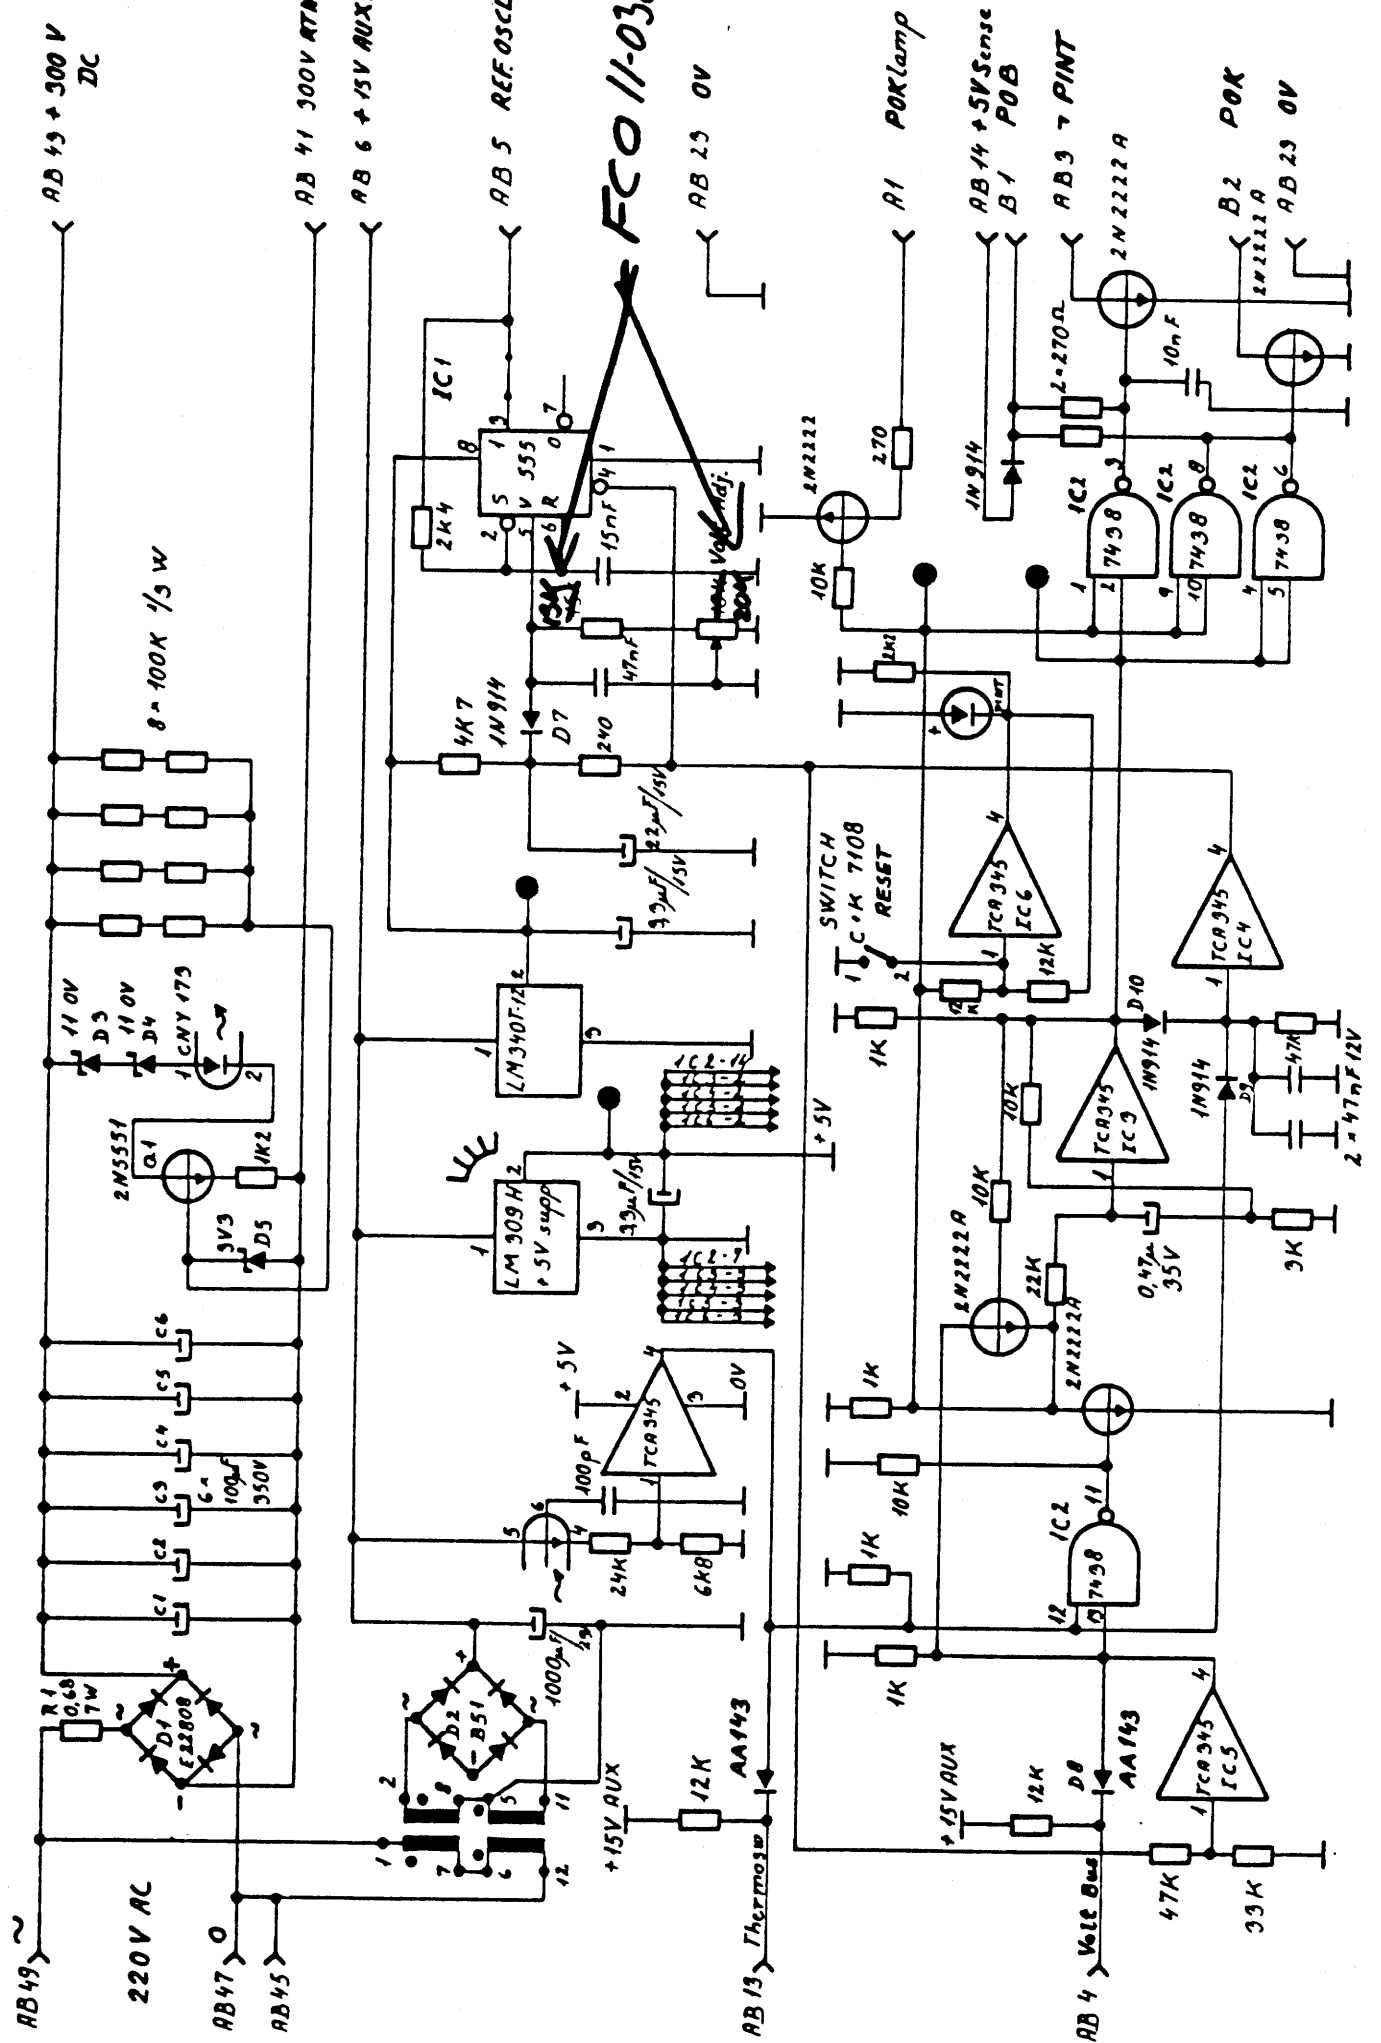
POW 728

On some POW728's, the Voltage Adjustment Range does not cover the nominal +5% marginal of the Reference Clock (5.25 Volts DC).

1. Replace the 10 Kohms Voltage Adjustment Potentiometer with a 20 Kohms Potentiometer (see page 2).
2. Replace the 15 Kohms resistor, serial-connected to the Voltage Adjustment Potentiometer, with a 13 Kohms resistor (see page 2).
3. Code the FCO-label 11-038.

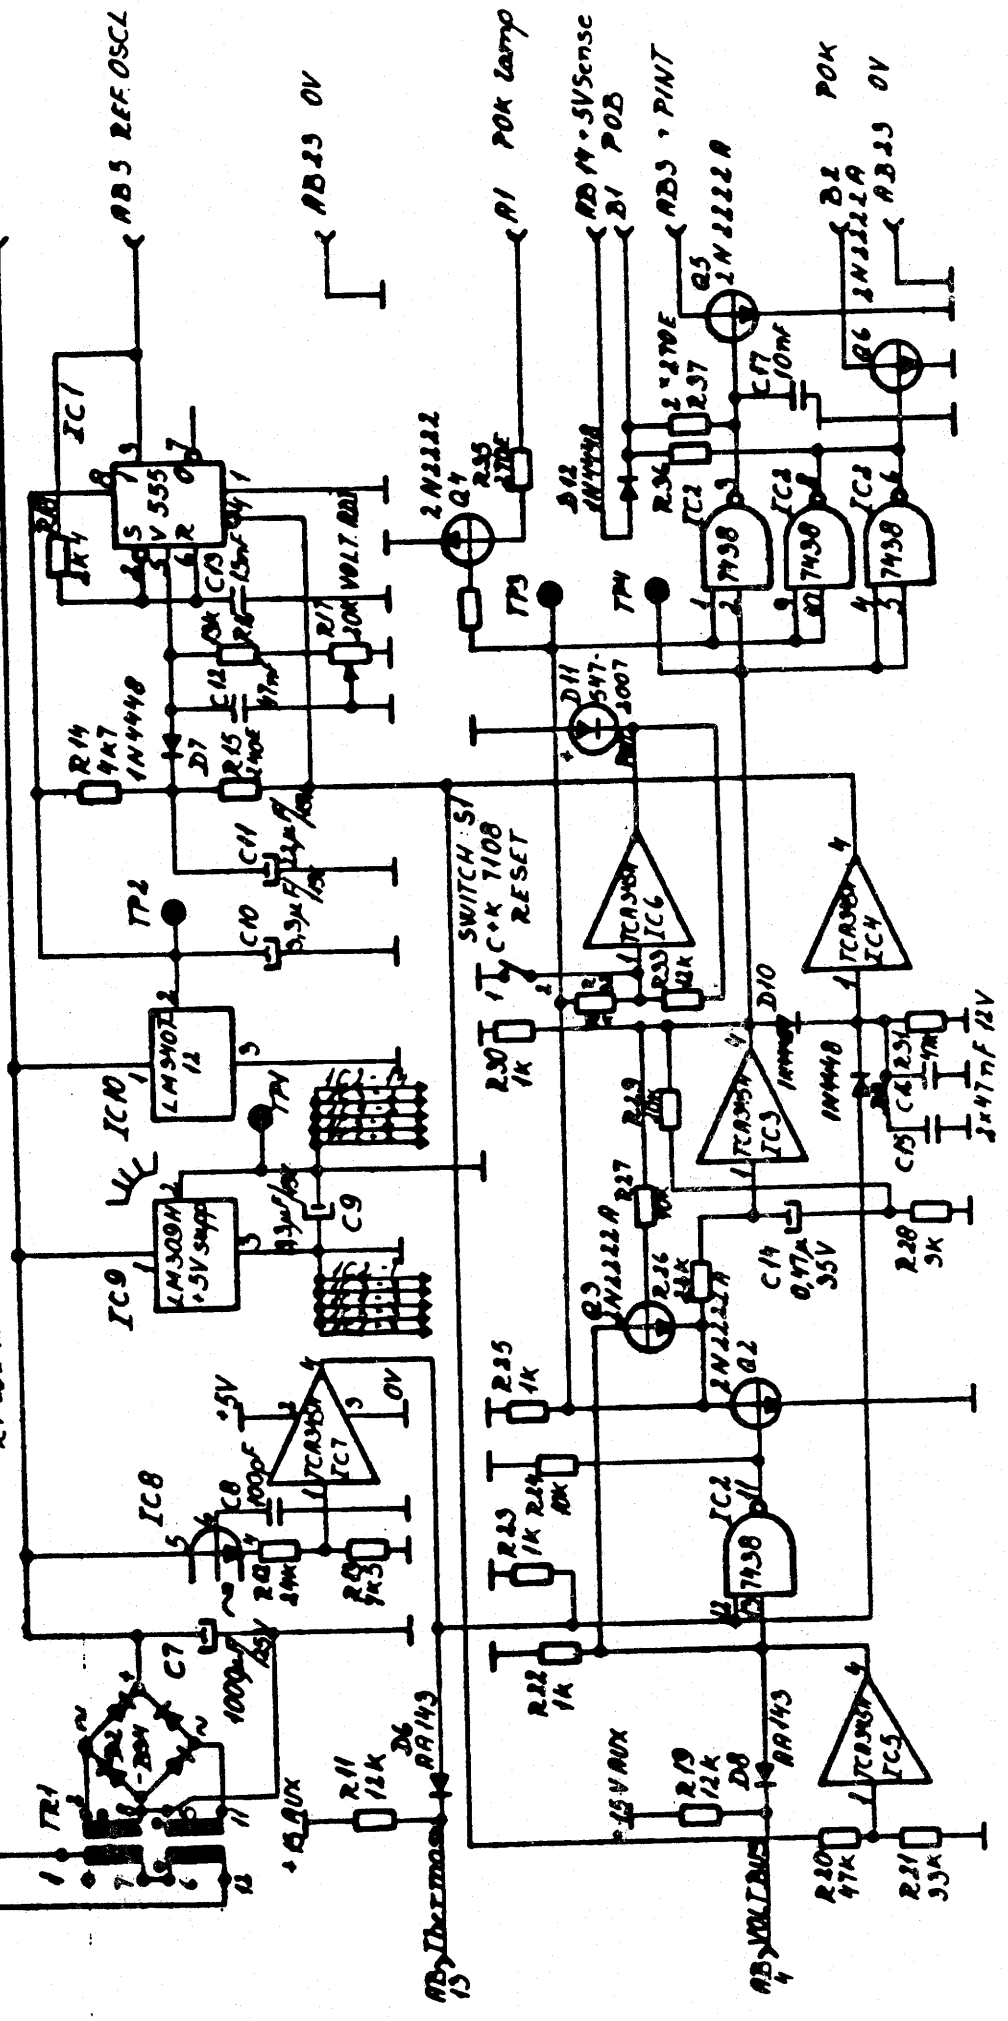
CONTROL MODULE
POW 138

The POW 738 power control module sometimes fails to short circuit the inrush current delimiting resistor before the switch-modules are turned on. This causes the power supply to turn on and off, and will eventually damage resistor R1.

Replace the 2K4 resistor R40 by a 2K resistor.
See page 2.
Fill in the FCO-label.
Please inspect Q8 and Q9. It must not be a Q400E3.
If necessary, L400E3 or L401E3 can be ordered under p/n 501021.
