**Dansk Data Elektronik A/S**

**Technical TPP  
Field Change Notes**

**Updated 27th December 1994**

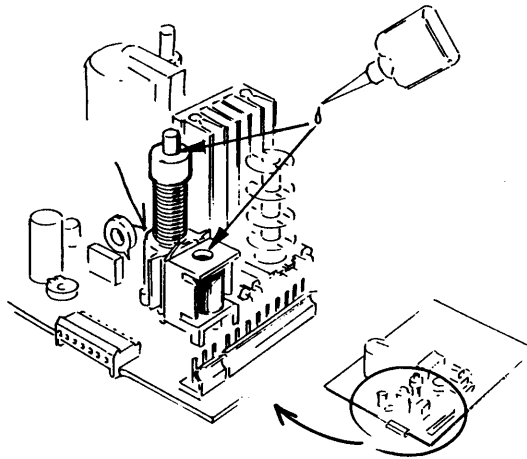
## PROBLEM WITH HIGH FREQUENCY NOISE FROM COIL L1 ON MONITOR BOARD

If that kind of noise appears, put a drop of varnish to secure the coil (see the picture below).

This is implemented from serial No. 9014 0001 on A/G3400 and from 9013 0034 on DG-terminals.

Usable varnish is "Beckers industrifärg" FG-001-0246 or Loctite 414.

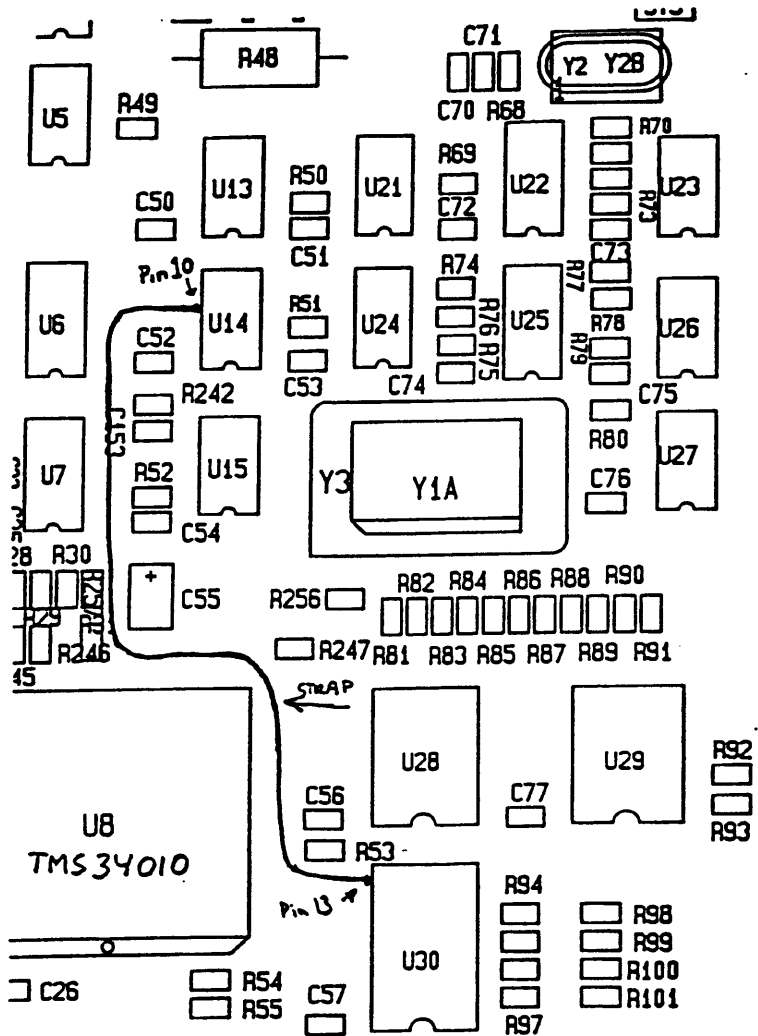
This appendix shows the strap between U14.10 and U30.13.

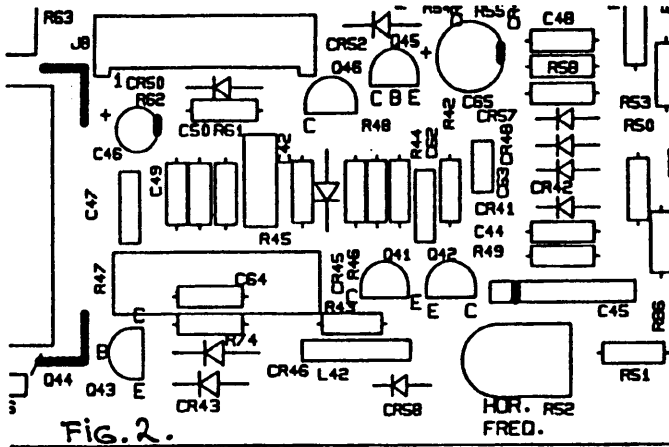
FIG. 2.

The modification of the Horizontal Oscillator circuit is as shown in Fig. 1 to 5. Fig. 3 shows the component side layer of the PCB, where a cut has been made as indicated. Fig. 2 shows the present state of the PCB layout. Fig. 4 and 5 shows the present and modified circuit diagram respectively.

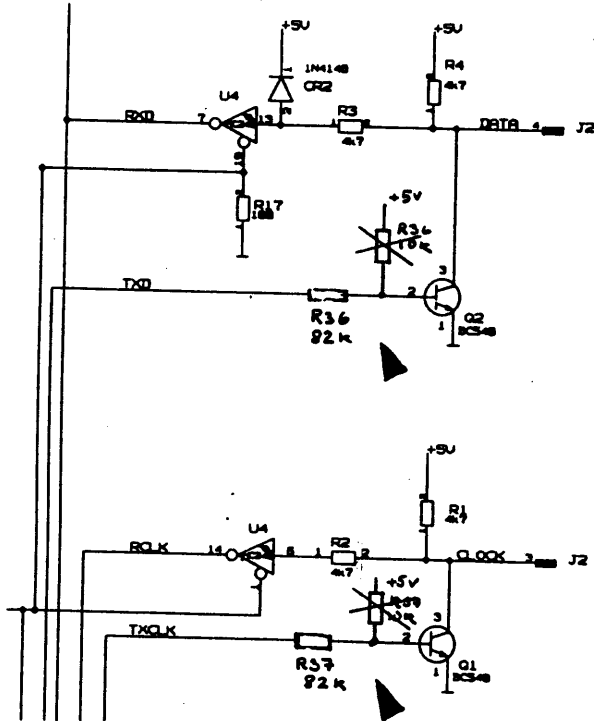
The connections from microcontroller 80C51 (U2) pin-10 and pin-11 to the base of transistors Q1 and Q2 are cut, and 82kohm resistors (R36,R37) are inserted.

Tandberg Data A/S partnumber for the 82kohm 1% 0.4W resistor is: 401477

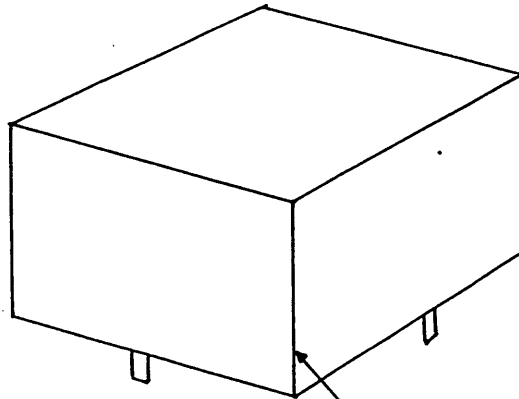
APPLY SOLDER  
ON ALL  
FOUR CORNERS

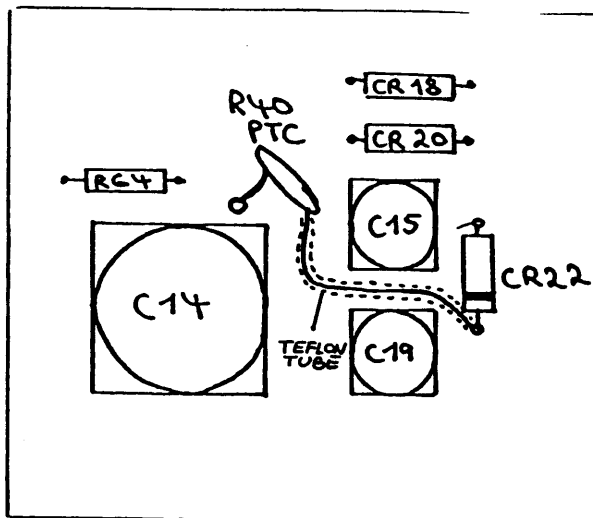
The drawing below indicates how the PTC is mounted on the component side of the circuit board.

- 1) R40 : PTC Ordering no. 421018
- 2) Teflon Tube Ordering no. 348305

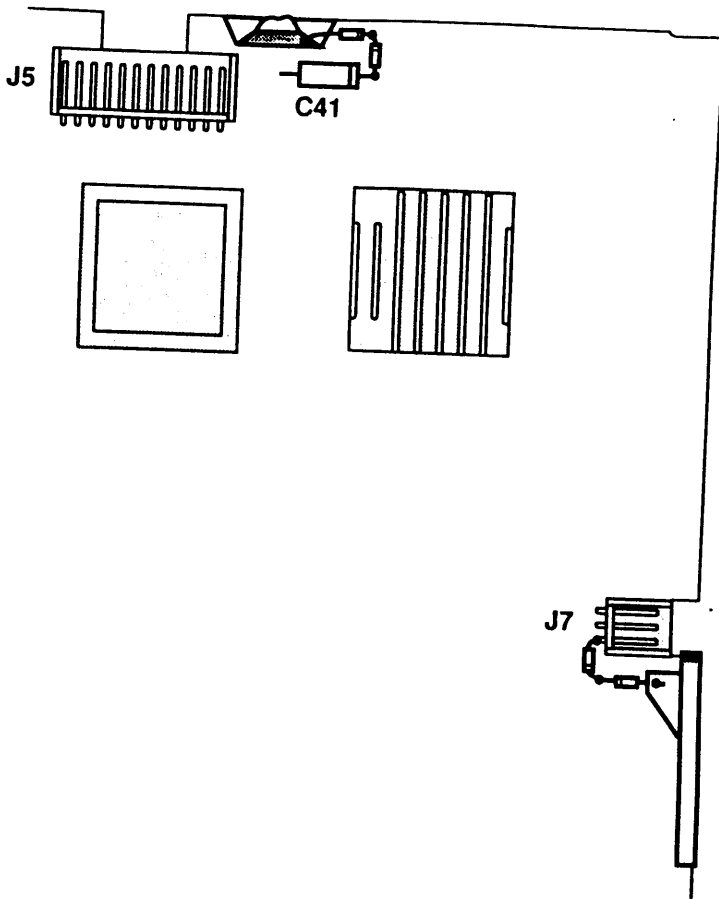
Improved protection against damage caused by flashover in the CRT.

The decoupling will ensure that high-voltage spikes from a flashover in the CRT quickly are lead to Chassis GND, thus avoiding damage to the electronics on the Digital Board or on the interface adapters.

Component	Name	Partno.
Spring		417156
Clip		417158
Zener Diode	CR20	383124
"	CR21	"
"	CR22	"
"	CR23	"

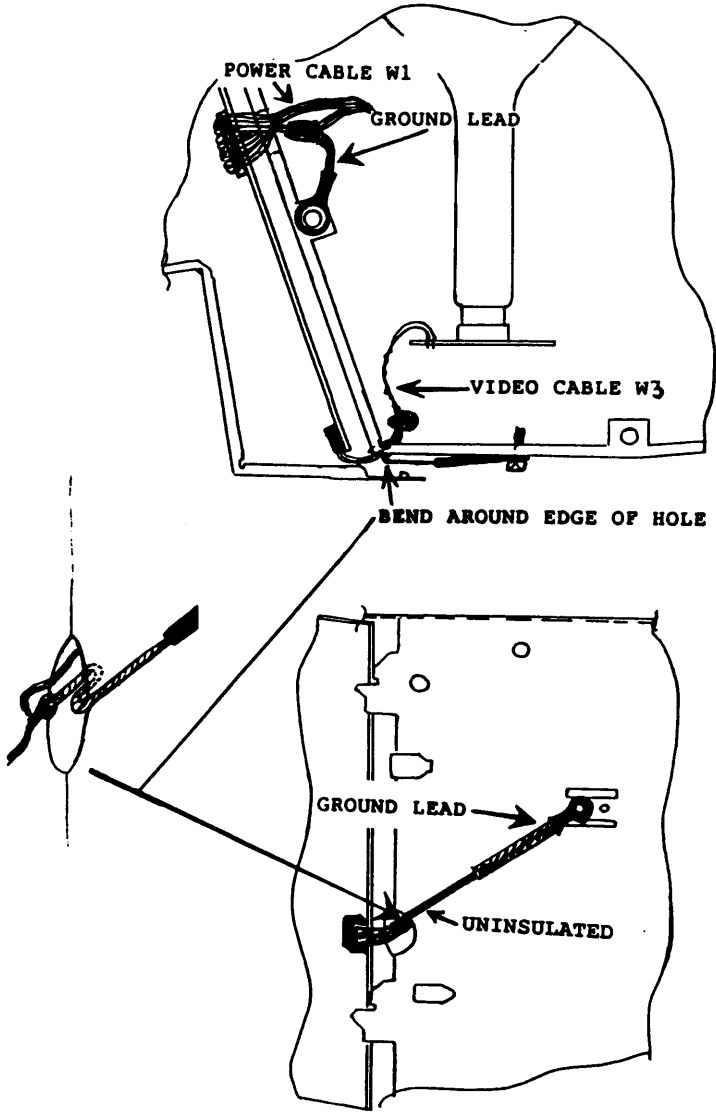
Due to high-voltage pulses caused by flashover in the CRT, there is a possibility of damage to the electronics on the digital boards, i.e. Mainboard, Processor Board, Coax Board and Syncboard, or on the interface adapters.

The flashovers are caused by small particles present in the CRT and occur normally at power up when the terminal is new.

The decoupling will ensure that high-voltage spikes from a flashover in the CRT quickly are lead to Chassis GND, thus avoiding damage to the electronics on the Digital Board or the interface adapters.

For practical reasons the cables and ground leads are delivered as a kit:  
**Ordering number: 967589 - Cable Kit w/Ground**

The kit substitutes:  
Power Cable W1 (410280)  
Video Cable W3 (414378)

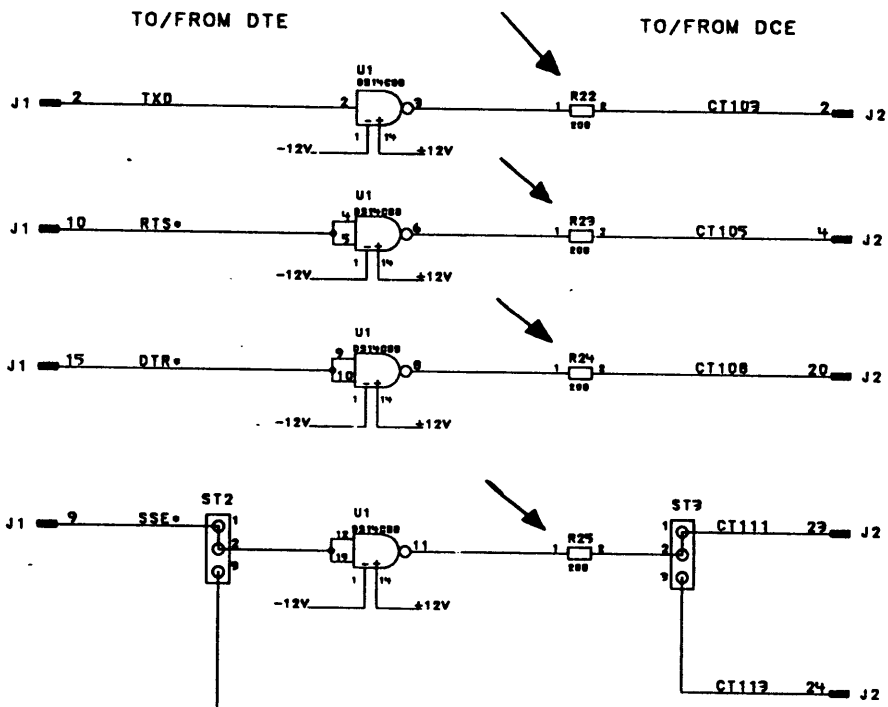
Static discharge and flashover in the CRT may cause damage to the V.24 driver U1, DS14C88, with a stop in the data communication as a result. In order to reduce the possibility of damage, a damping resistor has been mounted in series with every transmitter output.

New resistors R22, R23, R24 and R25, value 200 ohm,  
Tandberg Data part no.: 398828

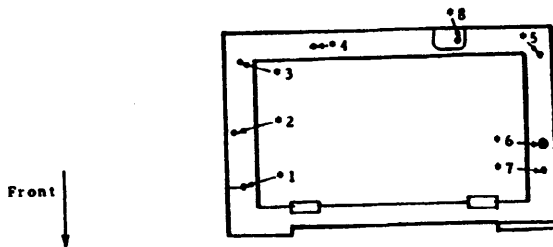
Fig. 1: Lower cover

- a. Lower cover: Seven screw holes or positioning holes and one tapped hole have been made (figure 1).
- b. Power switch arm: Two oval holes have been added (figure 2).

\*1 to \*7: screw holes or positioning holes  
\*8: tapped hole

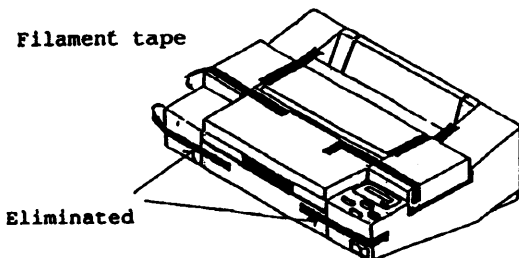
Figure 1

To facilitate production, two filament tapes used for fixing both sides of the ink cartridge cover have been eliminated. It has been proven that the change does not affect the quality and performance.

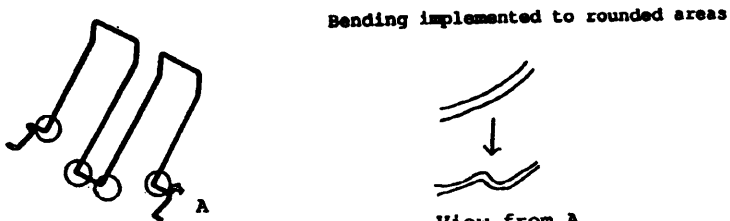
Figure 3

To prevent sheets of paper from running onto the paper support (QB1-0210), the shape of paper support has been changed in shape as shown in Figure 3. (The change has been implemented from the beginning of mass production. Along with this, the revision number has been advanced from 000 to 020.)

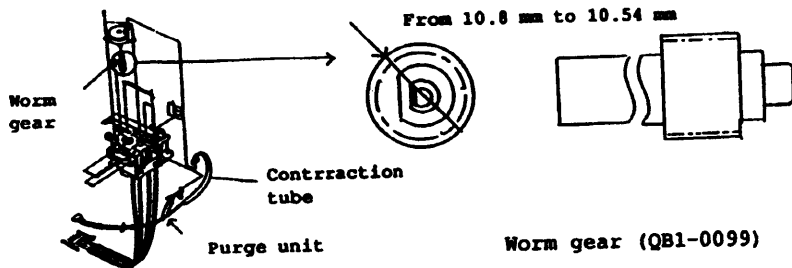
Figure 7

To avoid the noise during the purging operation, the diameter of the worm gear has been reduced.

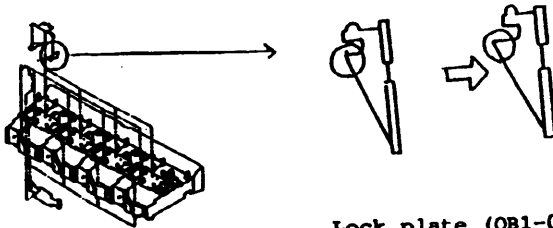
Figure 12

To make the cartridge inserted smoothly, the lock plate (QB1-0158) has been changed in shape.

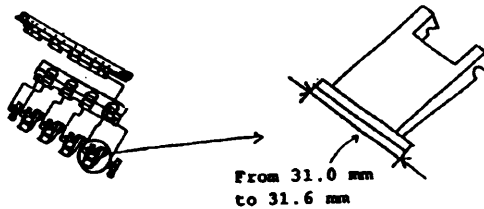
Figure 13

To facilitate production, the pinch roller arm (QB1-0010) has been changed in shape.

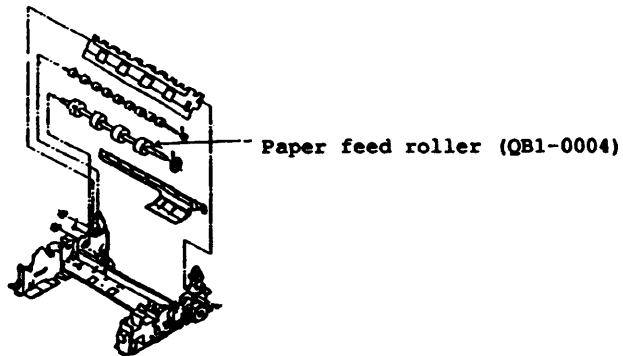
Figure 15

To improve the paper feed accuracy, the rubbers used for the paper feed roller has been changed in hardness.

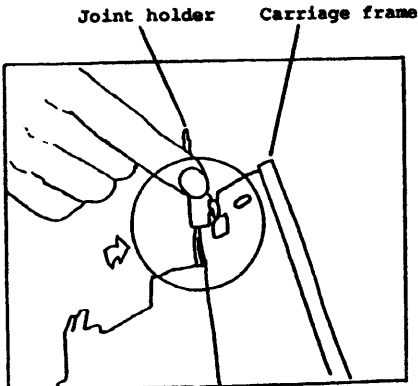
Figure 3

The following figures show the cases, in which the ink supply tubes are lifted up (Figure 4), and in which they are not (Figure 3).

When the ink supply tubes are not lifted up, the joint holder barely reaches the carriage frame.

If the ink supply tubes come off or loose, wipe off the ink attached around the joint part of the tubes completely and re-insert them into the supply joint.

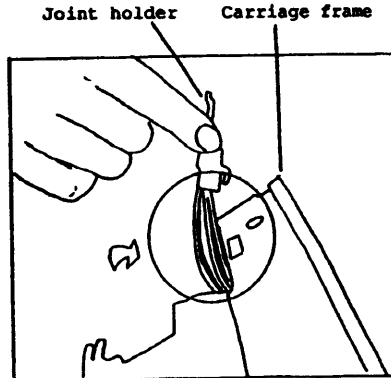
Figure 4

When the ink supply tubes are lifted up, the joint holder fully reaches the carriage frame.

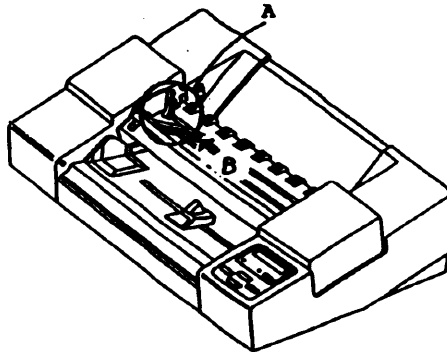
Figure 1

If the printer is powered OFF and ON during the paper pick-up operation (while the pressure plate comes up and the cam is rotating), the carriage may stop around A in figure 1, indicating "5E SERVICE".

When the printer is powered OFF during the paper pick-up operation, the cam stops rotating at the abnormal position. In such a case, when the printer is powered ON again, the carriage (C in figure 2) hits the cam (D in figure 2) during initialization, causing the "5E SERVICE" error. This occurs only when the above abnormal operation is done in the printer with the modified cam (QB1-0024-020), whose outer round part was thickened.

If the "5E SERVICE" is indicated, try the following two steps.

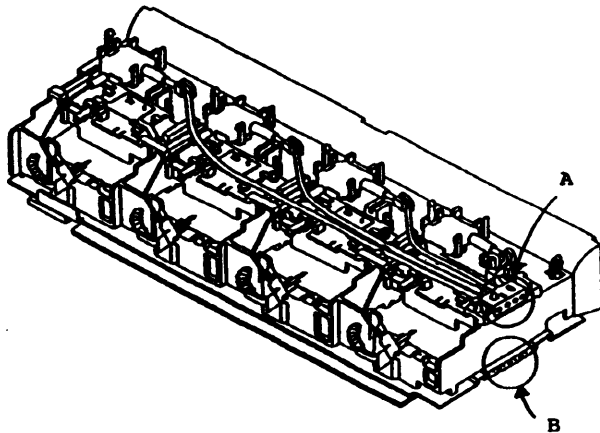
Figure 1

When the ink compartment unit is returned from a customer, instruct service personnel to send it in the following manner to avoid the ink leakage from the ink tubes.

1. Insert the tip of a syringe (assigned as a special tool) into the ink outlet at the ink supply joint (A in Figure 1), then suck the ink from the ink supply tubes.
2. Conduct the above for all (four) colors.
3. Remove the ink compartment unit from the printer main body, then the ink cartridges from the ink compartment unit. Insert the ink outlet at the ink drain joint (B in Figure 2), then suck the ink from the ink drain tubes in the same way.
4. Conduct the above for all (four) colors.
5. Cover the ink supply joint and the ink drain joint with paper towel, and with the vinyl bag.

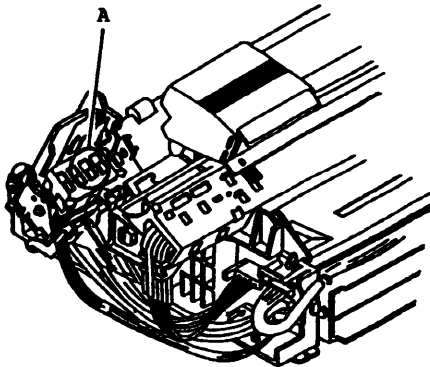
Figure 1

If the capping operation is not performed by the failures of power supply (including the electrical system) or purge unit, the heads should be capped manually. However, there is a possibility that the ink leaks from the air-through holes (A in Figure 1) since they may not be properly closed according to the abnormal capping position. Also, they cannot be capped manually. Therefore, if the problematic printer is returned from a customer, cope with the problem in the following method.

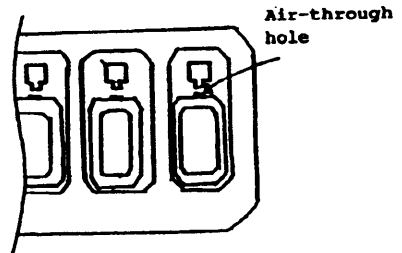
Air-through holes are opened.

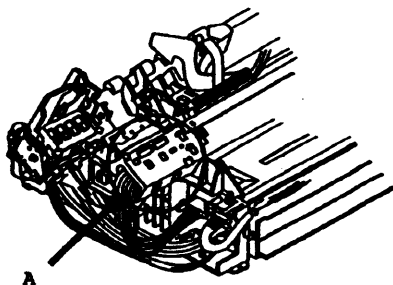
Figure 1

The following changes have been made to the carriage frame:

1. To prevent electrostatic discharge in the BJC-880, a M3-tapped hole has been added (figure 3).
2. To easily confirm the level of ink in the subtank (figure 2) in the carriage unit, the shape of the observation hole has been changed as shown in figure 3.

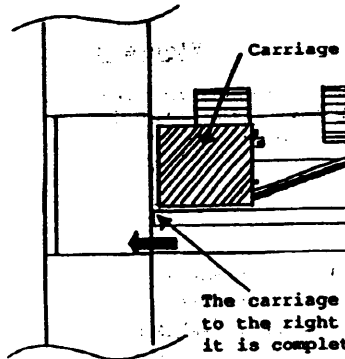
**Figure 1**

The printer performs cleaning operation in the following sequence: capping the head, purging the ink, moving the carriage to the right (figure 1), then wiping the head while the carriage is returning to the home position. (In addition to the above, in cleaning B, which is performed after the ink cartridge is replaced, the carriage moves to the left and right slightly several times). In the above cleaning operation, the ink may remain on the face of the head since the purging capability of the ink absorber is relatively low. The ink is splashed on the paper by the shock caused when the carriage moves to the right.

The carriage moves to the right until it is completely visible, stops for 0.5 second, then slowly returns to the home position (in the direction of the arrow).

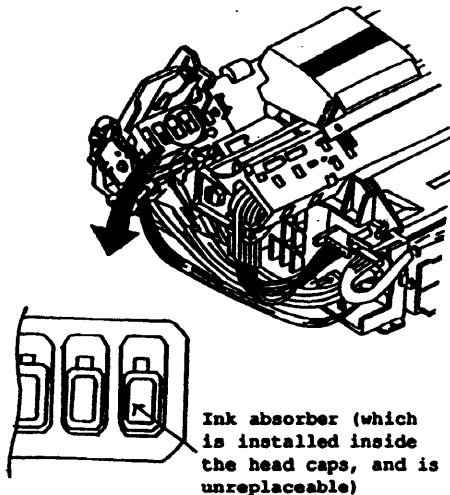
Figure 2

Thickness: from 1 mm  
to 1.5 mm  
(changed)

To prevent this, the thickness of the ink absorber has been increased from 1 mm to 1.5 mm (figure 2).

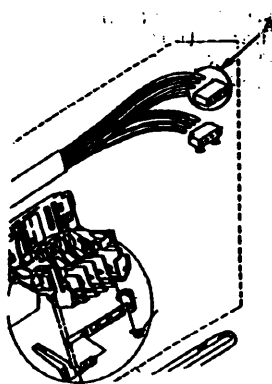
Figure 1: Carriage unit (2)

The colour of the rubber joints listed below has been changed from grey to black:

1. Supply joint (B) : A in Figure 1, QB1-0075
2. Rubber joint 16mm : B in Figure 2, QB1-0150
3. Rubber joint 10mm : C in Figure 2, QB1-0163
4. Supply joint (A) : D in Figure 2, QB1-0166

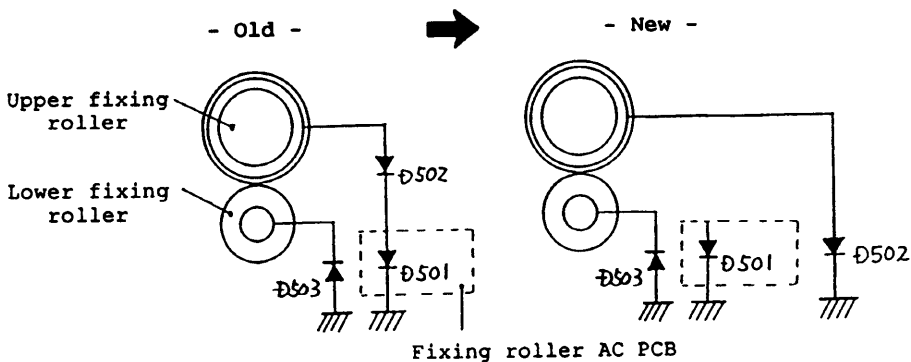
Figure 1

The location of D502 has been changed.  
Along with this change, the grounding method of the upper fixing roller has been changed. Refer to figures 1, 2 and 3.

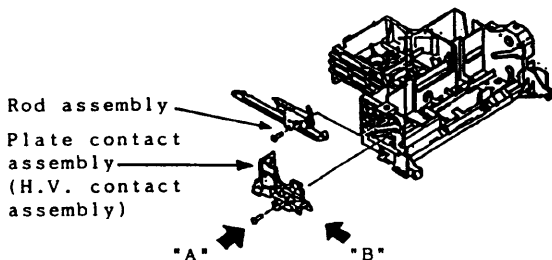
Figure 1

When the EP-L cartridge is installed, the plate contact mount might be deflected. To prevent this, the shape of the plate contact has been modified as shown in figures 1, 2 and 3.

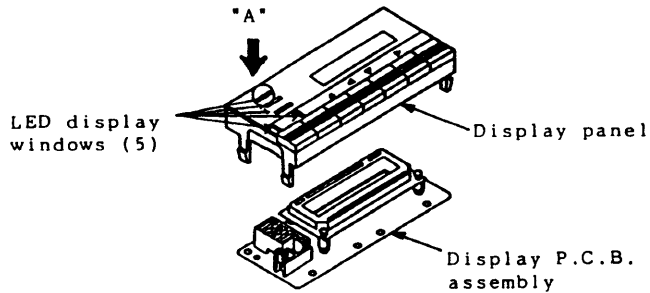
**Figure 1**

The LED display windows may not overlap the LEDs completely, causing uneven brightness. To ensure even brightness, the back of the LED display windows is painted in milky white. Refer to figures 1 and 2.

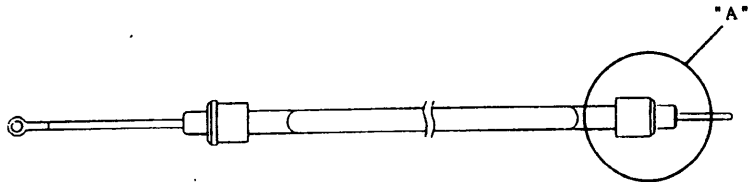
**Fig. 1: Halogen heater**

To lessen the impact on the halogen heater during transportation, a wave washer has been added to the heater. Refer to figures 1 and 2.

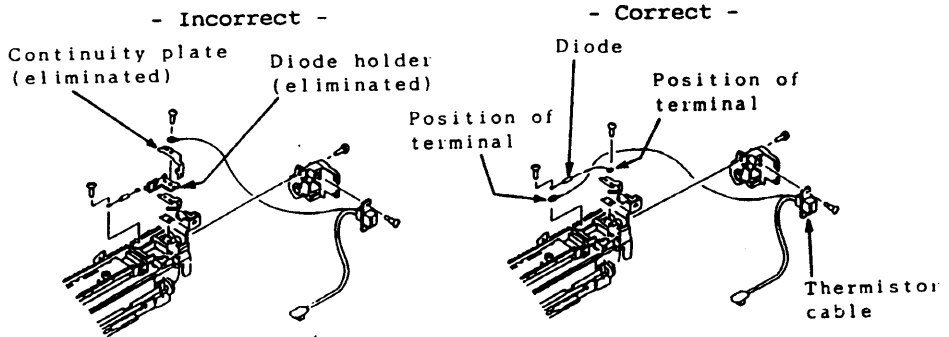
**Figure 1**

Please correct the errors in Figure 810 (Fixing Assembly) of the Parts Catalogue for models LBP-4 PLUS & LBP-4 LITE as shown in figure 1.

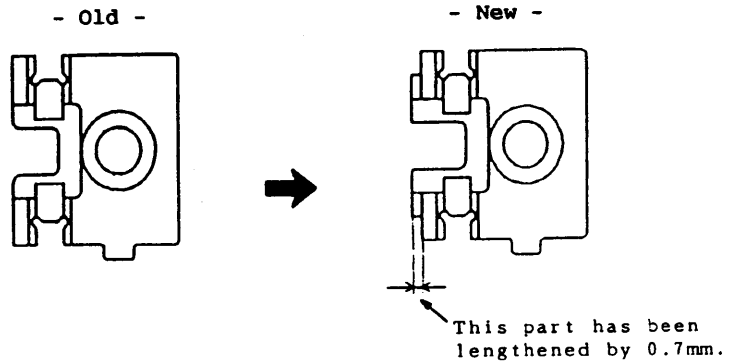
**Fig. 1: Bushing**

The lower fixing roller bushing in the Fixing Assembly has been modified as illustrated in figure 1.

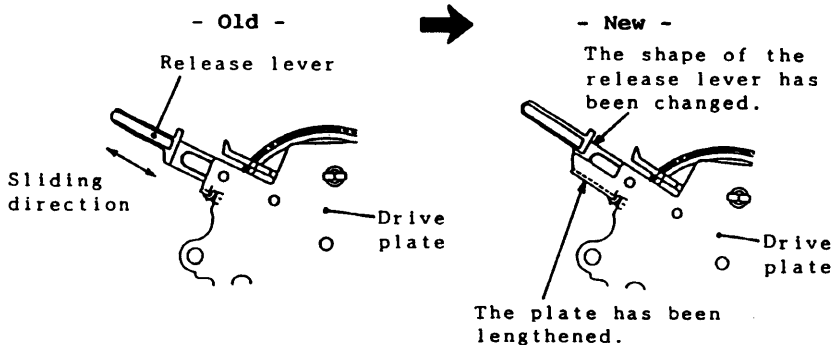
**Figure 1**

**SUBJECT : DRIVE ASSEMBLY/DRIVE PLATE**

The release lever may come off from the front cover unit. To prevent this, the drive plate has been changed as shown in figure 1.

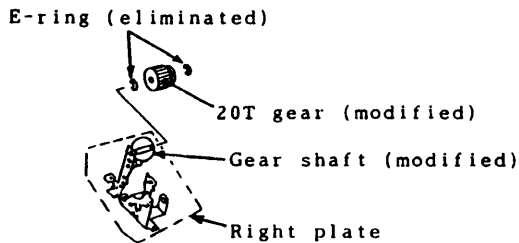
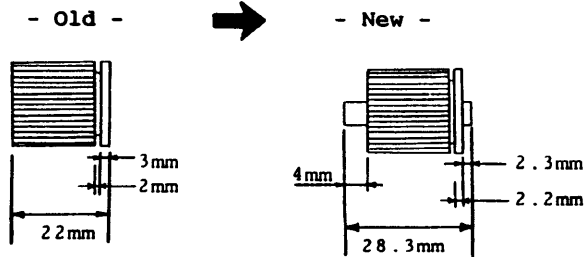
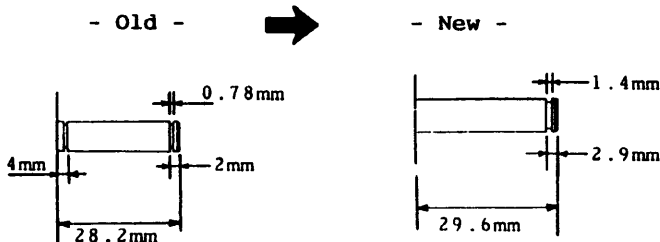
**DESTROY : SERVICE BULLETIN LBP-228**  
**SUBJECT : FIXING ASSEMBLY/20T GEAR**

The 20T gear in the Fixing Assembly was secured to the gear shaft with two E-rings. The gear and shaft have been modified and the E-rings have been eliminated. Refer to figures 1, 2 and 3.

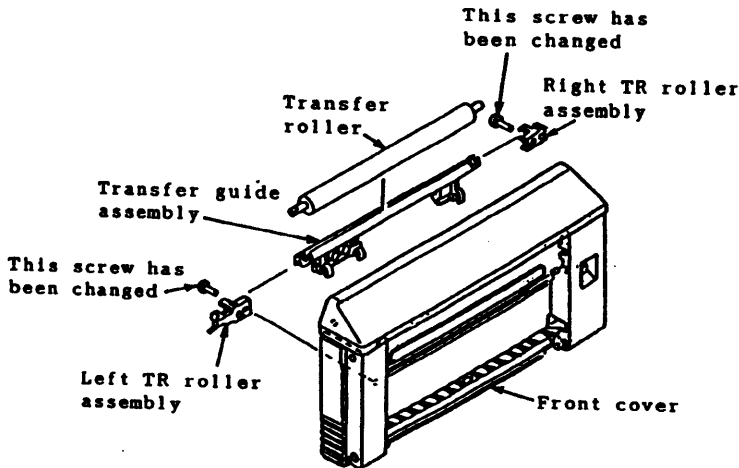
**Figure 1**

**SUBJECT : FRONT COVER ASSEMBLY**

The screws fixing the right and left TR Roller Mount Assemblies have been changed. Refer to figure 1.

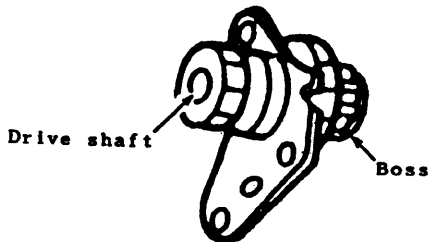
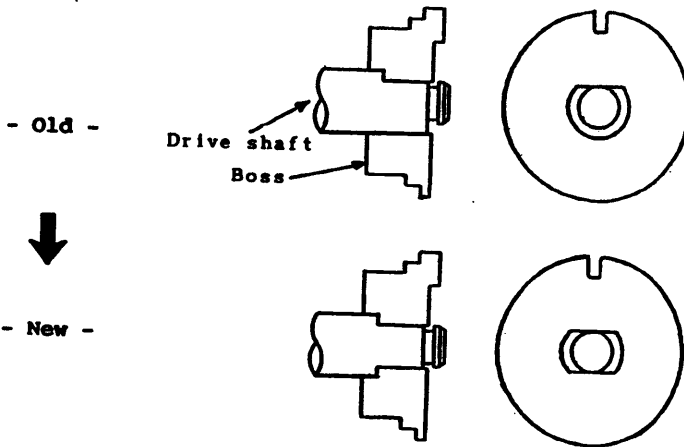
**SUBJECT : DRUM DRIVE ASSEMBLY**

To secure the joint of the drive shaft and drive clutch, the joint of these two parts has been changed as shown in figures 1 and 2.

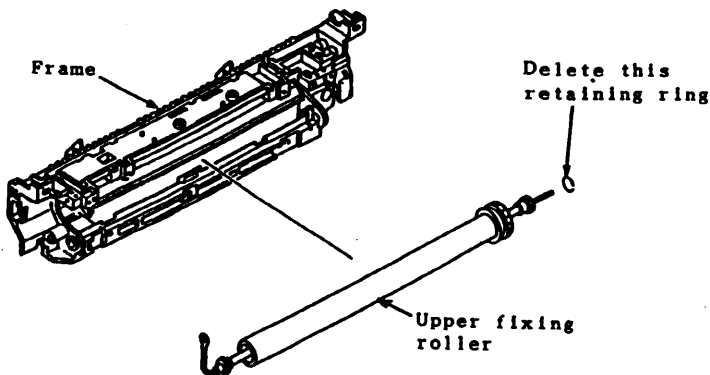
Figure 1

**SUBJECT : CORRECTION OF PARTS CATALOGUE**

Although a retaining ring is not used, it is shown in the Parts Catalogue for model LBP-4/4 PLUS (figure 1). Please correct the Parts Catalogue as indicated.

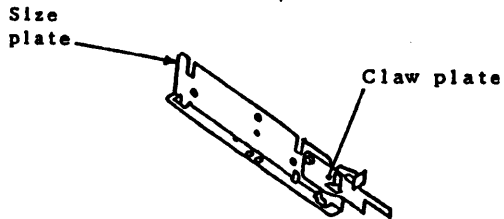
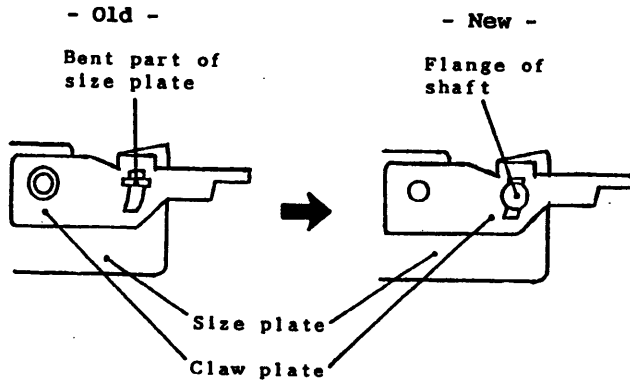
**SUBJECT : SIZE PLATE OF CASSETTE**

To ease the movement of the claw plate of the cassette, the cassette size plate has been modified. Refer to figures 1 and 2.

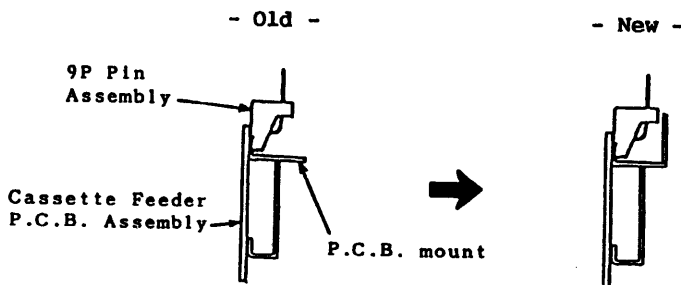
Figure 1

**SUBJECT : CASSETTE FEEDER**

When the cassette feeder is installed in the machine, the Pin Assembly (9P) may topple down. To prevent this, the P.C.B. mount has been modified. Refer to figure 1.

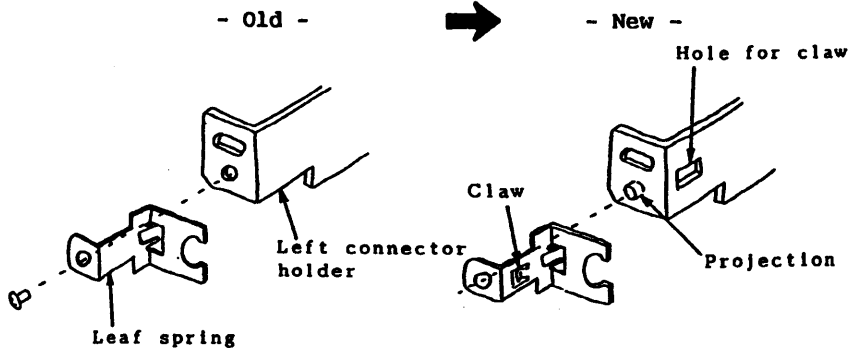
**Figure 1**

**SUBJECT : FIXING ASSEMBLY/MOUNTING THE LEAF SPRING**

The leaf spring was mounted to the left connector holder with a binding head screw. This mounting method has been changed. Refer to figure 1.

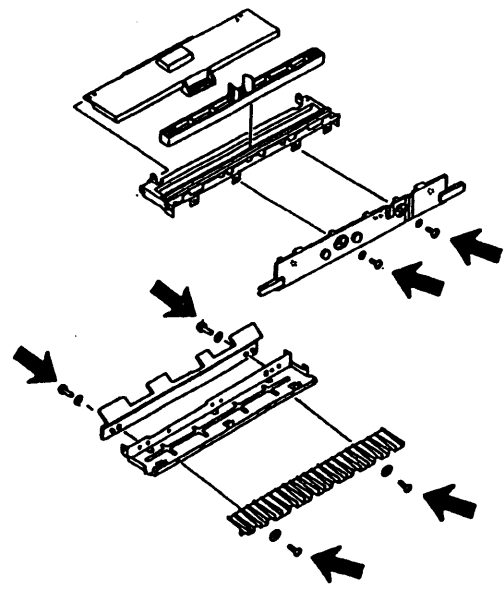
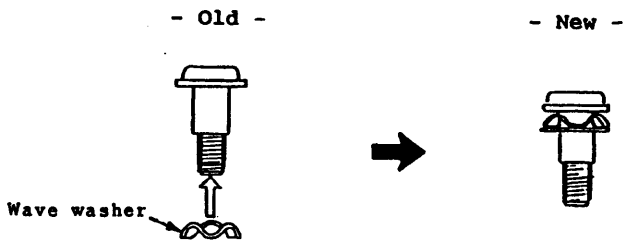
**SUBJECT : FIXING ASSEMBLY**

Stepped screws (indicated by arrows in figure 1) have been changed. Refer to figure 2.

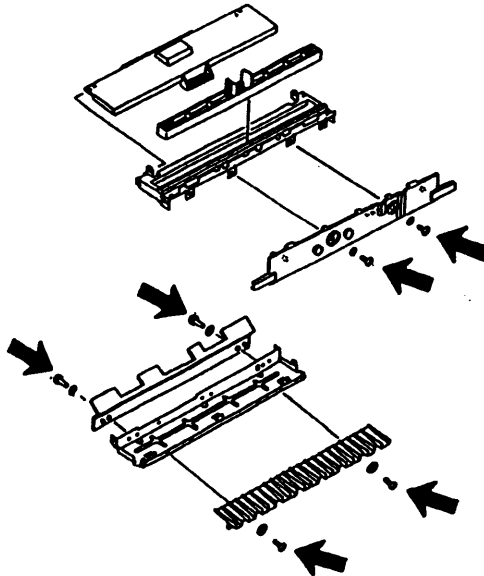
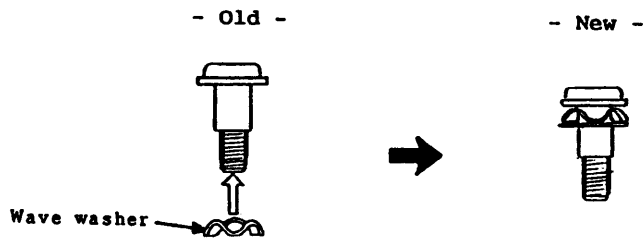
**SUBJECT : FIXING ASSEMBLY**

Stepped screws (indicated by arrows in figure 1) have been changed. Refer to figure 2.

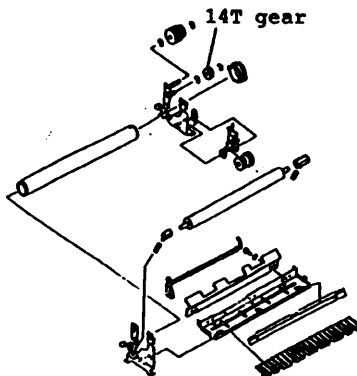
**Figure 1**

**SUBJECT : FIXING ASSEMBLY**

The inner diameter of the 14T gear shown in figure 1 has been changed: 6mm → 6.1mm.

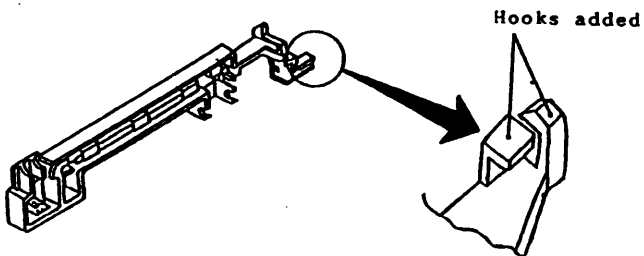
**Fig. 1: Sensor mount**

The sensor mount has been modified, so that it fixes the assembly cable at (added) hooks. Along with this modification, a cable band\* has been eliminated.

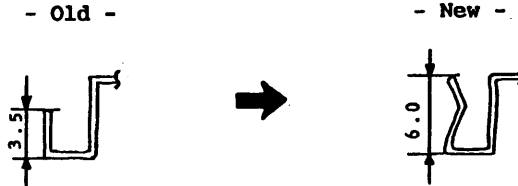
**Fig. 1: Cable plate**

**SUBJECT : FIXING ASSEMBLY/CABLE PLATE**

The cable plate has been modified as shown in figure 1.

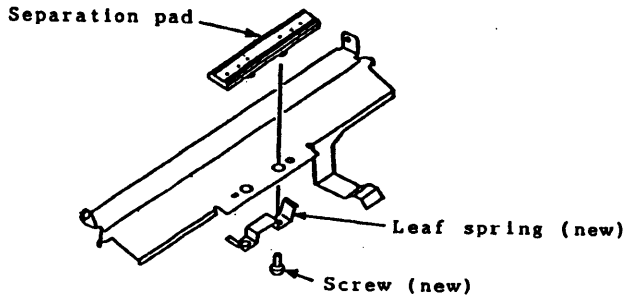
Figure 1

**SUBJECT : TRANSFER GUIDE ASSEMBLY/SEPARATION PAD**

The separation pad in the Transfer Guide Assembly has been modified. Refer to figures 1 and 2.

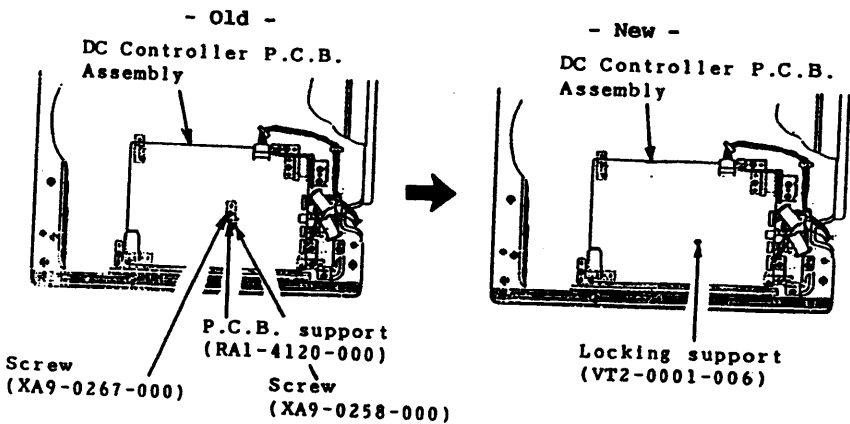
**Figure 1**

The following modifications have also been made (figure 1):

1. The diameter of the hole in the DC Controller P.C.B. Assembly has been changed from 4.5mm to 4.0mm.
2. An additional hole (4.8mm) is made in the bottom plate.
3. Two screws have been eliminated.

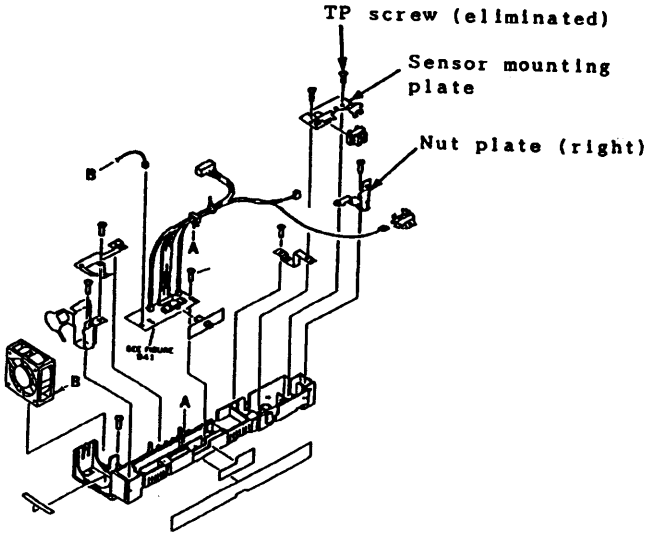
**Figure 1**

**SUBJECT : SENSOR MOUNTING PLATE**

The sensor mounting plate and right nut plate (figure 1) have been combined. Along with this change, a TP screw has been eliminated.

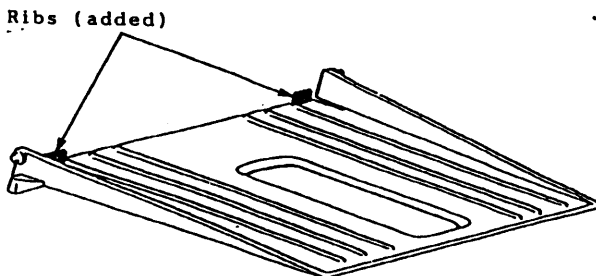
**Fig. 1: Face-up tray**

Printed sheets may slip, in the face-up delivery mode, through the gap between the printer main body and the face-up tray.

To prevent this, ribs have been added to the tray. Refer to figure 1.

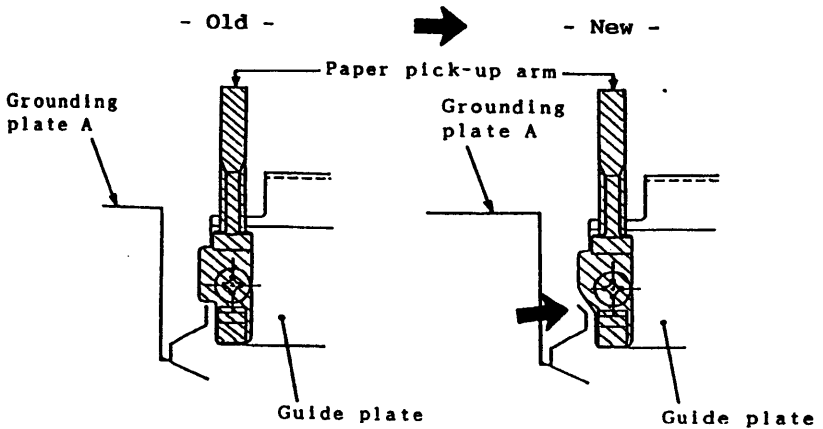
**Figure 1**

When the guide plate is attached to the front cover, the paper pick-up arm may catch grounding plate A.

To prevent this, the paper pick-up arm and grounding plate A have been modified. Refer to figure 1.

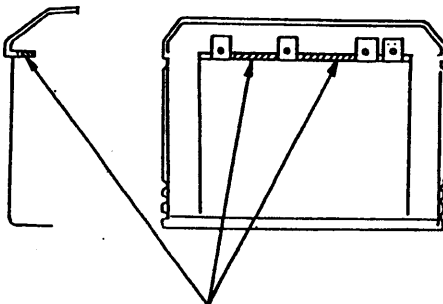
**Fig. 1: Front panel**

The ribs on the rear side of the front panel have been lengthened.

Ribs (shaded parts) have been lengthened by 4mm.

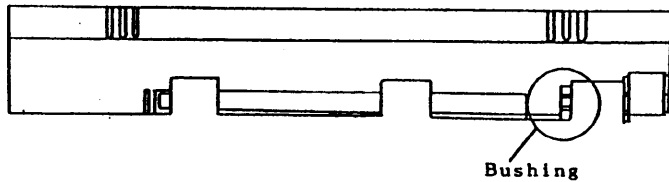
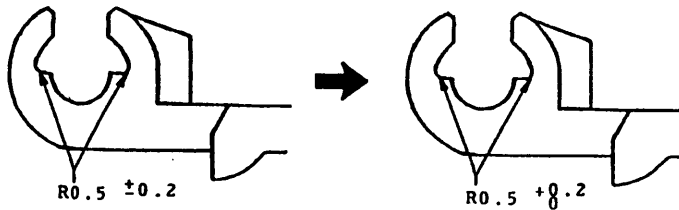
**Fig. 1: Front upper cover (top view)**

The front upper cover bushing has been strengthened as illustrated in figures 1 and 2.

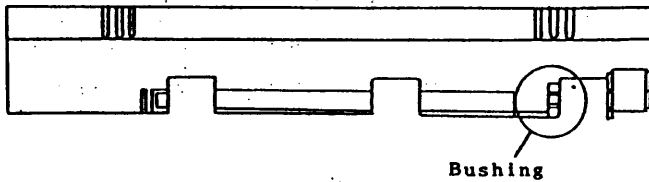
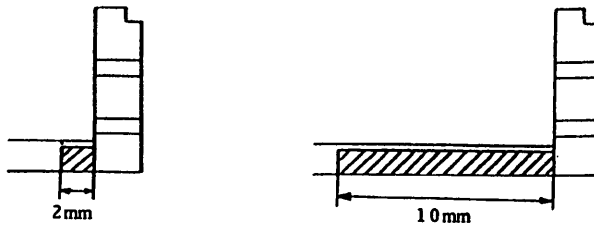
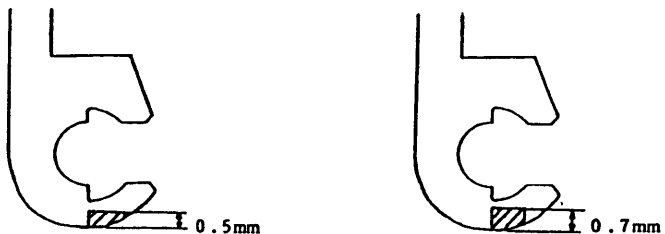
**Fig. 1: Front upper cover (top view)**

The front upper cover bushing has been strengthened as illustrated in figures 1, 2a & 2b.

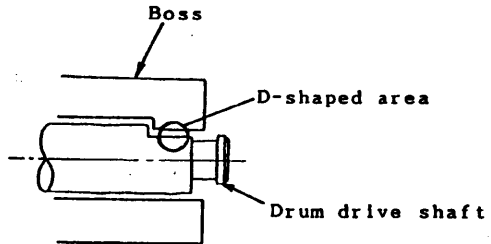
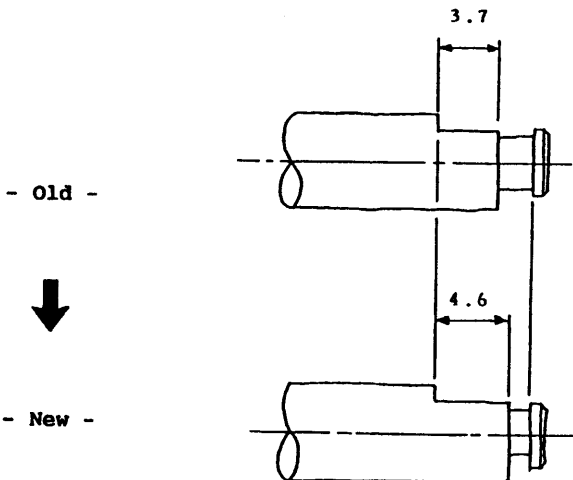
**Fig. 1a: Drum Drive Assembly**

The flat D-shaped area of the drum drive shaft has been lengthened by 0.9mm. Refer to figures 1a & 1b.

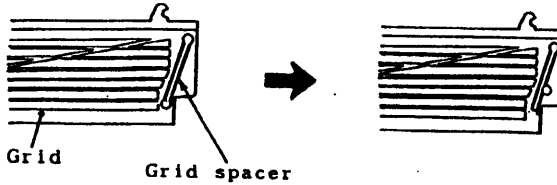
Figure 3

Toner stains on the primary corona wire may cause black streaks at the right edge of the printed image. To prevent this, the following modifications have been implemented:

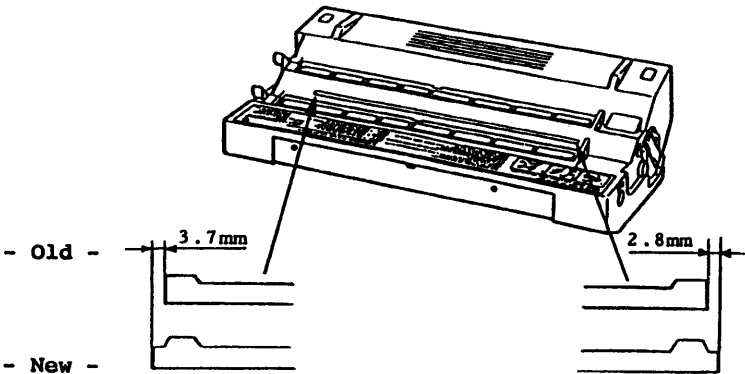
Figure 4

4. The primary corona wire access window has been lengthened (figure 4).

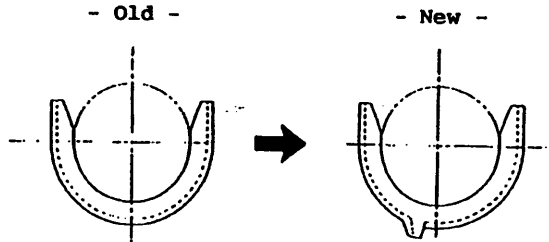
**Fig. 1: U-bushing**

To prevent the "U-bushing" in the Fixing Assembly from rotating together with the upper roller, a projection has been added. Refer to figure 1.

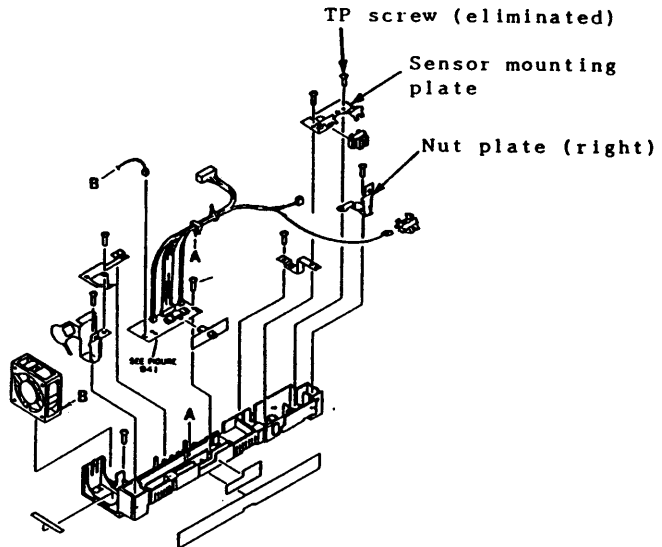
Figure 1

The sensor mounting plate and right nut plate (figure 1) have been combined. Along with this change, a TP screw has been eliminated.

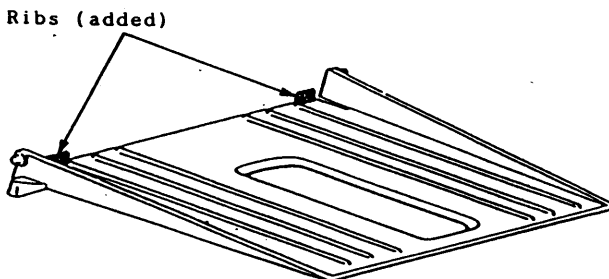
**Fig. 1: Face-up tray**

Printed sheets may slip, in the face-up delivery mode, through the gap between the printer main body and the face-up tray.

To prevent this, ribs have been added to the tray. Refer to figure 1.

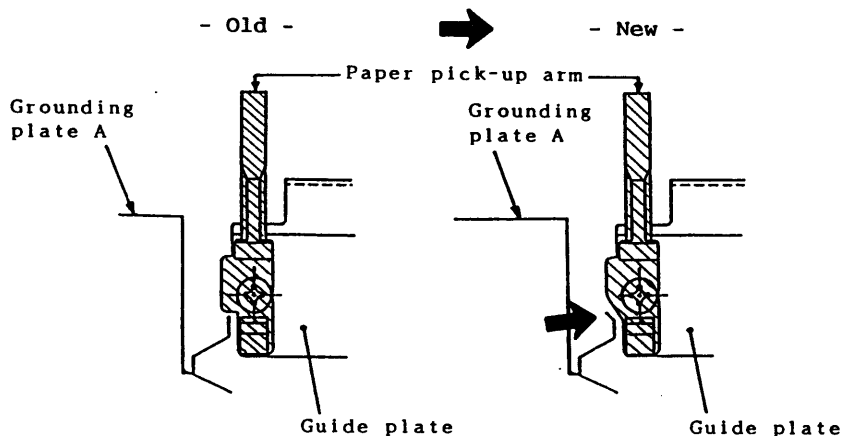
**Figure 1**

When the guide plate is attached to the front cover, the paper pick-up arm may catch grounding plate A.

To prevent this, the paper pick-up arm and grounding plate A have been modified. Refer to figure 1.

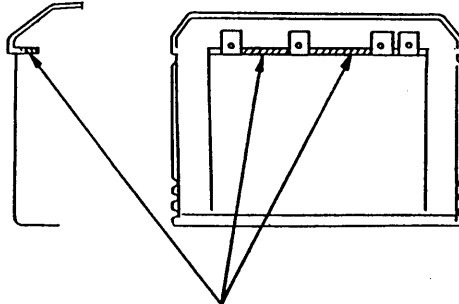
**Fig. 1: Front panel**

The ribs on the rear side of the front panel have been lengthened.

Ribs (shaded parts) have been lengthened by 4mm.

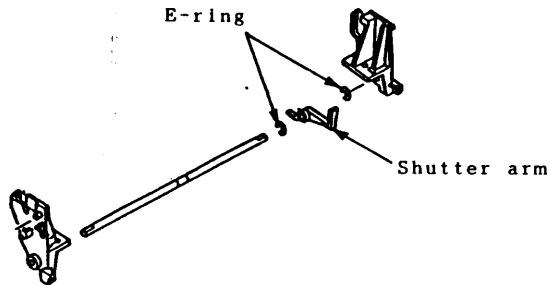
Figure 1

The shutter arm has been modified. It is no longer secured using left and right E-rings.

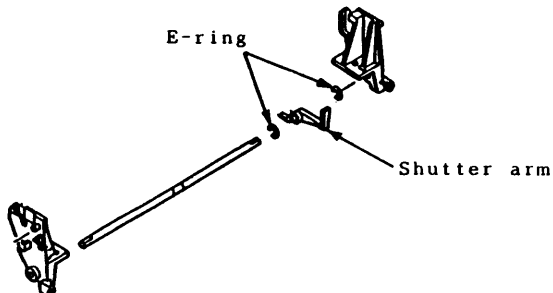
Figure 1

The shutter arm has been modified. It is no longer secured using left and right E-rings.

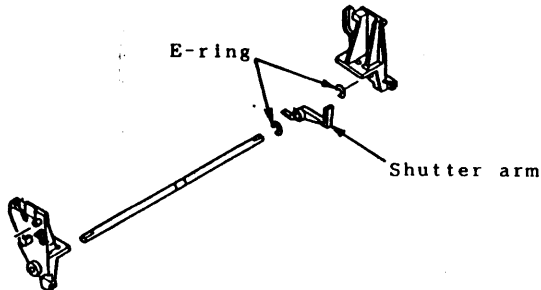
Figure 1

The shutter arm has been modified. It is no longer secured using left and right E-rings.

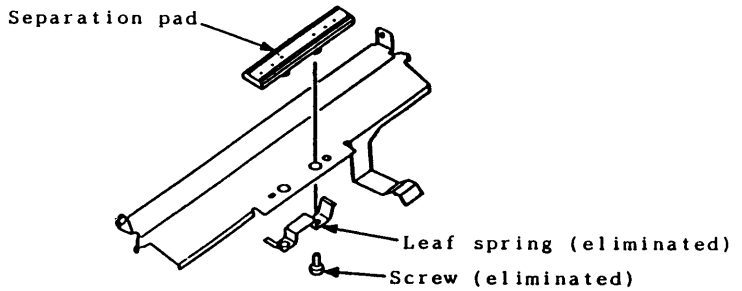
Figure 1

The separation pad in the Transfer Guide Assembly has been modified. Refer to figures 1 and 2.

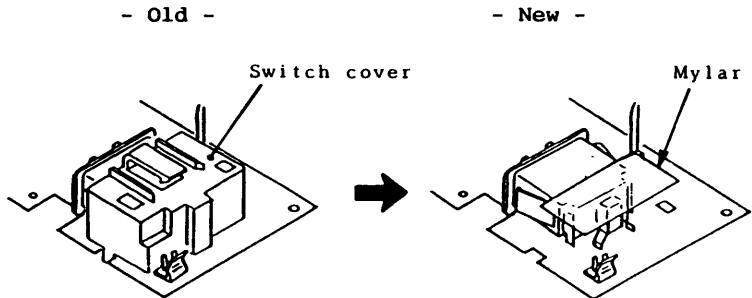
Figure 1

The switch cover on the AC Controller P.C.B. Assembly has been changed as illustrated in figure 1.

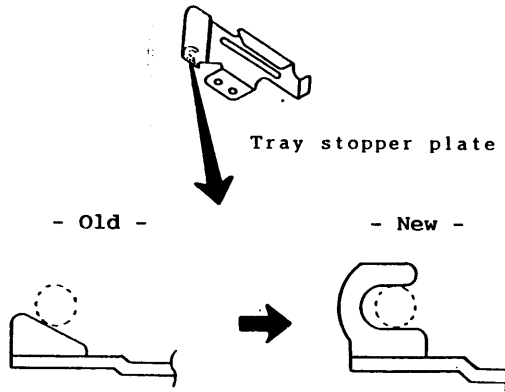
**Figure 1**

The tray stopper plate has been modified to prevent it from shifting. Refer to figure 1.

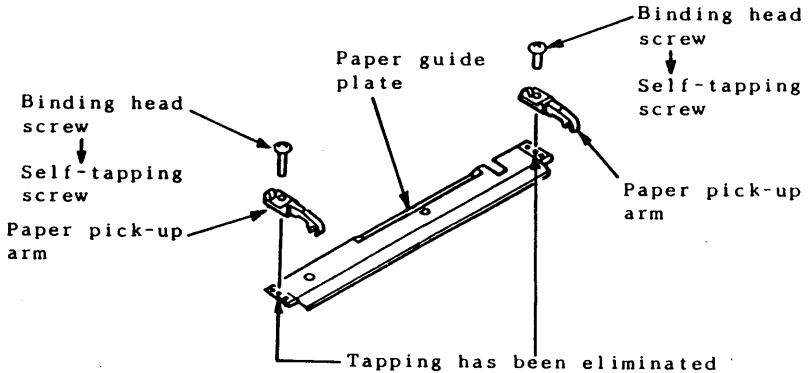
**Figure 1**

The screws securing the paper pick-up arms to the paper guide plate have been changed from binding head screws to self-tapping screws. Refer to figure 1.

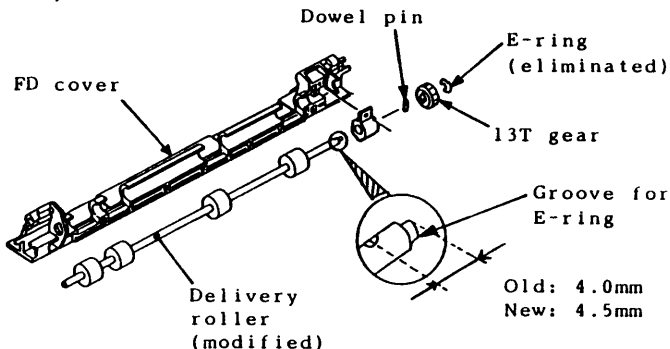
**Figure 1**

1. The E-ring and the groove for this E-ring in the delivery roller have been eliminated (figure 1).
2. The position of the dowel pin in the delivery roller has been changed (figure 1).

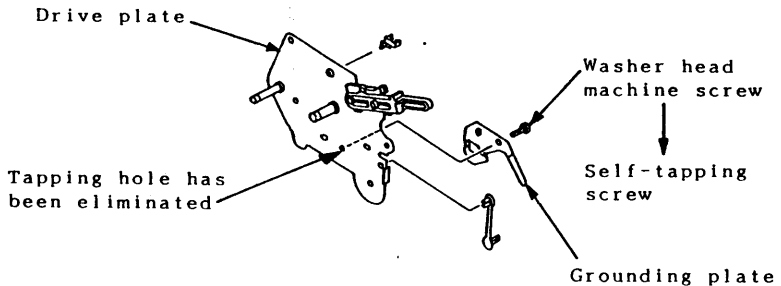
Figure 1

The screw securing the grounding plate has been changed from a washer head machine screw to a self-tapping screw. Refer to figure 1.

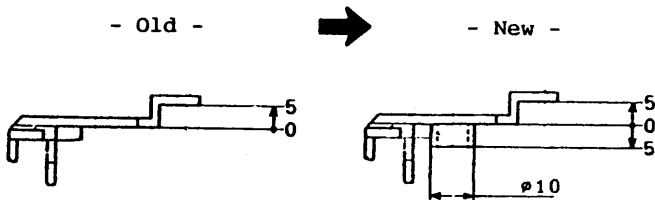
**Fig. 1: Front cord cover**

The cord might be caught by the front cord cover. To prevent this, the shape of this cover has been changed as shown in figure 1.

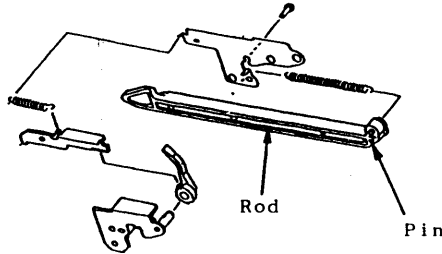
Fig. 1: Rod Assembly

The separate metallic pin, which was originally attached to the rod (figure 1), is now incorporated into the molded assembly.
