**Dansk Data Elektronik A/S**

**Technical TPP  
Field Change Notes**

**Updated 27th December 1994**

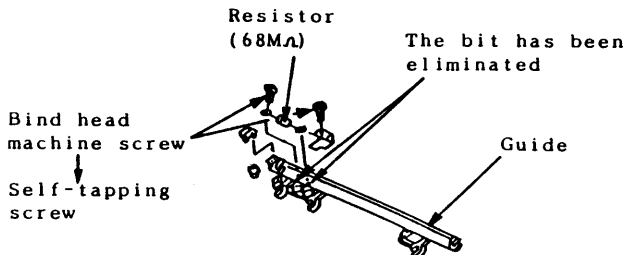
**Figure 1**

The bit where the 68MΩ resistor is fixed has been eliminated. Along with this change, the screws to fix the resistor have been changed from bind head machine screws to self-tapping screws. Refer to figure 1.

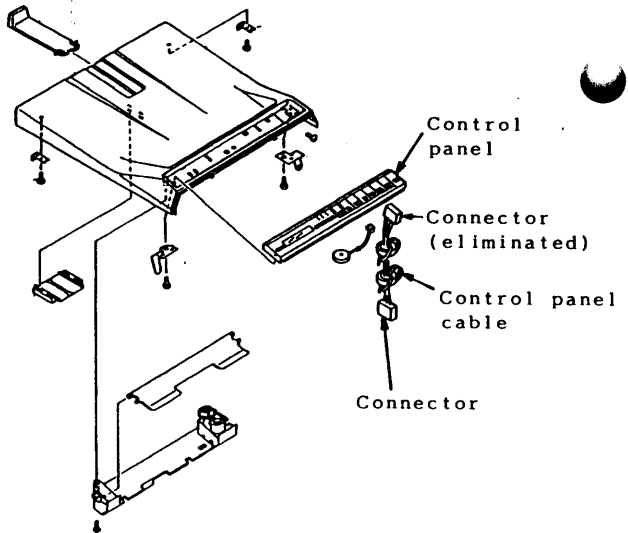
Figure 1

The control panel cable is now directly soldered to the Control Panel P.C. Board.  
The cable is, therefore, no longer available as a separate service spare part. Refer to figure 1.

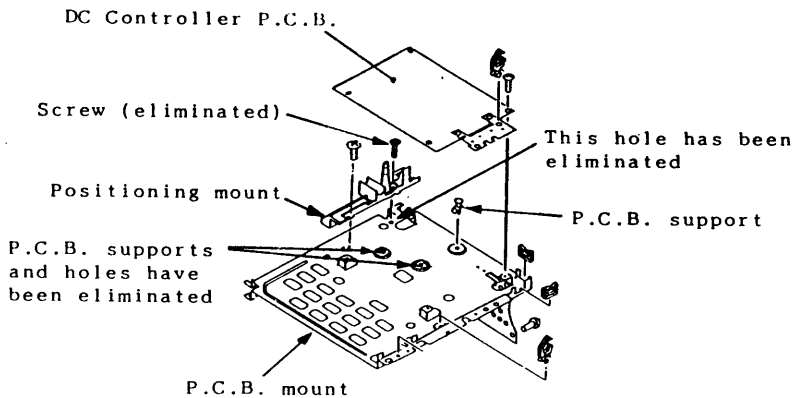
**Figure 1**

Two of the three P.C.B. supports for the DC Controller P.C. Board have been eliminated. Along with this, the two holes for these P.C.B. supports in the P.C.B. mount have also been eliminated. Refer to figure 1.

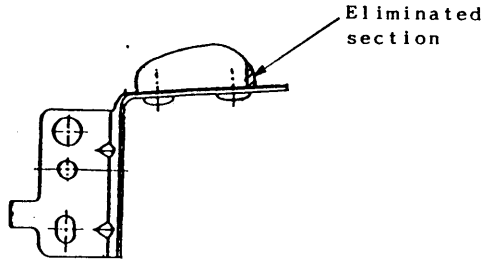
Fig. 1: Leaf spring

- A. To prevent the leaf spring from interfering with the main body block, its shaded part has been eliminated. Refer to figure 1.

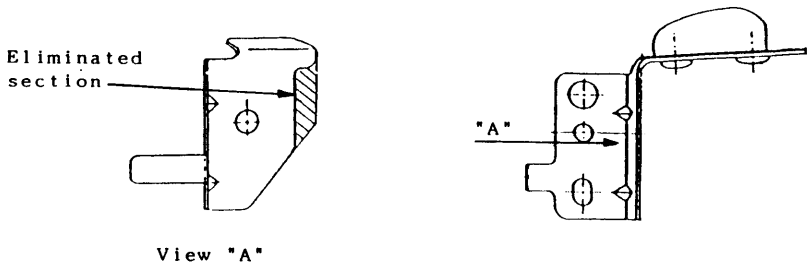
Fig. 2: Leaf spring

- B. The leaf spring may come in contact with the paper sensing arm and restrict its movement. To prevent this, the shaded part of the spring (figure 2) has been eliminated.

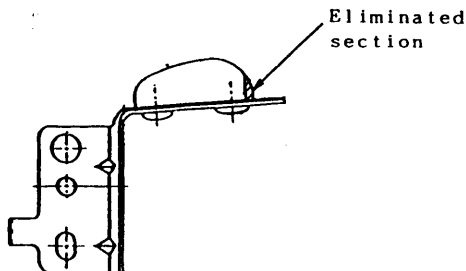
**Fig. 1: Leaf spring**

- A. To prevent the leaf spring from interfering with the main body block, its shaded part has been eliminated. Refer to figure 1.

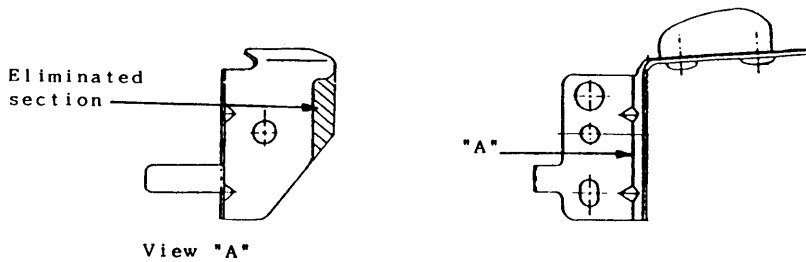
**Fig. 2: Leaf spring**

- B. The leaf spring may come in contact with the paper sensing arm and restrict its movement. To prevent this, the shaded part of the spring (figure 2) has been eliminated.
