Dansk Data Elektronik A/S

**Technical
Field Change Notes**

Updated 1st November 1996

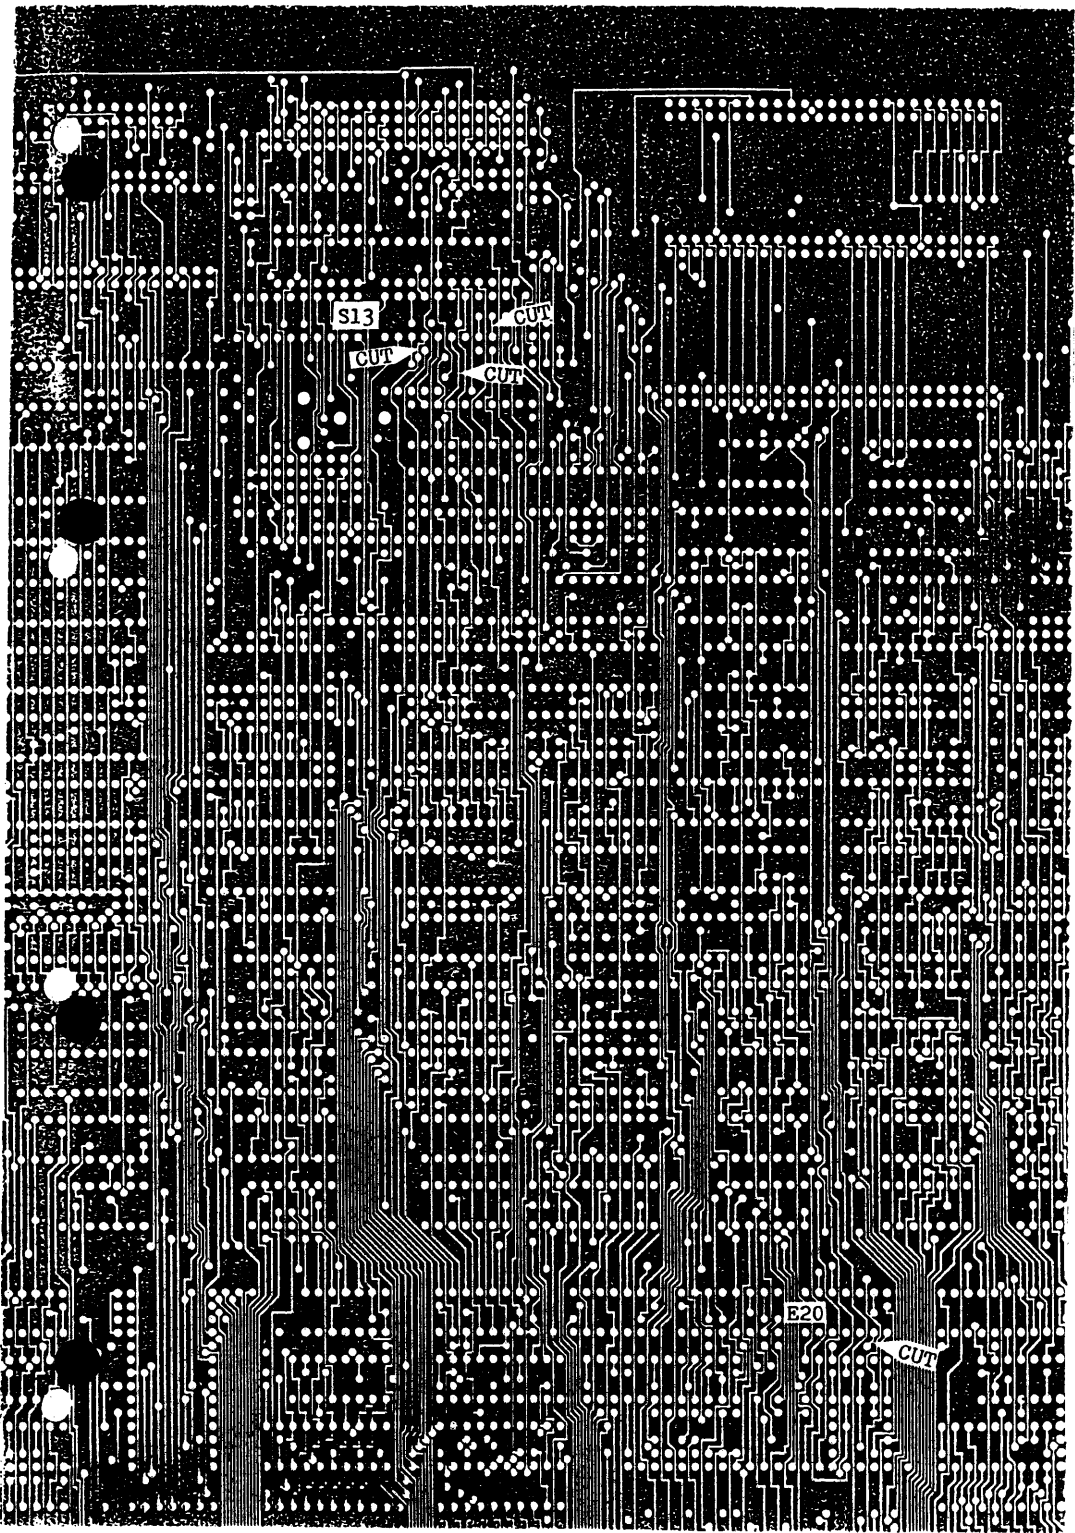
CIRCUITS INVOLVED:

Name	Type	Position
S13	PAL D2P60	B 13,5.
D2	2681	B 13,2.
S3	74LS273	B 11,7.
S10	74S74	B 11,5.
S18	74S74	B 12,7.
E20	74S00	A 11,8.
G6	74S04	B 1,3.

S13

CUT

E20

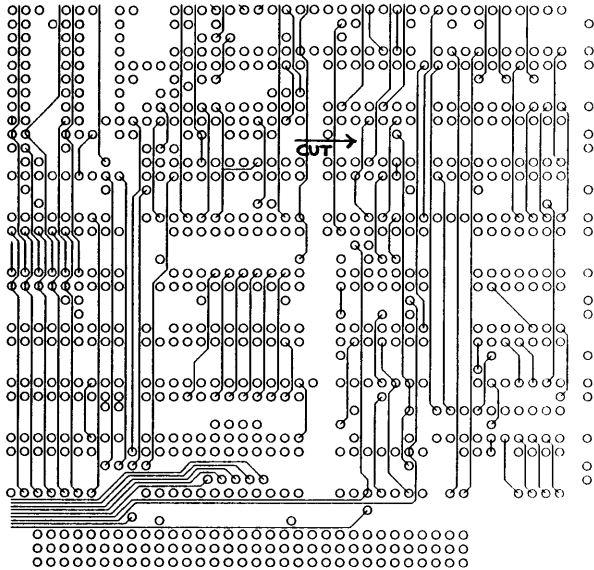
DIOC 4000 ISS 1:

Name	Type	Position
P5	74F74	B4
O6	74F74	B3
L1	D3161	A4

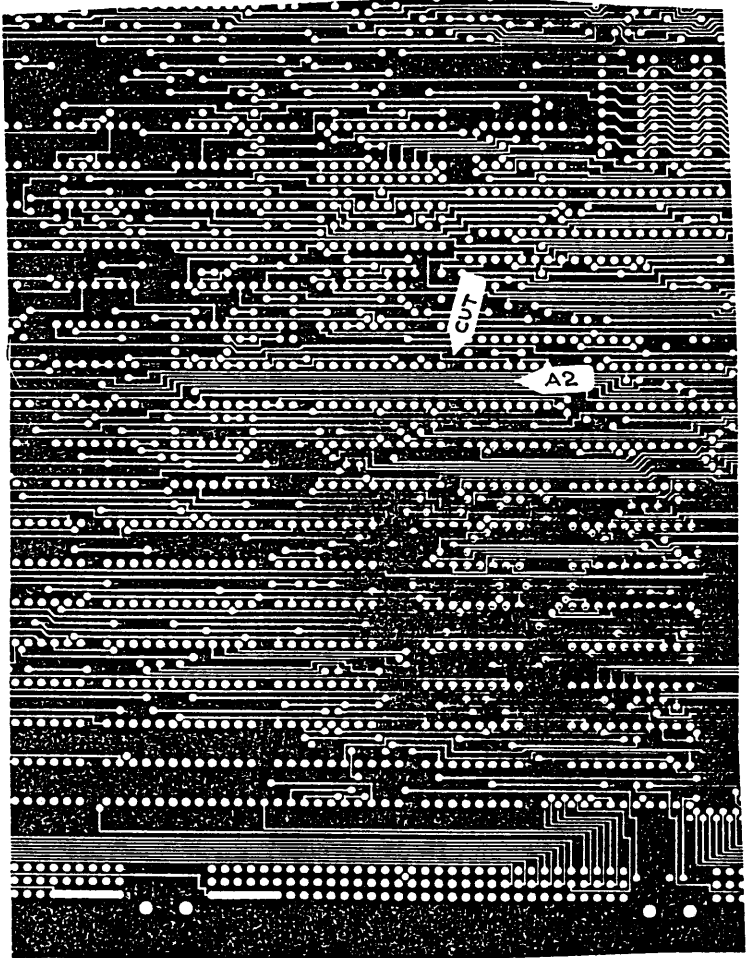
Component side:

Name	Type	Position
A2	74LS05	A 6,5.
A3	74LS03	B 2,10.
A4	74LS257	B 1,10.
F2	74ALS573	A 7,3.
01	PAL CC70	A 8,7.
02	PAL CC40	A 9,7.
M9	74LS00	B 6,1.
T2	PAL CC10	B 5,4.

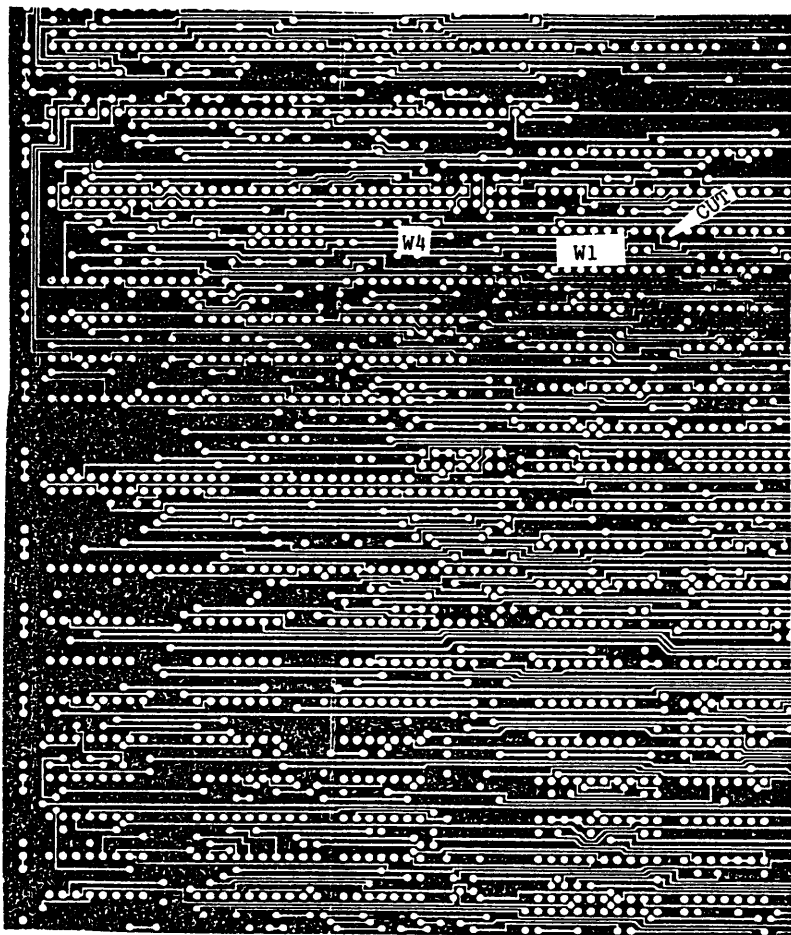
Component side:

NAME	TYPE	POSITION
W1	PAL CC130	B 10,7
W4	8251	B 10,8

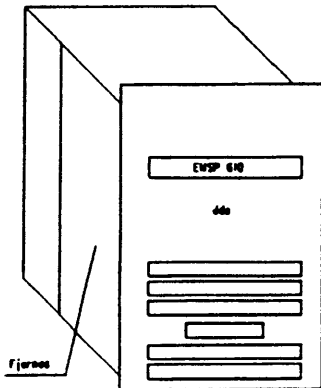
Figure 1.

MODIFISERING EMSP-610

MOD B. 12/11-92 J.C.C.

1. Remove the front left heat sink by removing 12 screws.
2. Mount the resistor 4k7 4W in the two empty holes in the PCB. See figure 1 for mounting details.
3. Secure the resistor on the PCB by using some silicone glue.
4. Mount the heat sink again.
5. Update the revision field on the front plate of the power supply from "empty" to B by writing a B in the revision field.
